## The combined use of PSInSAR and UAV photogrammetry techniques for the analysis of the kinematics of a coastal landslide affecting an urban area (SE Spain)

**Abstract** In the present work, the case of the Cármenes del Mar resort (Granada, Spain) is shown. It can be considered one of the most extreme examples on the Mediterranean coast of severe pathologies associated with urban development on coastal landslides. The resort, with 416 dwellings, was partially built on a deep-seated landslide which affects a soft formation composed of dark graphite schists. In November 2015, the City Council officially declared a state of emergency in the resort and 24 dwellings have already been evacuated. We have used two remote sensing techniques to monitor the landslide with the aim of identifying and measuring a wide range of displacements rates (from mm/year to m/year): (1) PSInSAR, exploiting 25 ENVISAT SAR images acquired from May 2003 to December 2009, and (2) photogrammetry, considering the output from two Unmanned Aerial Vehicle (UAV) flights made in June 2015 and January 2016 and the outdated photos from a conventional flight in 2008. The relationship between the geology of the site, d

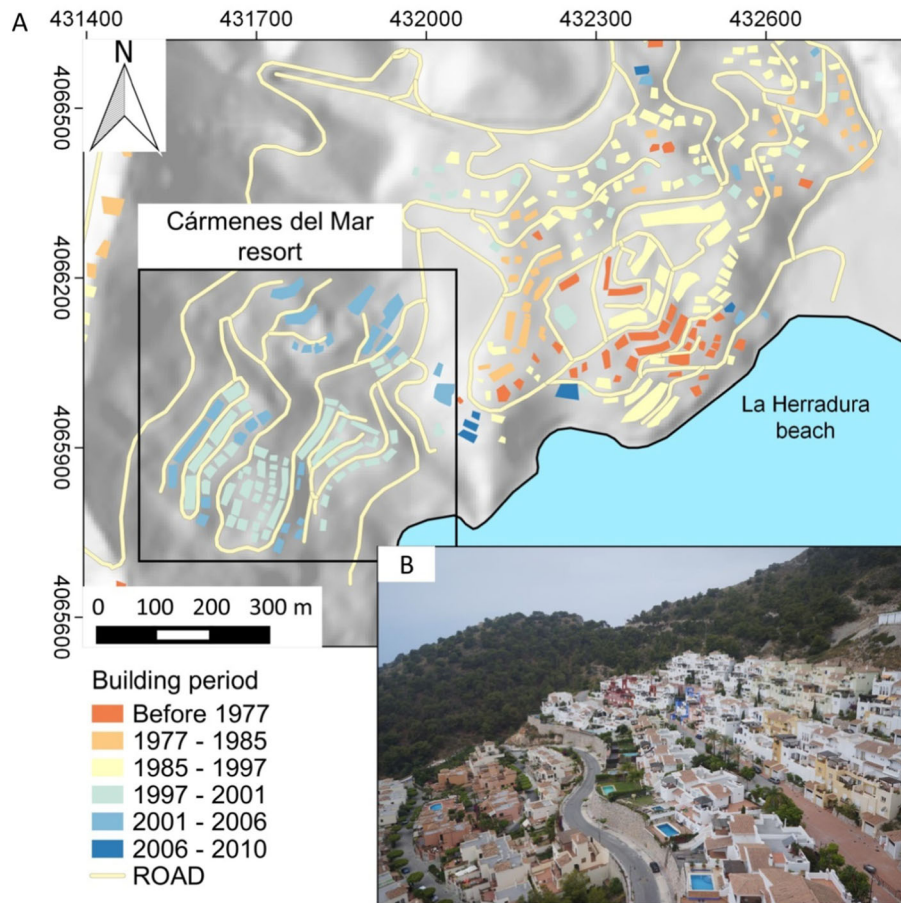
**Fig. 2** a History of the urban development on the eastern side of the Cerro Gordo Promontory. b The community of the Cármenes del Mar resort consists of 416 houses (detached or terraced) as well as some communal facilities

until 2006, when the last dwellings in the resort were completed (Fig. 2). The resort is located on a steep coastal slope (35° on average) which is covered by scrub vegetation and pine trees. The area had to be terraced, and numerous earthmoving and fill-in works were carried out to level the land. The uppermost houses are located at an altitude of around 200 m and the urban development was extended downslope to an altitude of 50 m. The development consists of 416 luxury houses with two to three floors, many of them with private swimming pools (Fig. 2b). They are detached or terraced housing, the most recent dominating the seafront. Shallow foundations were used in all the houses, and especially spread-footing foundations. Some communal facilities (gardens, swimming pools, paddle courts) and access roads were also built. Eighty-five percent of the houses are used as holiday residences, and during the summer, a population of around 1500 people live in the resort, which is scarcely occupied during the winter season.

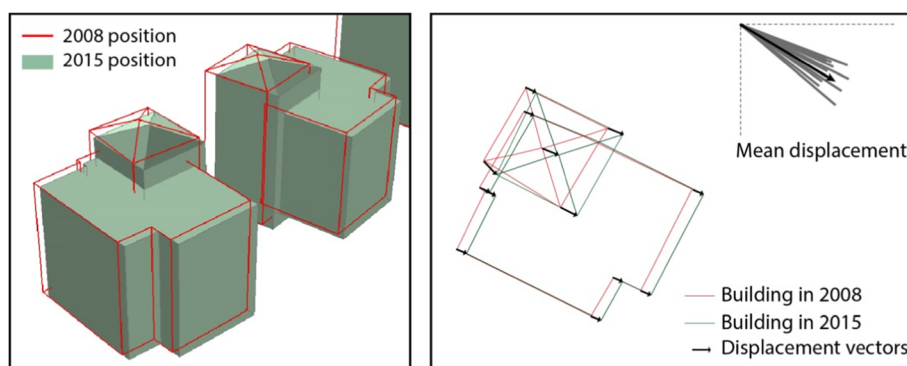
All the analysed buildings were characterised by averaging a mean displacement vector with all the individual vertex displacements between the 2008 and 2015 building footprints (Fig. 9). The individual displacement vectors were calculated taking the horizontal projections and the absolute distances for the 2008–2015 timespan. Averaged mean vectors were scaled to centimetre/year. This approximation evaluates each building as a displacement unit, thus avoiding small discrepancies between vertices from the same building footprint (Fig. 9).

Figure 9 shows an example of the stereo restitution carried out on a building displaying its position in 2008 and 2015. Based on this, and considering all the vertices of the building roof, the displacement vector for each vertex has been calculated. The displacement vector for the entire building is considered the average value of all of its vertices. Based on this, Fig. 10 has been created showing the total displacement vector obtained for each building located in the most damaged areas (with the exception of the indicated failed areas) for the eight monitoring years. We can observe that the largest displacements are recorded in the houses located in Especiales with values close to 2 m. In the SW part of Calaiza, the displacement values are between 0.75 and 1.25 m, and in Pueblo, the values range from 0.25 to 0.75 m. The direction that the vector shows is a very interesting data because it allows the landslide flanks as well as the three previously defined lobes

**Fig. 9** Stereo restitution (3D) carried out on a building displaying its position in 2008 and 2015 (*left figure*). The *right figure* shows the way to calculate the average vector for each building, considering all the vertices of the roof. Based on this, displacement vectors of the buildings for the period spanning 2008–2015 have been calculated
