Space Shuttle debris and meteoroid impacts

E.L. Christiansen^{a,*}, J.L. Hyde^b, R.P. Bernhard^b

Abstract

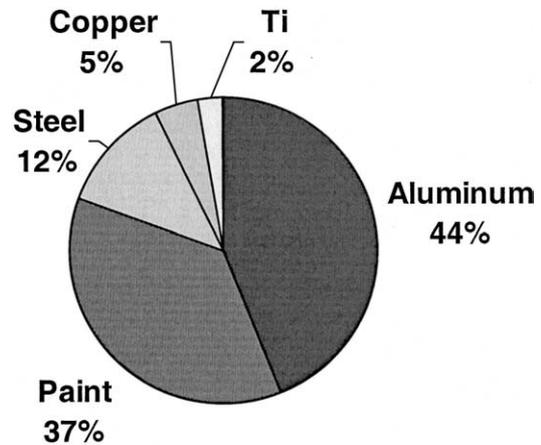
Generally there are many small impacts found on the Shuttle windows that do not cause any concern. In some cases, the impacts are large enough to require the window to be replaced, because of the potential for flaw growth during subsequent launch/landing cycles. The replacement criteria vary for each window on the Orbiter and location of the flaw, because of the different stresses experienced by the windows during launch. Although 1578 impacts were recorded on the windows, only 98 were large enough to cause the window to be replaced due to hypervelocity impact damage over the 50 missions sampled for meteoroid/debris damage from STS-50 to STS-110. Of the 98 impact replacements, SEM/EDX analysis revealed 41 were from orbital debris, 18 from meteoroids, 10 were unknown (no definitive SEM/EDX results), and 29 had no sample returned. Fig. 3 illustrates the composition of orbital debris for the 41 debris impacts that caused a window replacement. Aluminum and paint particles resulted in a majority of the window replacements, although steel and

Fig. 3. Composition of orbital debris particles that caused 41 window replacements during the period from STS-50 (June 1992) to STS-110 (April 2002).

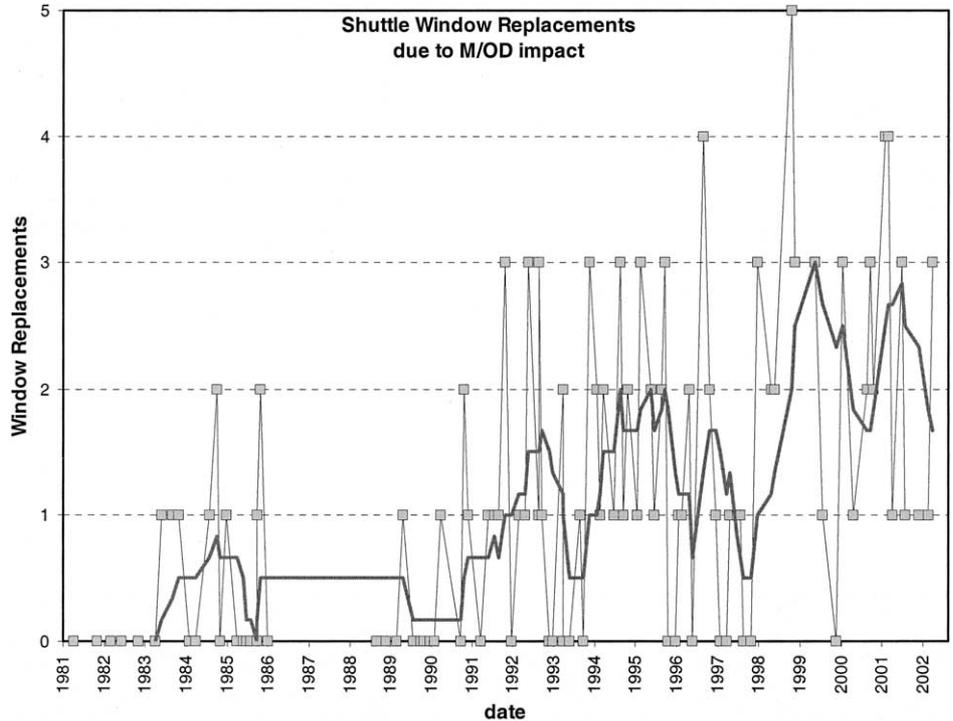
titanium, while less frequent, have caused some of the largest impact damages to windows and radiators. There have been 121 windows replaced due to M/OD impact from STS-1 (April 1981) through STS-110, with the trend illustrated in Fig. 4 indicating generally higher replacements than historical averages since 1998. Clearly, the missions depicted in Fig. 4 vary in terms of mission duration, altitude and other factors which influence meteoroid and orbital debris impact rates. However, the figure illustrates two things: (1) the variability in impact rates from mission to mission and (2) the general upward trend in impact rates causing window replacement over the life of the program.

Fig. 4. Window replacements from M/OD impact with the bold line indicating the trend over a 6-mission running average.

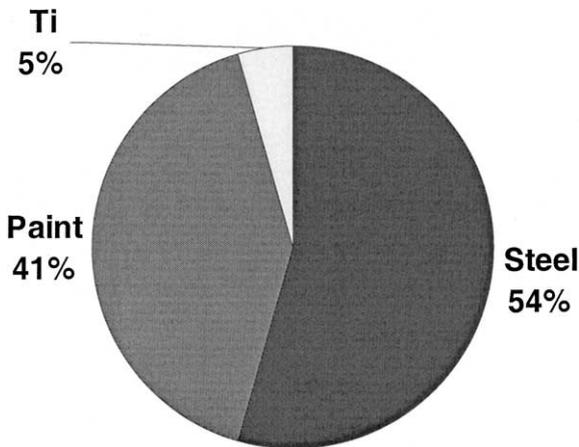
unknown. Fig. 5 illustrates the composition of the orbital debris that resulted in radiator facesheet perforations.

Fig. 5. Composition of orbital debris causing 22 perforations of the radiator facesheet over 50 missions from STS-50 to STS-110.

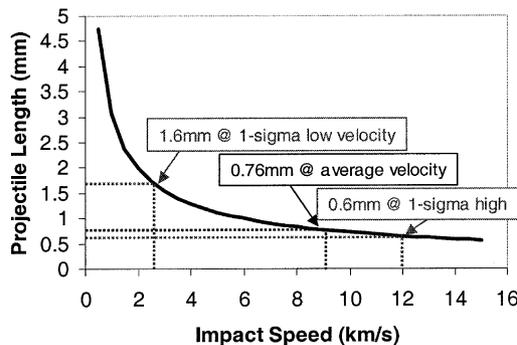
Fig. 8. Particle size sensitivity analysis considering 1σ variation in possible debris impact velocities for the STS-92 window #2 impact shown in Fig. 3.

indicates average estimated particle size causing orbital debris damage given in Table 1 is biased toward the lower end of the potential size range.

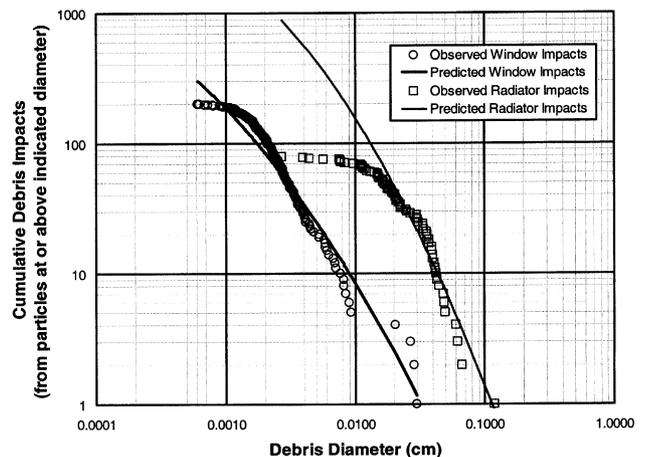
It should be noted that all “Unknowns” and “No Samples” in the window impact database have been classified as “meteoroids”, so that the on-orbit debris impact total shown in Fig. 9 potentially undercount debris impacts to the windows. In addition, radiator observations are not sensitive to aluminum impactors, therefore the radiator impact predictions have been adjusted by a 50% factor to account for the expected component of aluminum impactors in the orbital debris

Fig. 9. Comparison of actual window (in squares) and radiator (in circles) damage to predicted (lines) cumulative for 28 flights: STS-50, 56, 71, 72, 73, 75, 76, 77, 79, 80, 81, 84, 85, 86, 87, 88, 89, 91, 94, 95, 96, 106, 92, 97, 98, 104, 108, and 109.
