# How to ensure better consideration and mitigation of the shrinkage–swelling risk of clays?

Steve Gruslin\*, Tiffany Hennebaut and Mattia Tirone

The studied case is a single-family building affected by differential settlement in the south of Luxembourg.

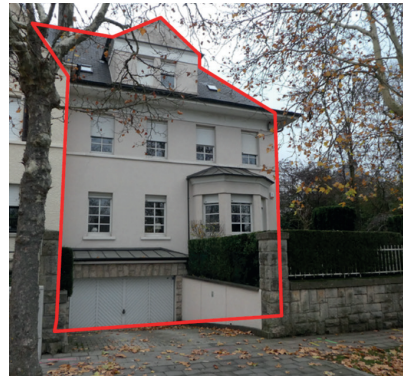
Figure 7: Photos of the building.

with 3 floors and a basement. It is located in Esch-sur-Alzette, in rue Bessemer (Figure 7). The construction is from the 1920s and it is located at the end of a complex of terraced houses positioned along the street on the southwest side. Boulevard Prince Henry develops in a northwest-southeast direction at 15 m from the house. The semi-detached building is located on the northwest side. The land descends along the boulevard about 10 m at a distance from the site of 300 m in the southeast direction. The building is surrounded by a garden and plants and large trees are located near the cadastral limit at 5.0 m on the south side.

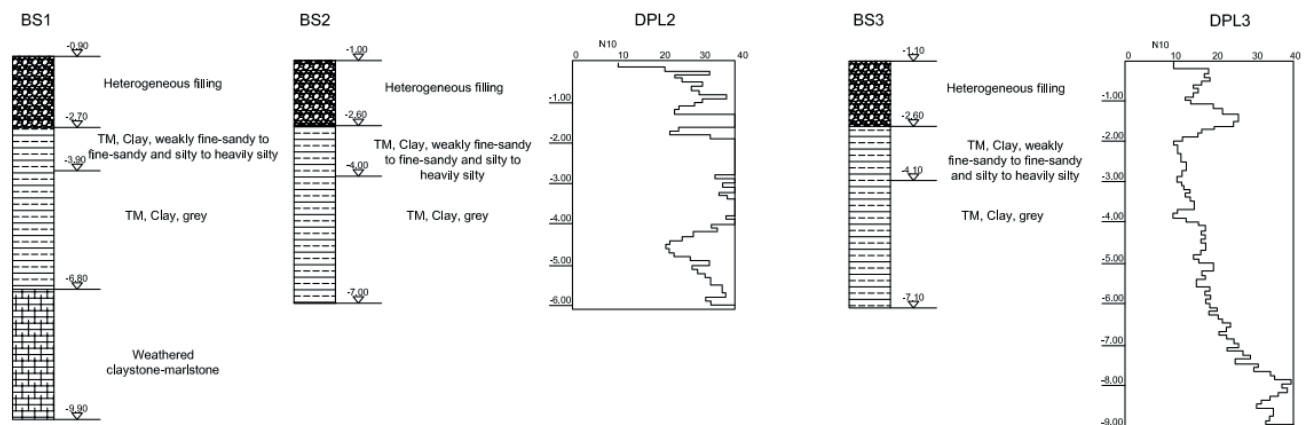
on the clay consistency. Taking as the 0.0 level the building's ground floor, the soil is a sandy and silty fill between -0.90 and -2.70 m. In BS2 and BS3, clays of different colors (ranging from red to gray with depth) of stiff to very stiff consistency are found up to -5.10 m. Between -5.10 m and -6.0 m the clays have a stiff consistency, then the number of blows increases until the weathered claystone is reached. As indicated in Figure 8, the number of blows is very different in BS2 and BS3. This is related to the different moisture content, with a more plastic behaviour in the BS3 borehole due to its higher moisture content. The clays between -2.60 m and -5.10 m were classified as firm. Up to the weathered claystone layer (-7.10 m), the clays are then classified as stiff. The weathered claystone was found under -6.8 m in borehole BS1.

The consistency difference can be found in the soil water content. The analysis revealed a very significant difference between the area exposed to the east at the depth between -3.90 and -6.90 m (BS3, water content of 26%) and the southwest areas (BS1, w=14.1 %, BS2 w=14.5 %). At this depth, clays in boreholes BS1 and BS2 are classified "TM" (clays with medium plasticity) and in BS3 "TA" (clays with high plasticity) following DIN 18196. The

Figure 8: Site soil stratigraphy.

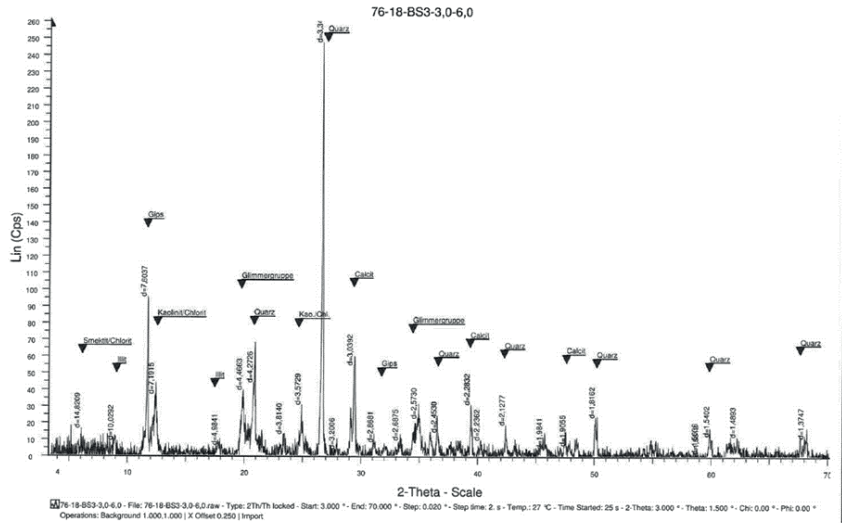
Figure 9: X-ray diffractogram on a clay sample taken from BS3 borehole (WPW Design Office, 2019).

A mineralogical analysis with an X-ray diffractogram was done on the claystone (BS1, depth between 6.90 and 10.0 m) and on a clay sample (BS3, between -4.10 and -7.10 m, *Figure 9*). This showed the presence, among other things, of smectite-chlorite, together with more common clay minerals like illite and kaolinite (*Figure 9*).

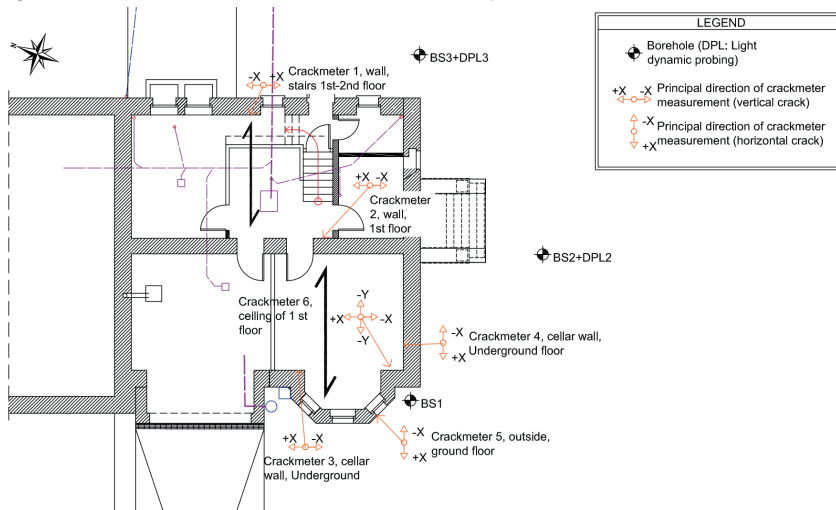
Figure 11: Plan view of the basement, direction of slab support, crackmeters and borehole position and crackmeter No. 5.

A monitoring system was set up in November 2019 using six crackmeters (PPW-POLYPLAN-WERKZEUGE GmbH, Rissobservator Artikel-Nr.: 1395, see *Figure 11*). The cracks were monitored over a six-month period. No further opening of cracks was noted. On the contrary, the cracks partially closed during the autumn-winter seasons due to the increase in moisture content.

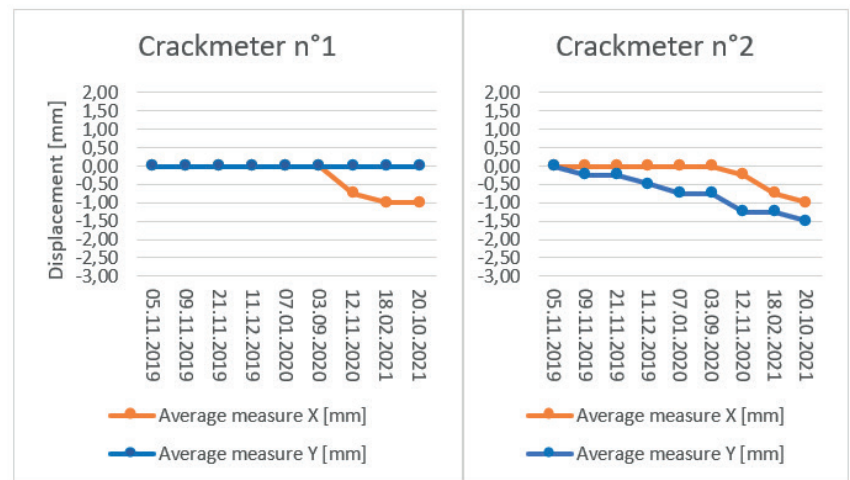
Figure 16: Measurements from crackmeters No. 1 and 2 (Nov. 2019 to Feb. 2022).

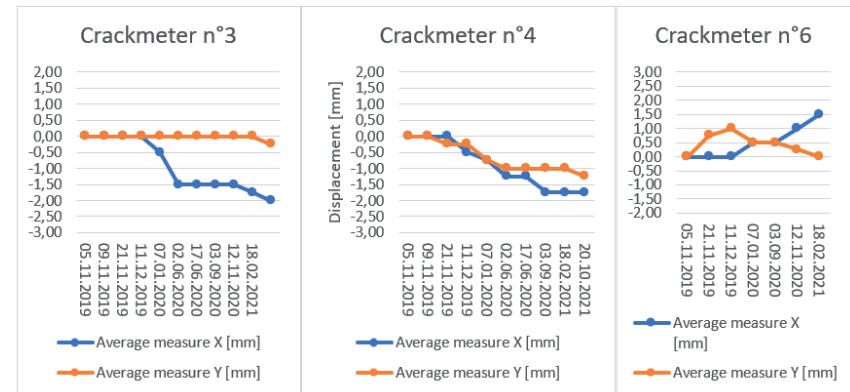
Figure 17: Measurements from crackmeters No. 3, 4, and 6 (Nov. 2019 to Feb. 2022).
