ENVIRONMENTAL EFFECTS, CAUSED BY THE M_s 6.7, M_b 6.9, NOVEMBER 19th, 1912, ACAMBAY EARTHQUAKE, MEXICO

Reassessment of intensity and macroseismic field with the ESI-07 scale

ACAMBAY EARTHQUAKE

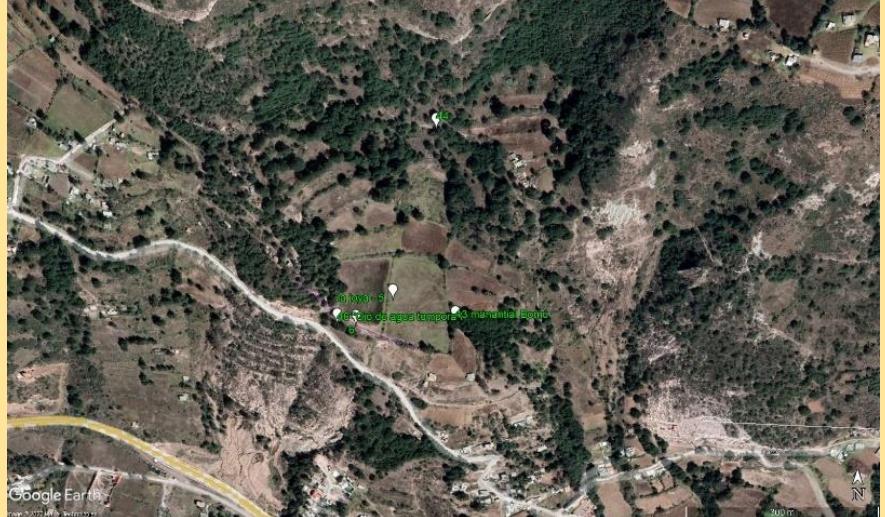
Site number	005
Latitude	2208314.35
Longitude	410845.59
Distance from epicenter	4.92 km
Locality	"La Jolla"
Type of effect	Tectonic Surface rupture
Description	Segmented crack of several tens in length, semi-parallel to the streams, subdivided into small parallel cracks with a separation of 5-9 m. Maximum vertical unevenness of the edges of 17 cm.
ESI intensity	IX
Geomorphologic setting	In the Acambay valley.
Photographic documentation

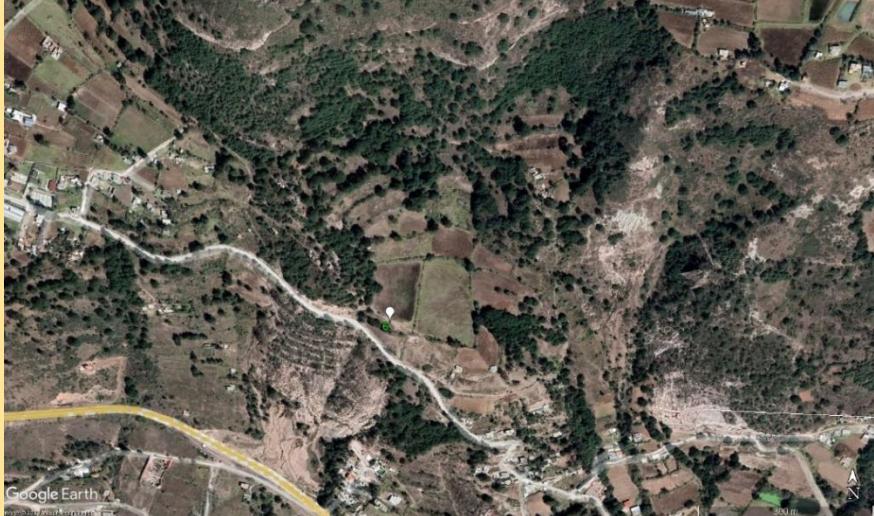
Site number	006
Latitude	2208277.41
Longitude	410791.31
Distance from epicenter	4.91 km
Locality	Dongú (Bomú stream)
Type of effect	Tectonic Surface rupture
Description	Parallel to and near a stream (Bomú) heading N 76° W, 15 cm wide and 20 cm uneven. It changes direction to N 15° W and cuts off the road to Dongú and branches off.
ESI intensity	IX
Geomorphologic setting	Near the stream. It branches.
Photographic documentation

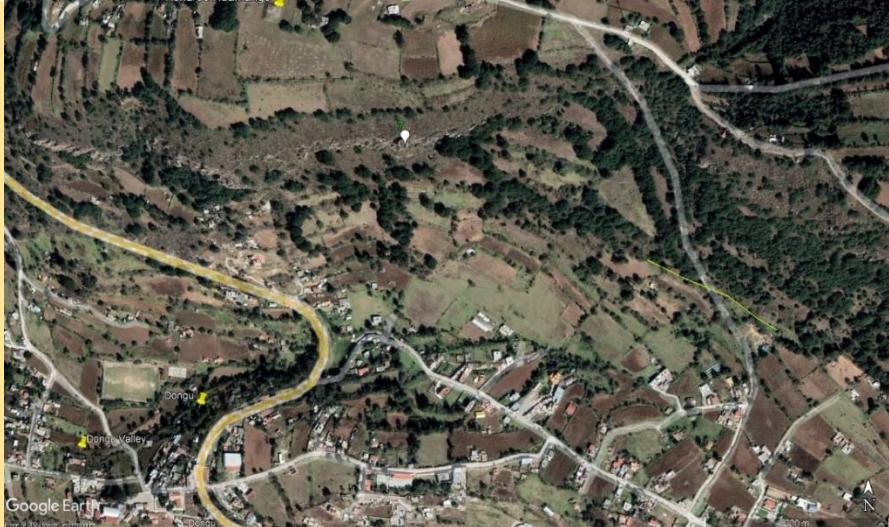
Site number	007
Latitude	2209180.93
Longitude	409571.03
Distance from epicenter	6.33 km
Locality	Dongú valley
Type of effect	Tectonic Surface rupture
Description	Same orientation of the valley (E-W), on the northern edge and the Huamango road. 200 m long, 25 cm wide.
ESI intensity	IX
Geomorphologic setting	In the Dongú valley, at the foot of a labradorite stream.
Photographic documentation

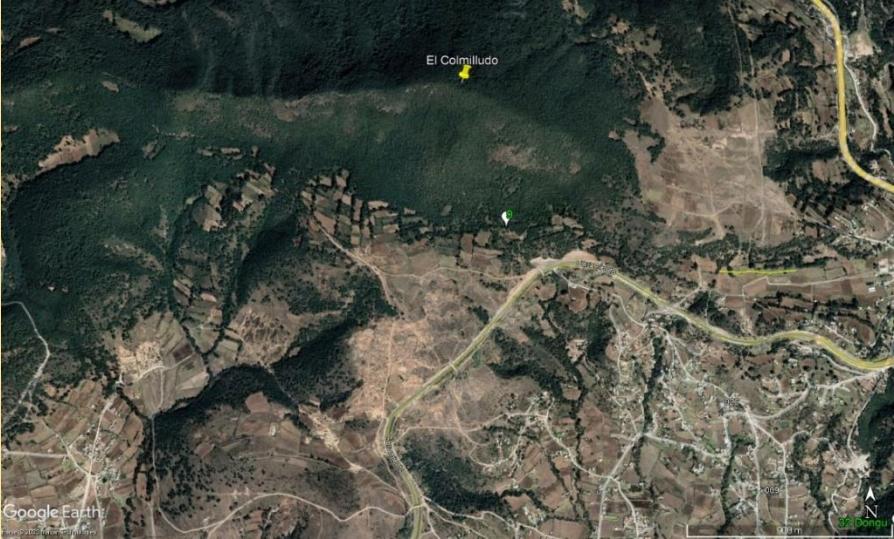
Site number	009
Latitude	2210000.90
Longitude	406985.22
Distance from epicenter	8.87 km
Locality	El Colmilludo
Type of effect	Tectonic Surface rupture
Description	In the stratified tuffs, there are joints oriented from East to West.
ESI intensity	X
Geomorphologic setting	Inside the valley of "El Colmilludo". Here, the cracks belonging to the same northern system reappear.
Photographic documentation

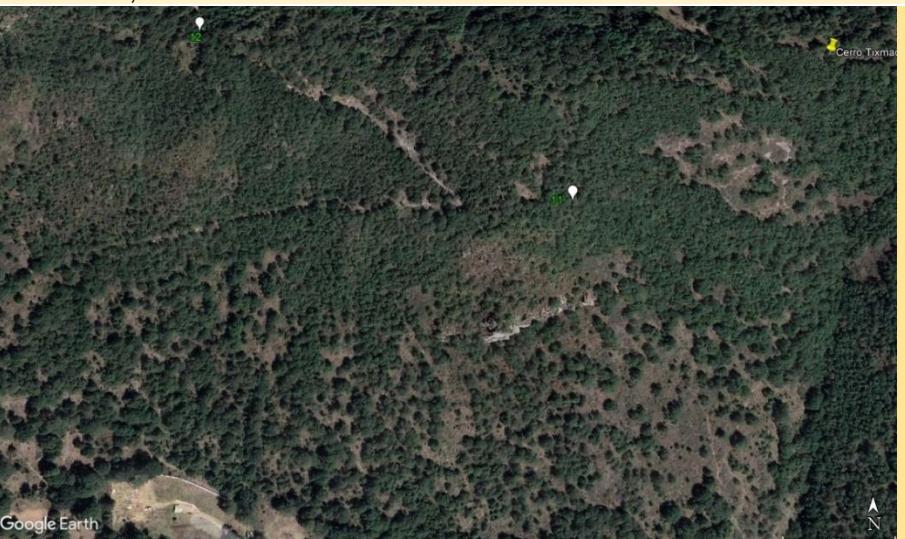
Site number	011
Latitude	2209287.50
Longitude	401818.64
Distance from epicenter	12.52 km
Locality	Cerro Santa María Tixmadejé
Type of effect	Tectonic surface rupture
Description	System of cracks that extends from the top of Santa María Tixmadejé to the western end of the Acambay-Tixmadeje mountain massif. 10 - 40 cm wide and 50 cm uneven. 2900 masl.
ESI intensity	X
Geomorphologic setting	On the side of the hill, with a 30° slope and parallel to the crack in the town of Santa María Tixmadejé, there is a crack at 2,900 meters above sea level and another at 3,030 meters above sea level.
Photographic documentation

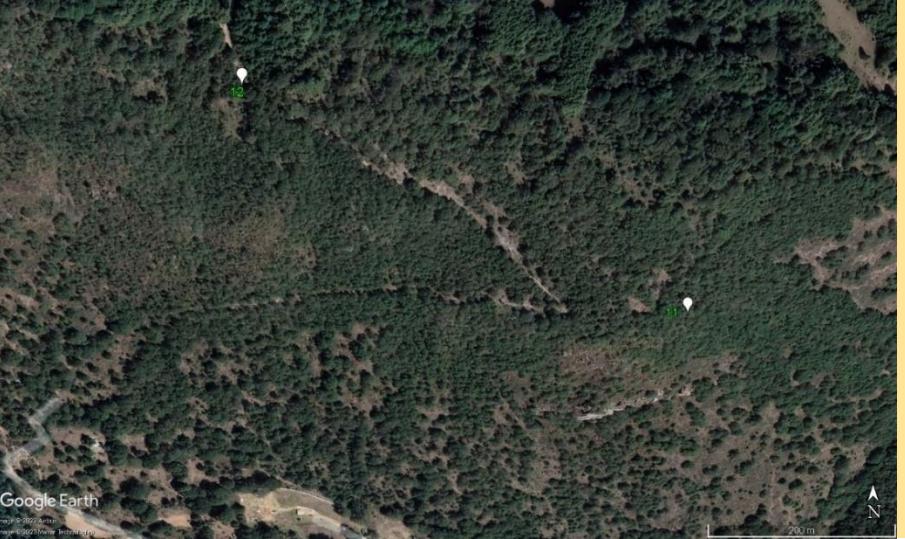
Site number	012
Latitude	2209476.19
Longitude	401440.96
Distance from epicenter	13.26 km
Locality	Cerro Santa María Tixmadejé
Type of effect	Tectonic Surface rupture
Description	System of cracks that extends from the top of Santa María Tixmadejé to the western end of the Acambay-Tixmadeje mountain massif. 10 - 40 cm wide and 50 cm uneven. 3030 masl.
ESI intensity	X
Geomorphologic setting	On the side of the hill, with a 30° slope and parallel to the crack in the town of Santa María Tixmadejé, there is a crack at 2,900 meters above sea level and another at 3,030 meters above sea level.
Photographic documentation

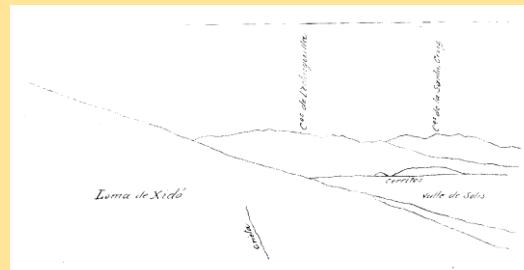
Site number	013
Latitude	2210265.02
Longitude	397259.79
Distance from epicenter	17.09 km
Locality	Xidó
Type of effect	Tectonic Surface rupture
Description	<p>Crack following the stratification plane of the tuffs. 8 cm wide and very little unevenness.</p> <p>The crack cuts the stream transversely, at the bottom it is lost and reappears on the opposite bank heading N. 76° W. (fig. 31, lam. XIX).</p>
ESI intensity	VIII
Geomorphologic setting	On the Xidó hill, on the southern slope of the Botí or Las Palomas hill, the crack formed in the tuffs and lapilli; in the dislocations raised towards the North. The rupture crosses the path parallel to the stream, from north to south, cutting through the tuffs and at the bottom of its bed it runs over the igneous gap with obsidian fragments.
Photographic documentation

<p style="text-align: right;">FOT. FOMENTO.</p> <p>Fig. 30.—Aspecto de la grieta en la falda de Xidó, sobre el camino de Sotiles al Agostadero, perteneciente al sistema septentrional</p>

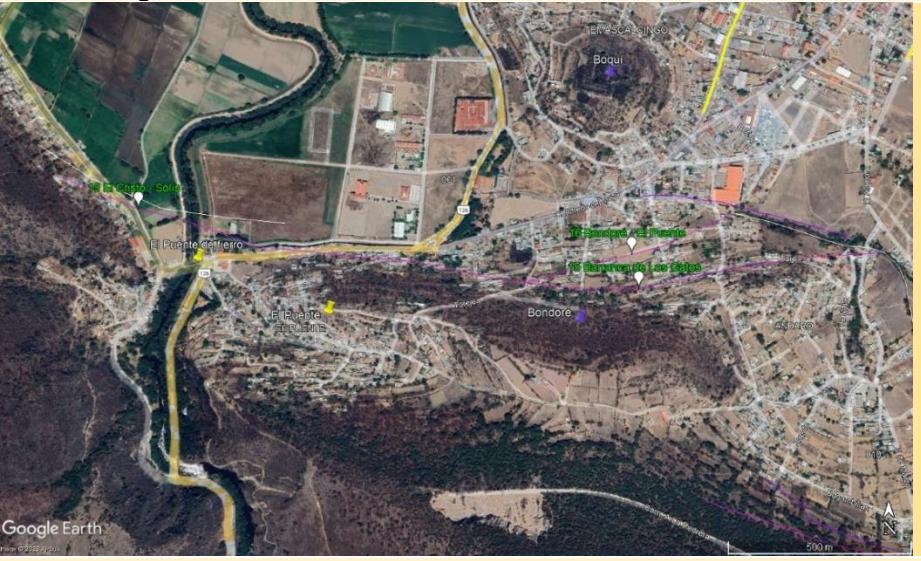
Site number	015
Latitude	2201781.37 - 2201557.39
Longitude	392879.75 - 394230.54
Distance from epicenter	20.56 km
Locality	El Cristo – Solís – Barranca de los Gatos
Type of effect	Tectonic Surface rupture
Description	The width and maximum difference in level of the crack, is 30 cm, before bifurcating.
ESI intensity	IX
Geomorphologic setting	From west to east, this rupture starts at the "El Cristo" hill, in the Solís hacienda. It descends into the valley, crosses the Lerma River 50 meters downstream. Here, the river aligns from south to north, obliquely concerning the line of maximum slope at an angle of 30 degrees. The rupture follows its course on the slope of the hill "Chato, Andaró or Puente" approaching more its general direction, east to west. Upon reaching a length of 1,050 meters, it forks: the upper branch continues along the side of "El Puente" hill and then descends to disappear into the "Los Gatos" ravine, situated south of Temascalcingo.

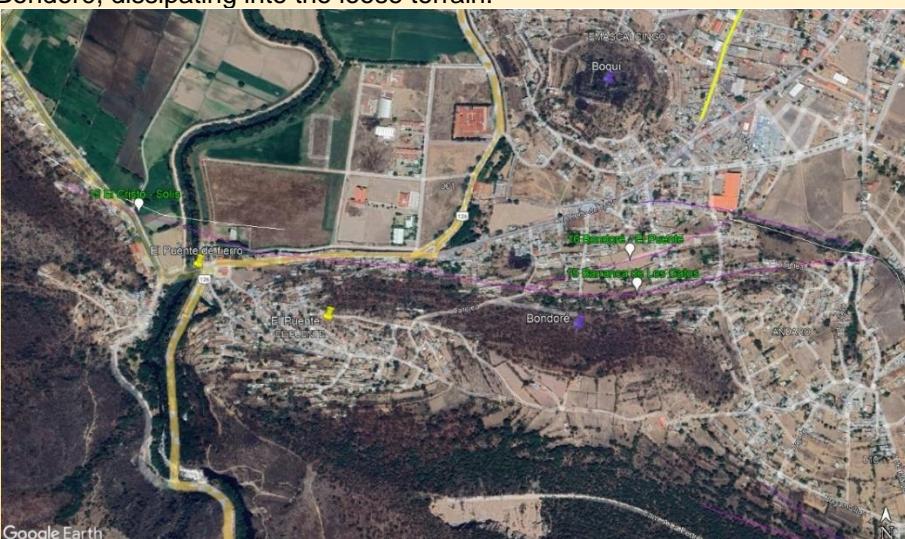
Site number	016
Latitude	2201649.09
Longitude	394230.54
Distance from epicenter	19.36 km
Locality	Boquí-Bondoré
Type of effect	Tectonic Surface rupture
Description	400 meters long. The width and the maximum unevenness of the crack, 30 cm.
ESI intensity	IX
Geomorphologic setting	This other branch of the rupture, continues from "El Cristo – Solís" heading N. 64° E. It descends toward the ravine nestled between the hills of Boquí and Bondoré, dissipating into the loose terrain.
Photographic documentation

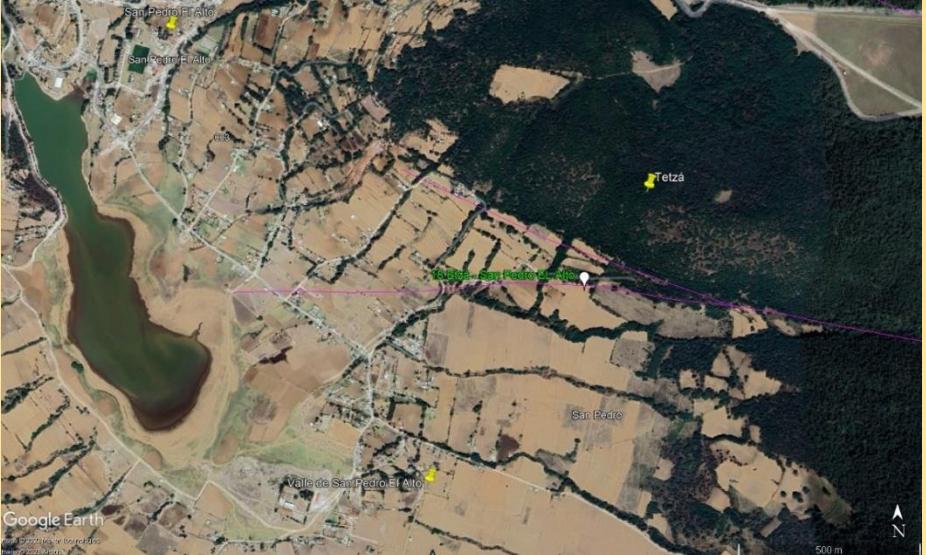
Site number	018
Latitude	2201092.13
Longitude	400520.64
Distance from epicenter	14.03 km
Locality	Etzá – San Pedro EL Alto
Type of effect	Tectonic Surface rupture
Description	Parallel to the previous surface rupture, between the Etzá hill and the San Pedro El Alto dam, two others are formed: one with a width of 15 cm (described in the cracks and fractures section) and the other, which produced ejection of mud and ends near the dam.
ESI intensity	IX
Geomorphologic setting	Formed between the hill of Etzá and the dam of San Pedro el Alto.
Photographic documentation

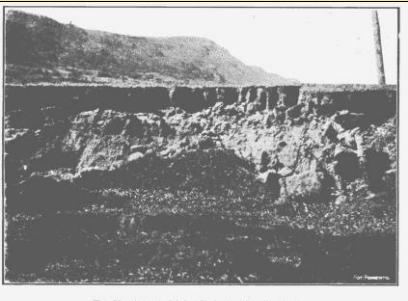
<p>Fig. 38.—Aspecto del hundimiento, visto de frente, en su desnivel máximo.</p> </div> </div>

<p>Fig. 37. Effect of the aforementioned sinking on the "Puente Grande"</p> <p>Fig. 38. Appearance of the subsidence e seen from the front, at its maximum unevenness.</p>

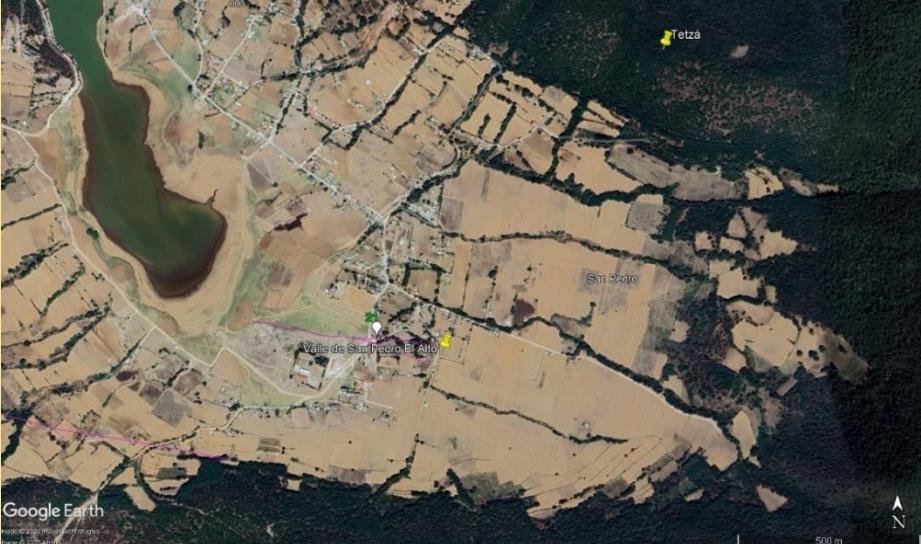
Site number	021
Latitude	2200505.89
Longitude	399802.45
Distance from epicenter	13.86 km
Locality	Etzá – San Pedro El Alto
Type of effect	Ground crack
Description	It is the furthest crack from the megaseismic zone, it is located on the land of Rancho del Rosal, southwest of Atlacomulco; 300m long and 6 cm wide and was formed on fairly flat terrain.
ESI intensity	VIII
Geomorphologic setting	Localizada en el Valle de San Pedro; a 190 metros sobre el Valle de Acambay, en lo que fue una cuenca cerrada.
Photographic documentation

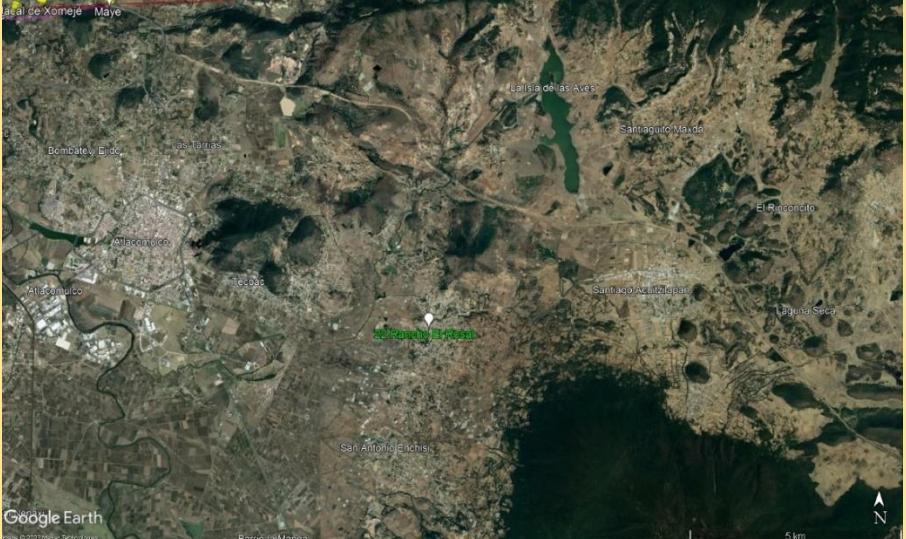
Site number	022
Latitude	2187293.61
Longitude	414696.30
Distance from epicenter	16.73 km
Locality	Rancho del Rosal
Type of effect	Ground crack
Description	It is located on the land of Rancho del Rosal, southwest of Atlacomulco; 300m long and 6 cm wide and was formed on fairly flat terrain.
ESI intensity	VIII
Geomorphologic setting	Located on the right bank of the Lerma River.
Photographic documentation

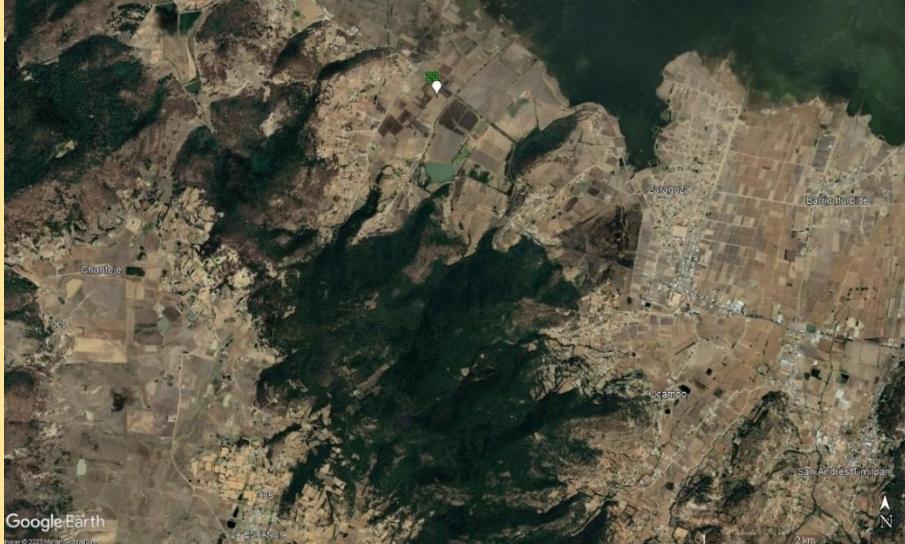
Site number	023
Latitude	2201529.85
Longitude	418887.47
Distance from epicenter	6.28 km
Locality	Acambay - San Andrés Timilpan
Type of effect	Lateral spreading
Description	Described as "slide cracks." Located on the southern fault line of the macroseismic field. Formed in sediments and rock and in the contact between them. Sandy clay.
ESI intensity	VII
Geomorphologic setting	In the proximity to streams, in gullies, in channels, edges of dams, etc.
Photographic documentation

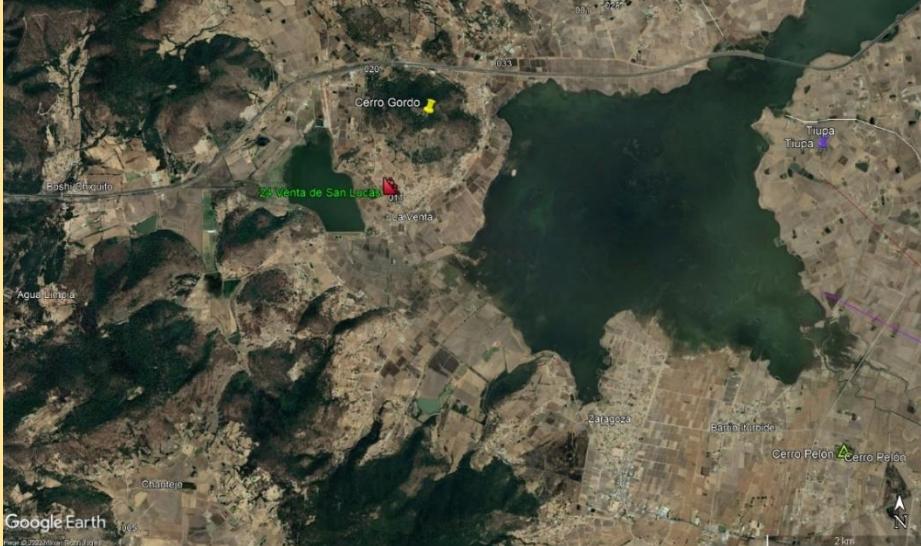
Site number	024
Latitude	2203452.00
Longitude	418446.27
Distance from epicenter	5.33 km
Locality	Venta de San Lucas
Type of effect	Lateral spreading
Description	Described as "slide cracks." Located on the southern fault line of the macroseismic field. Formed in sediments and rock and in the contact between them.
ESI intensity	VII
Geomorphologic setting	In the proximity to streams, in gullies, in channels, edges of dams, etc. It is a small valley.
Photographic documentation

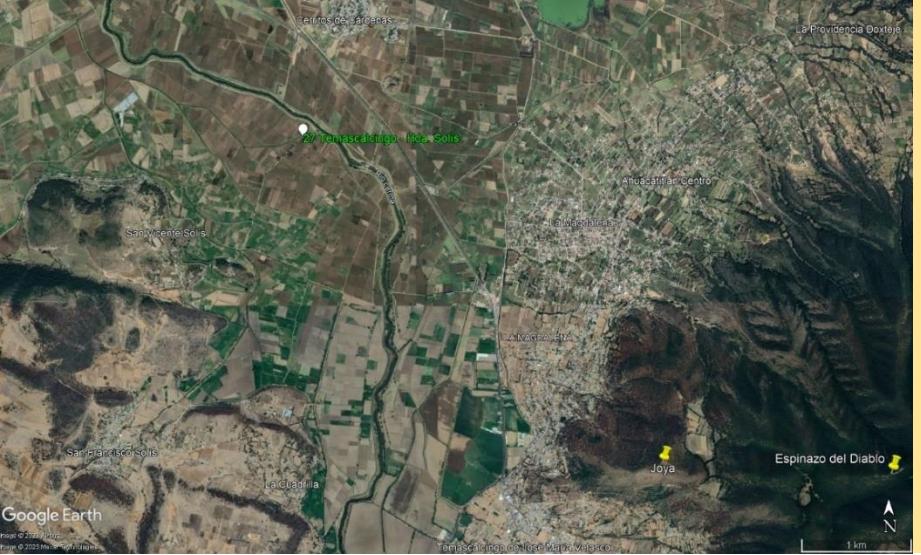
Site number	027
Latitude	2207066.27
Longitude	392564.84
Distance from epicenter	20.82 km
Locality	Temascalcingo – Hacienda Solís
Type of effect	Lateral spreading
Description	Described as "slide cracks." Located on the southern fault line of the macroseismic field. Formed in sediments and rock and in the contact between them. Sandy clay.
ESI intensity	VII
Geomorphologic setting	In the proximity to streams, in gullies, in channels, edges of dams, etc. In a section that is between two irrigation canals.
Photographic documentation

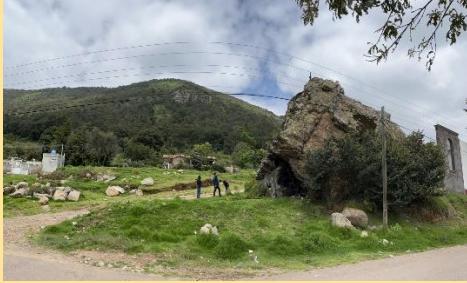
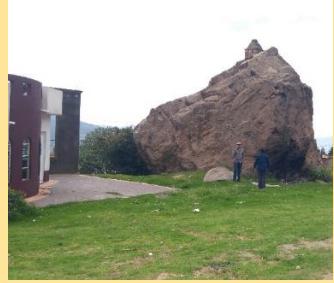
Site number	030
Latitude	2208867.55
Longitude	401672.73
Distance from epicenter	12.48 km
Locality	Santa María Tixmadejé
Type of effect	Rockfall
Description	Rockfall. An 8 m ³ boulder. The boulder came off the top and bounced until it reached the town.
ESI intensity	VII
Geomorphologic setting	Cliff with steep slope.
Photographic documentation

<p>Actual picture taken by us, of the same place.</p>

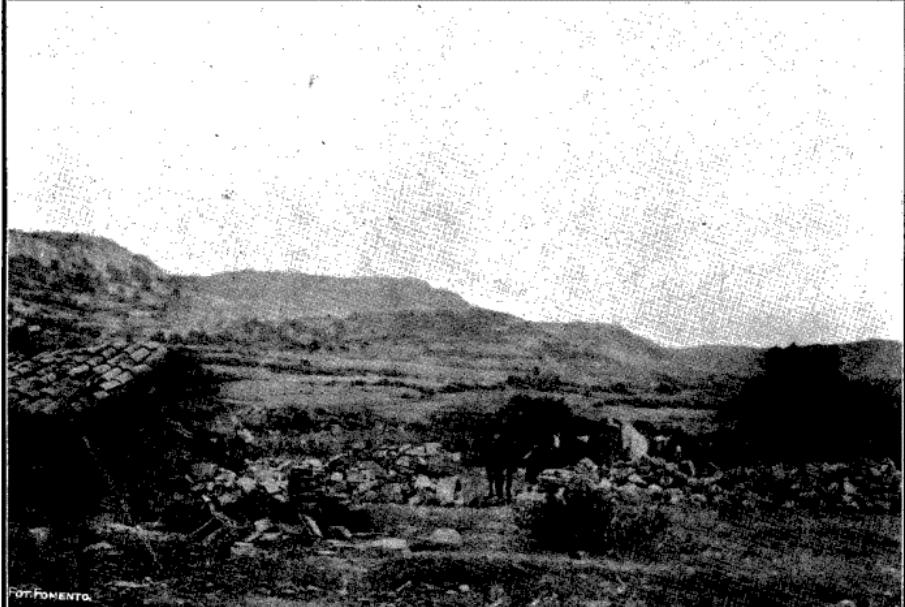
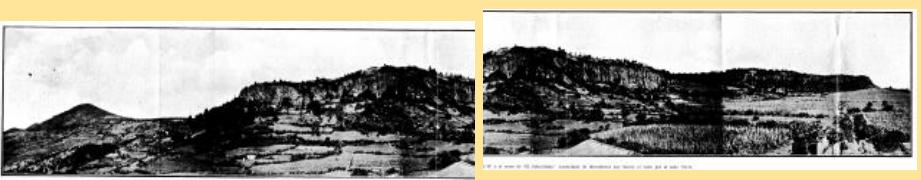
Site number	032
Latitude	2208664.45
Longitude	408725.53
Distance from epicenter	6.46 km
Locality	Dongú
Type of effect	Landslide and Rockfall
Description	Rockfall (Labradorite)
ESI intensity	VIII
Geomorphologic setting	Boulders fell from the cliffs of Dongú into the Dongú Valley.
Photographic documentation

<p>Fig. 8.—Perfiles meridionales de las mesas de Dongú, vistos desde el pueblo de Detiñá</p>

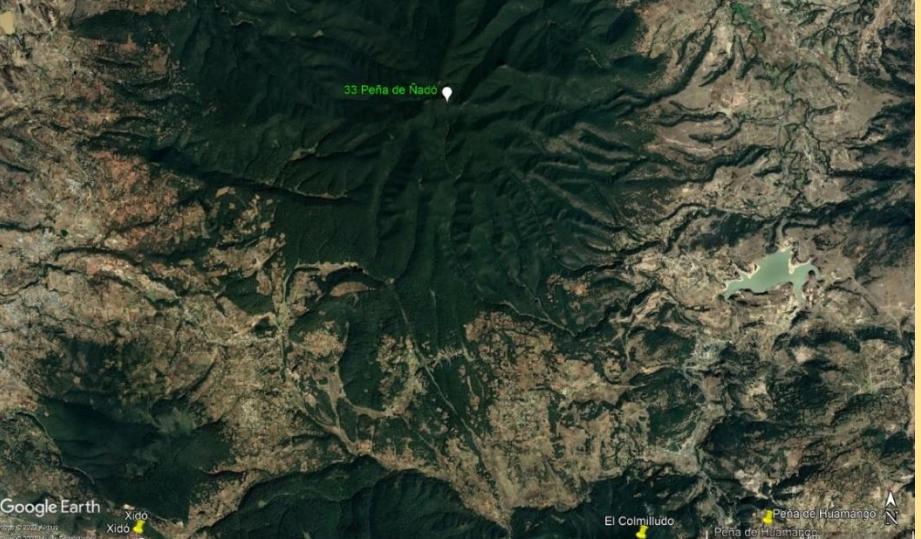
Site number	033
Latitude	2218767.26
Longitude	403209.51
Distance from epicenter	17.84 km
Locality	Peña de Ñadó
Type of effect	Landslide
Description	A landslide occurs in which large masses of land slide down from the top of the cliffs.
ESI intensity	VIII
Geomorphologic setting	Hills and steep cliffs.
Photographic documentation

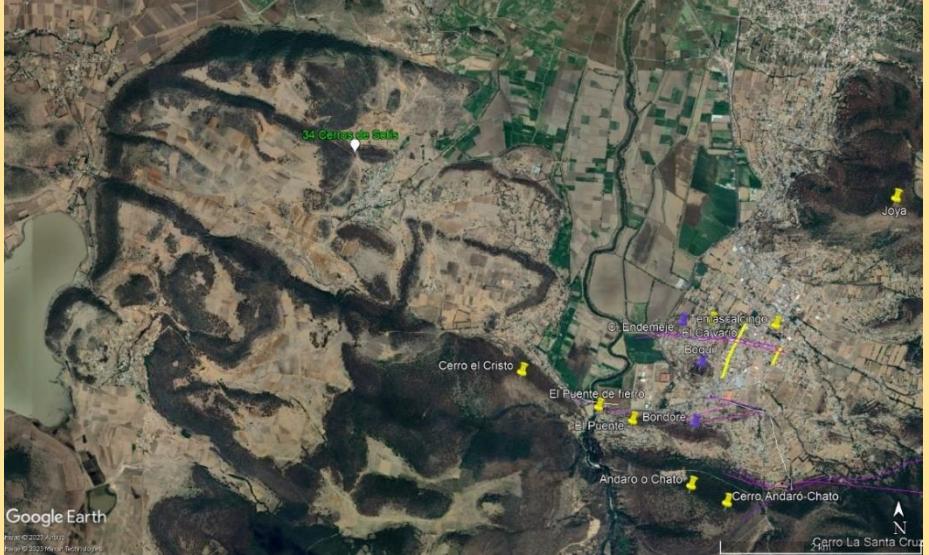
Site number	034
Latitude	2204450.99
Longitude	390410.17
Distance from epicenter	22.74
Locality	Cerro de Solís
Type of effect	Landslide
Description	A landslide occurs in which large masses of land slide down from the top of the cliffs.
ESI intensity	VIII
Geomorphologic setting	Hills and steep cliffs.
Photographic documentation

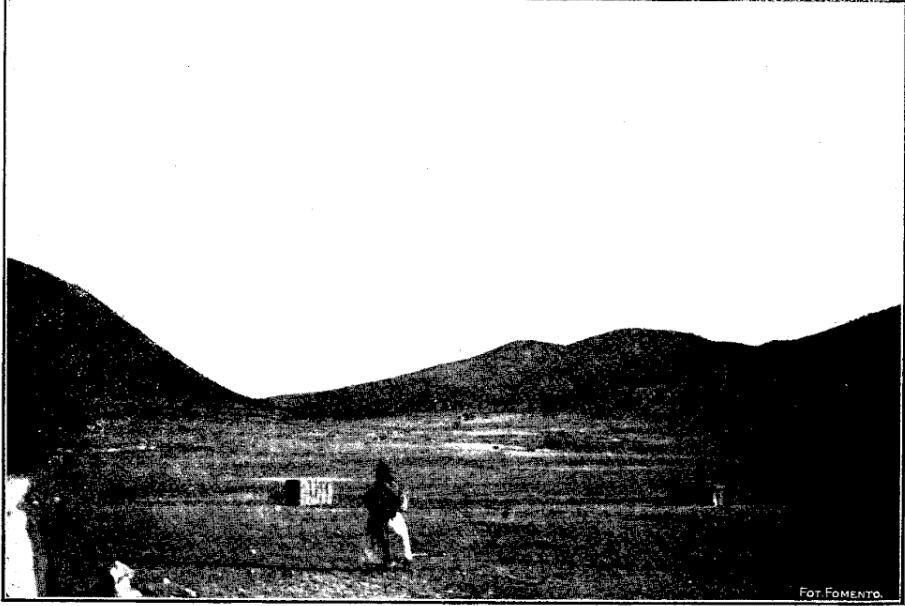
Site number	035
Latitude	2200703.48
Longitude	402853.30
Distance from epicenter	10.79 km
Locality	Cerro El Aguaje
Type of effect	Landslide
Description	A landslide occurs in which large masses of land slide down from the top of the cliffs.
ESI intensity	VIII
Geomorphologic setting	Hills and steep cliffs.
Photographic documentation

Fig. 44.—Derrumbes en las cimas de las montañas producidos por el temblor. “Derrumbaderos” en las cimas de los cerros de “El Aguaje” y el “Yeso,” vistos desde la estación de Manto, F. C. N. de M.

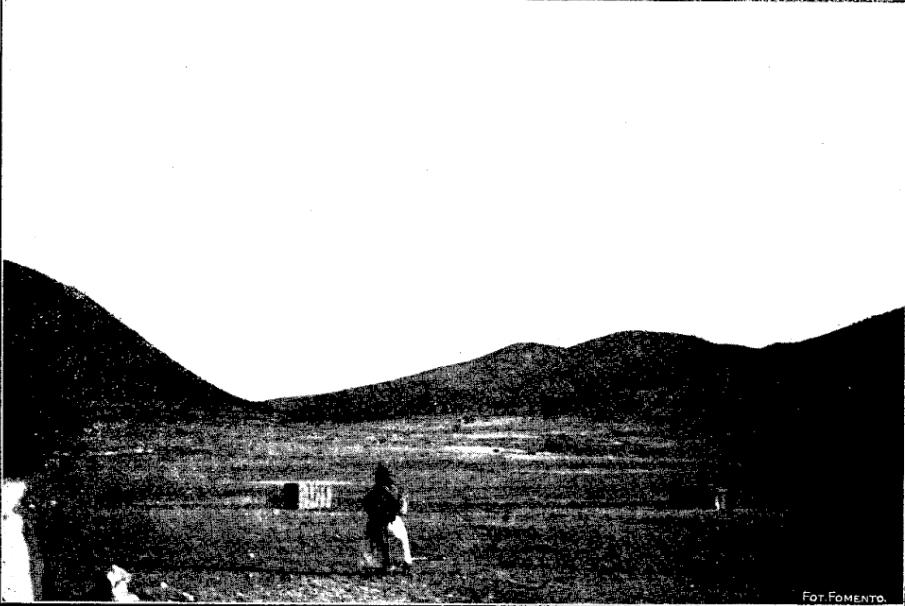
Site number	036
Latitude	2200300.59
Longitude	403330.89
Distance from epicenter	10.47 km
Locality	Cerro El Yeso
Type of effect	Landslide
Description	A landslide occurs in which large masses of land slide down from the top of the cliffs.
ESI intensity	VIII
Geomorphologic setting	Hills and steep cliffs.
Photographic documentation

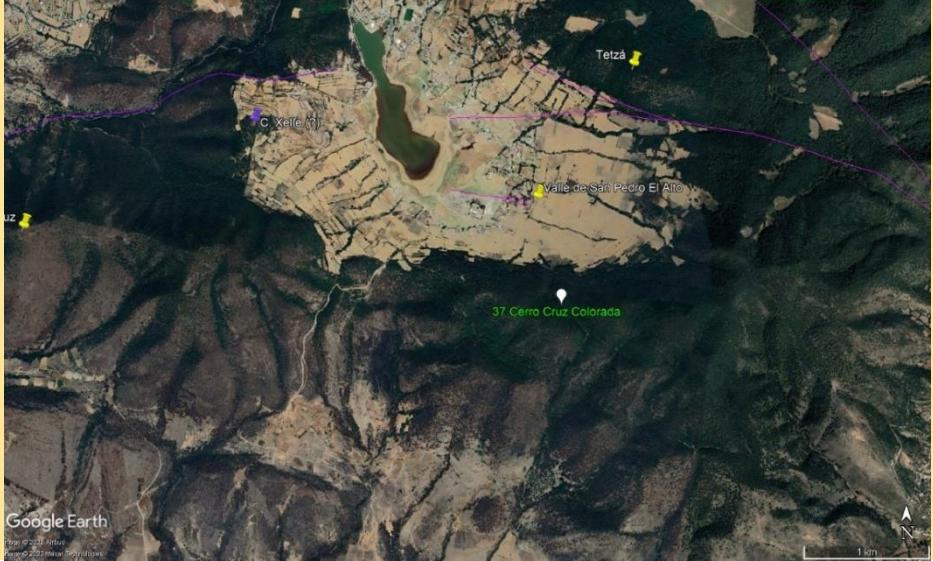
Site number	037
Latitude	2199702.08
Longitude	400178.15
Distance from epicenter	13.64
Locality	Cerro Cruz Colorada
Type of effect	Landslide
Description	A landslide occurs in which large masses of land slide down from the top of the cliffs.
ESI intensity	VIII
Geomorphologic setting	Hills and steep cliffs.
Photographic documentation

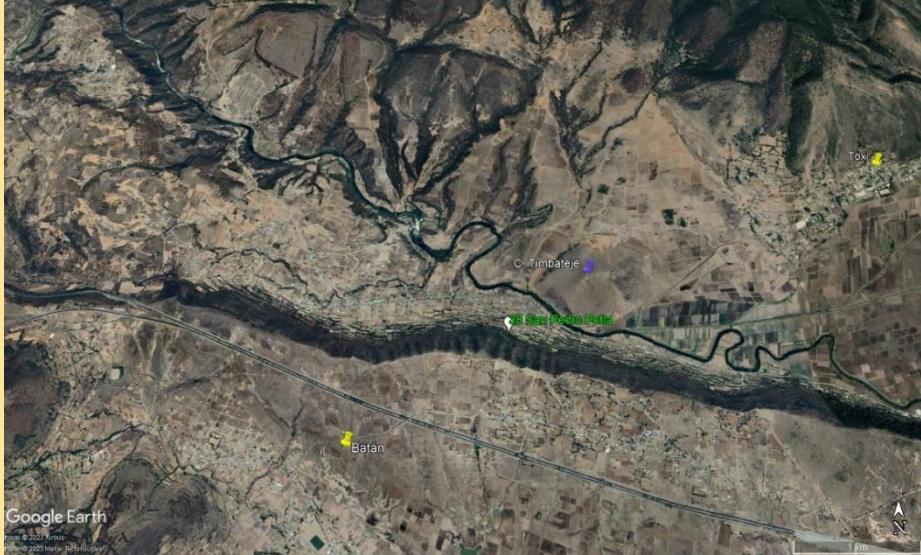
Site number	038
Latitude	2195538.24
Longitude	398353.47
Distance from epicenter	17.04 km
Locality	San Pedro Potla
Type of effect	Rockfall
Description	The boulders came off the hill. The blocks, when detached and rolled, marked their passage with destruction of fencing and vegetation.
ESI intensity	VII
Geomorphologic setting	Hills and steep cliffs.
Photographic documentation

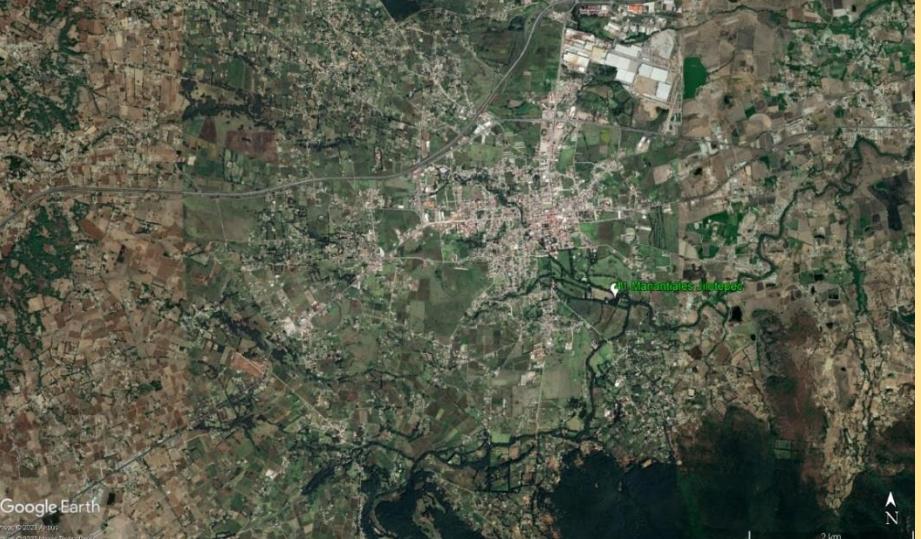
Site number	041
Latitude	2205349.81
Longitude	445102.32
Distance from epicenter	32 km
Locality	Jilotepec
Type of effect	Hydrogeological anomaly
Description	36 km from Acambay, the water of the Jilotepec springs, previously clear, turned cloudy after the earthquake.
ESI intensity	VI
Geomorphologic setting	Plain belonging to the Sierra de Querétaro.
Photographic documentation

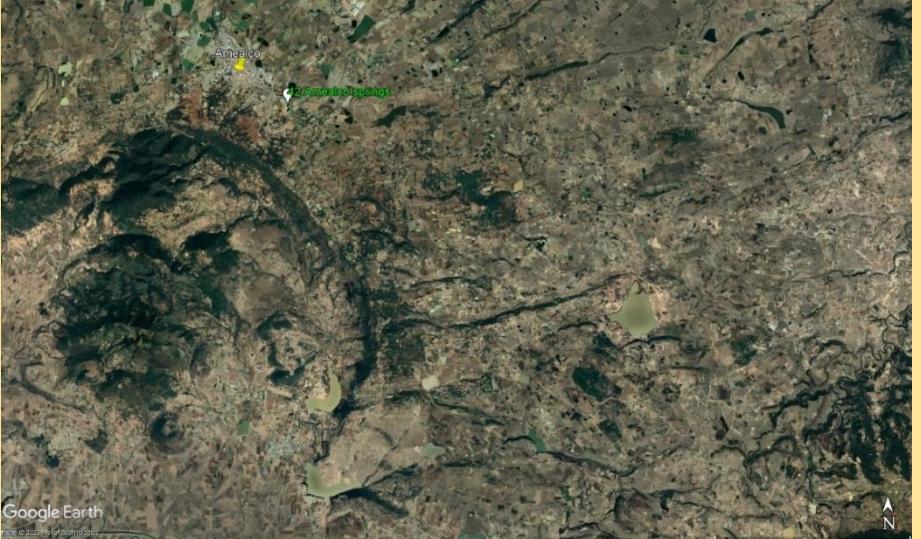
Site number	042
Latitude	2231684.34
Longitude	381596.91
Distance from epicenter	42.1 km
Locality	Amealco
Type of effect	Hydrogeological anomaly
Description	The spring presented cloudy water after the earthquake, even 80 days after the event the water was still cloudy. The amount of water from the spring increased, the water level in the ditches rose.
ESI intensity	VI
Geomorphologic setting	On the slopes of Cerro or Amealco caldera.
Photographic documentation

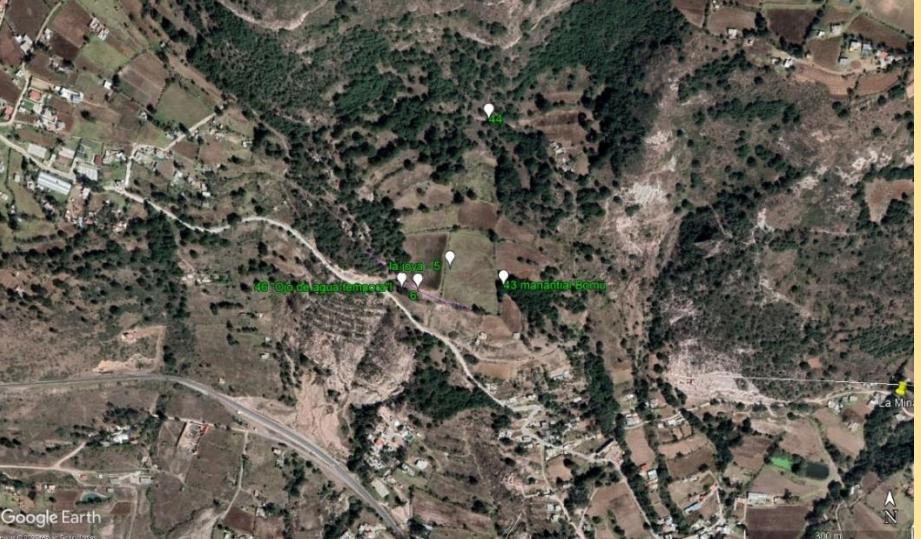
Site number	043
Latitude	2208282.34
Longitude	410936.62
Distance from epicenter	4.87 km
Locality	Bomú - Acambay
Type of effect	Hydrogeological anomaly
Description	In the Acambay valley, the spring that supplies water to the population temporarily disappeared.
ESI intensity	VIII
Geomorphologic setting	Inside the Acambay Valley.
Photographic documentation

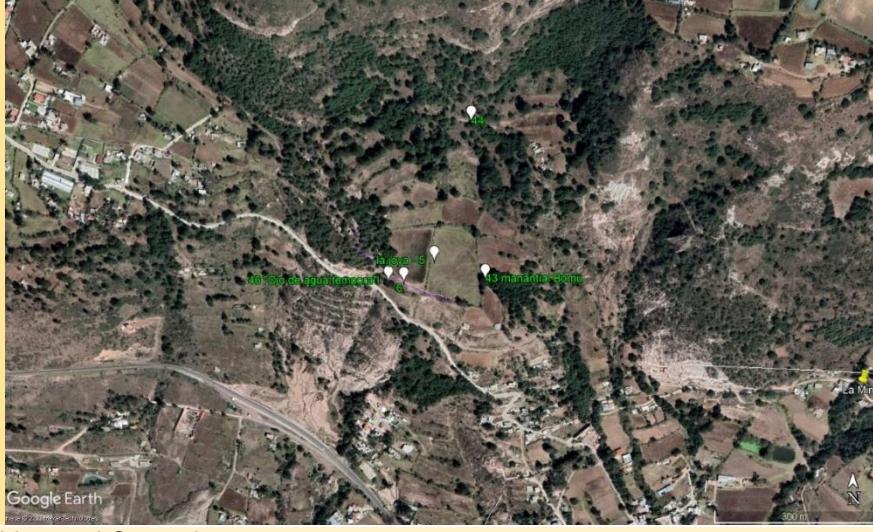
Site number	044
Latitude	2208549.93
Longitude	410910.08
Distance from epicenter	5.12 km
Locality	La Jolla (Mesa) Acambay
Type of effect	Hydrogeological anomaly
Description	In the Acambay valley, a small spring on "la mesa de La Jolla" disappeared.
ESI intensity	VIII
Geomorphologic setting	Top of the small Cerro de la Jolla.
Photographic documentation

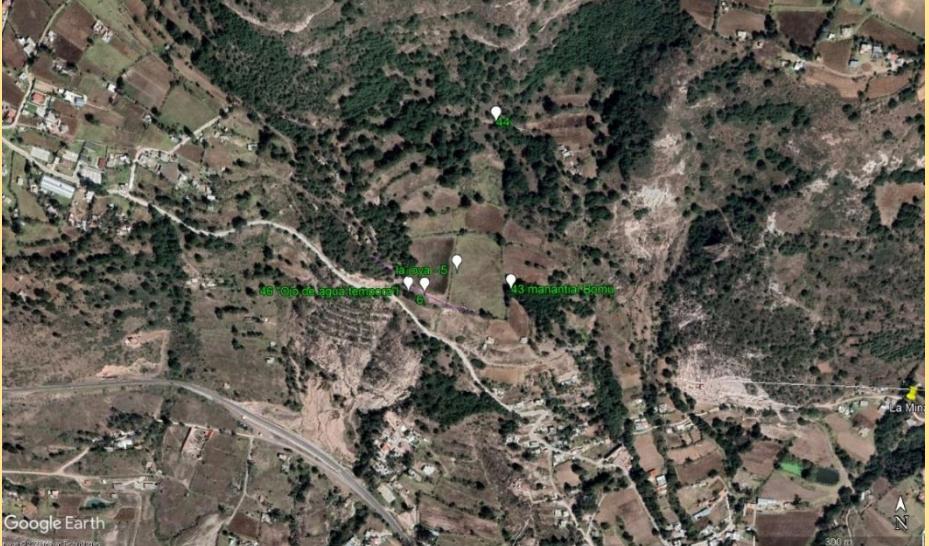
Site number	046
Latitude	2208279.53
Longitude	410763.96
Distance from epicenter	4.94 km
Locality	Into the megaseismic zone (ex. "La Jolla")
Type of effect	Hydrogeological anomaly
Description	Temporary emergence of spring. Appearance and disappearance of springs. Change in circulation flows water. "Within the megaseismic zone, while some springs disappeared, others sprouted."
ESI intensity	VIII
Geomorphologic setting	Valleys, foothills, tops of hills and hills.
Photographic documentation

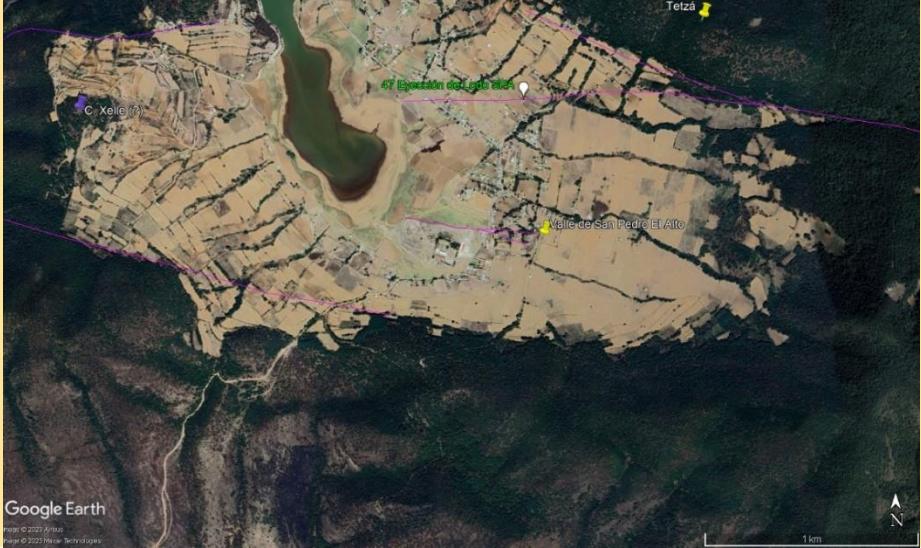
Site number	047
Latitude	2201088.72
Longitude	399936.51
Distance from epicenter	13.68 km
Locality	San Pedro El Alto Valley
Type of effect	Liquefaction processes
Description	Water and mud ejections from the cracks. The "thrown" material is silt, formed from volcanic glass, deposited in a 50 cm crack open with the water towards the dam.
ESI intensity	IX
Geomorphologic setting	Valley bottom plain.
Photographic documentation

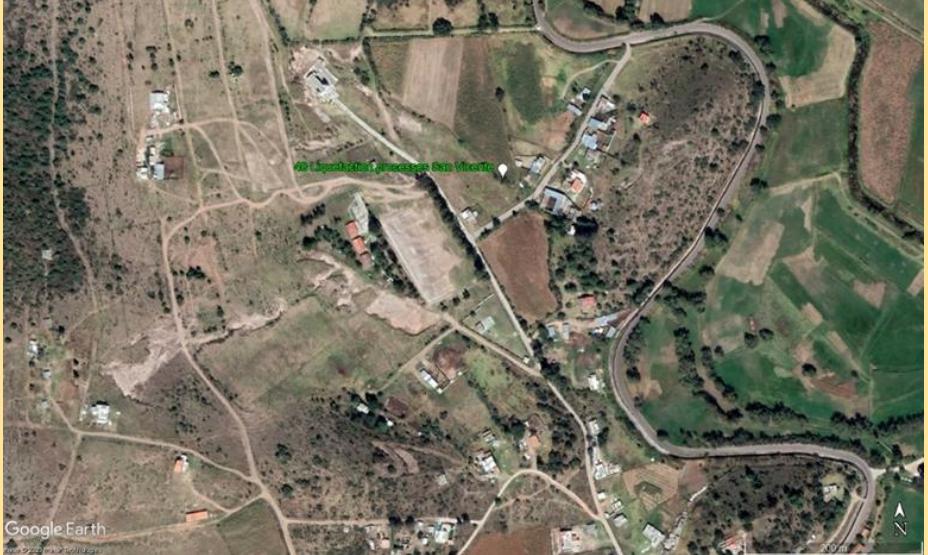
Site number	048
Latitude	2206124.95
Longitude	391158.44
Distance from epicenter	22.09 km
Locality	San Vicente, Solís
Type of effect	Liquefaction processes
Description	Water and mud ejections from the cracks. Liquefaction line with almost N-S direction, which presented ejecta of white sandy material.
ESI intensity	VIII
Geomorphologic setting	Valley bottom. Field sown with wheat.
Photographic documentation

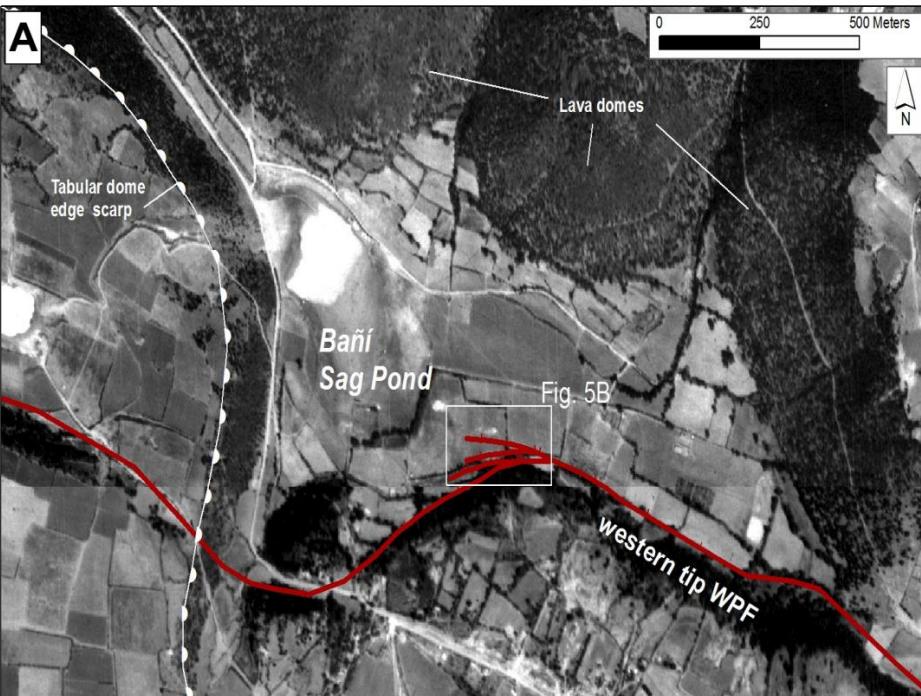
Site number	053
Latitude	2198314
Longitude	388695
Distance from epicenter	24 km
Locality	Laguna Bañí
Type of effect	Hydrogeological anomaly
Description	After the earthquake, a natural spring adjacent to the lake ceased to supply water.
ESI intensity	VIII
Geomorphologic setting	The site is located in an area of sag pond created by the fault, where the Bañí Lagoon could have formed.
Photographic documentation
