*A paper to be presented at the Charlotte meeting
of the American Institute of Electrical Engineers,
March 30-April 1, 1910.*

A PRACTICAL METHOD OF PROTECTING INSULATORS FROM LIGHTNING AND POWER ARC EFFECTS

BY L. C. NICHOLSON

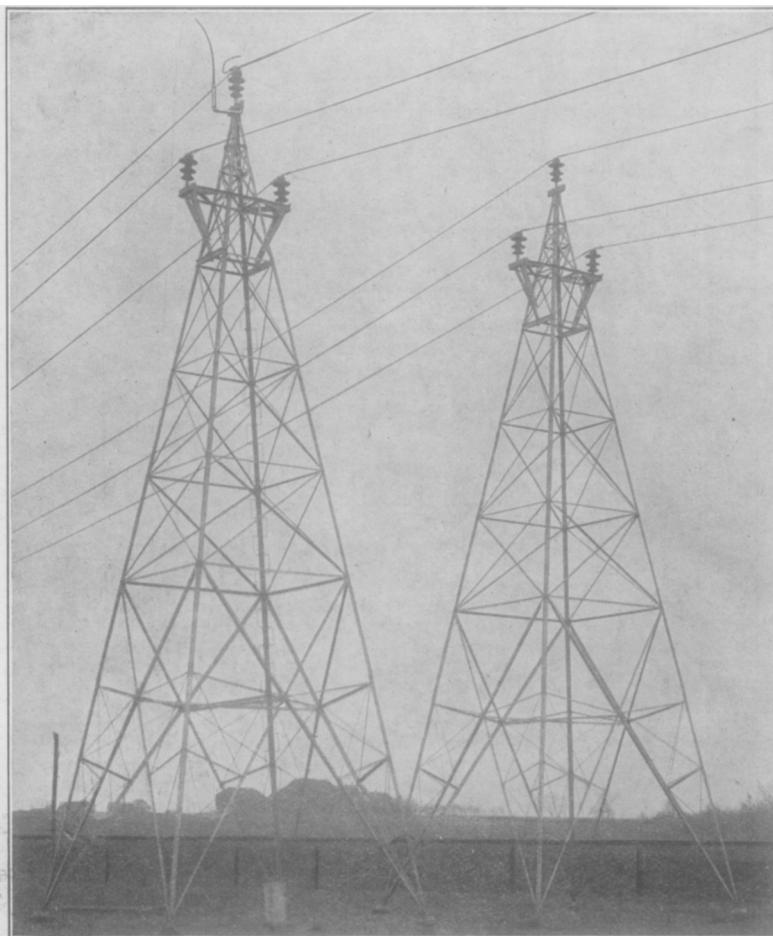
FIG. 3.—55-ft. structural steel towers, showing a relief gap, as used in 1907

This result formed a basis for corrective measures which were taken previous to the lightning season of 1907. These devices consisted of relief gaps installed on insulators at regular intervals on the top wire of both duplicate lines, and the installation of high resistances in the neutral earth connections of star-connected transformers. Fig. 3 shows the type and construction of the relief gap which was employed.

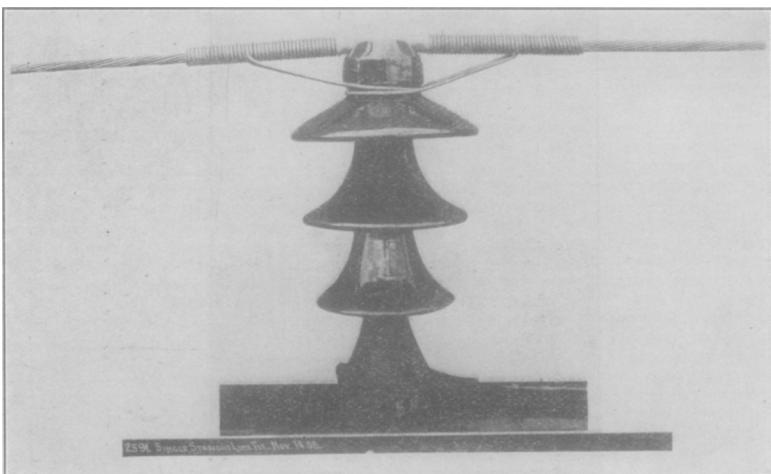
FIG. 5.—3-part main line insulator

Fig. 5 shows the principal insulator used, and, with the exception of a few smaller ones of the same general design, the only type of insulator employed until 1909. This is known as the "3-part main line" insulator. Its principal dimensions are:

Diameter of headpiece, $14\frac{1}{2}$ in.; diameter of intermediate shell, 13 in.; diameter of center shell, 11 in.; length of intermediate shell, 12 in.; length of center shell, 17 in.; height over all, $19\frac{1}{2}$ in. The dry flash-over voltage, that is, the voltage which will cause a flash-over when the surface is dry and clean, is 195,000. The wet flash-over voltage at $1/5$ in. per minute precipitation at 45 degrees is 120,000.

These tests showed what there was already good reason to suspect, *viz.*: that the insulators were not tested sufficiently before erection, and that many of those on the line could not resist lightning stresses, and some were liable to fail from abnormal voltages incident to operation. As stated above, the insulator parts were tested to 75,000 volts each, but no test was made on the assembled insulator.

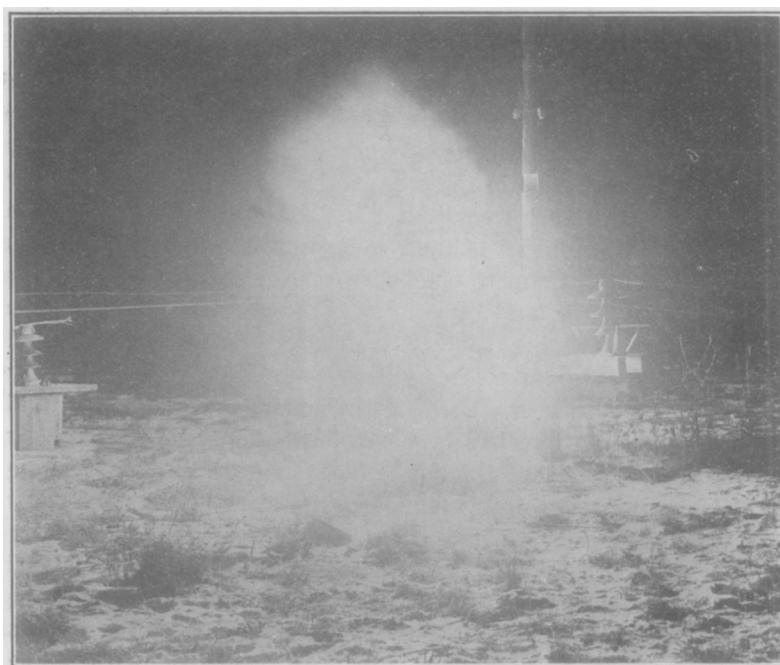
FIG. 8.—Night photograph of a 30,000-kw. 1200-ampere arc on an insulator equipped with arcing rings

Numerous tests were made, using as high as 30,000-kw. generator capacity, which under the short-circuit conditions of the test delivered 1200 amperes at an initial voltage of 60,000. In no instance was an insulator when equipped with both arcing rings damaged to the slightest extent. Fig. 8 is a night photograph of a 30,000-kw. arc. An insulator with arcing rings, in the midst of the fire, does not show. It was perfectly whole and fairly cool after this experience.

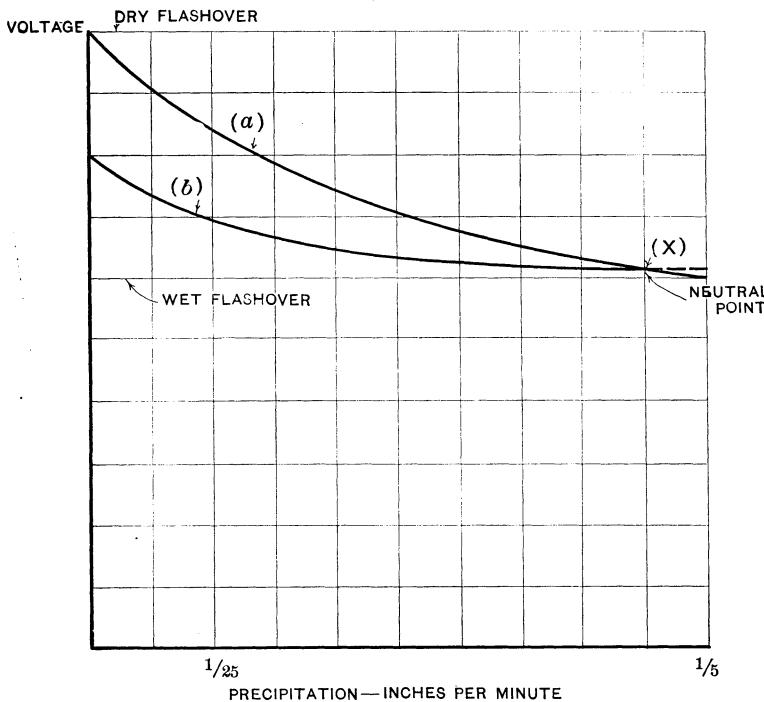
FIG. 11.—Flash-over characteristics of an insulator under spray, with and without arcing rings

These effects appear graphically in Fig. 11. Curve *a* represents the ordinary performance of an insulator on a metal pin under spray, the flash-over voltage decreasing with the increase of water. Curve *b* shows its performance with the arcing ring so proportioned and so placed with reference to the insulator

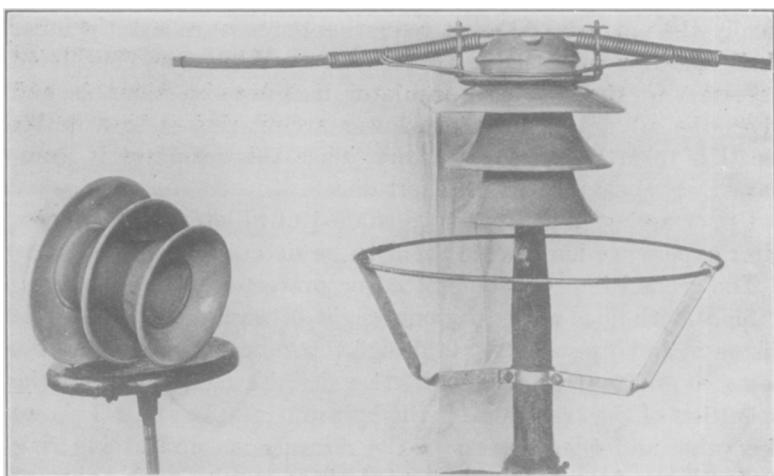
FIG. 12.—New style four-part insulator installed on top wire, 1909.
Also shows method of attaching arcing-ring supports to cylindrical pins

On the top wire where most damage by lightning had occurred in the past, and on the lower wires to the extent necessary to accomplish their insulation, a new type of insulator, shown in Fig. 12, was installed. This is a four-part insulator of about the same outside diameter as the old style three-part insulator, but considerably shorter, 6 inches in fact. It flashes over dry at 190,000 volts, and wet at 105,000 volts. The individual parts and the assembled insulators were tested to dry flash-over voltage

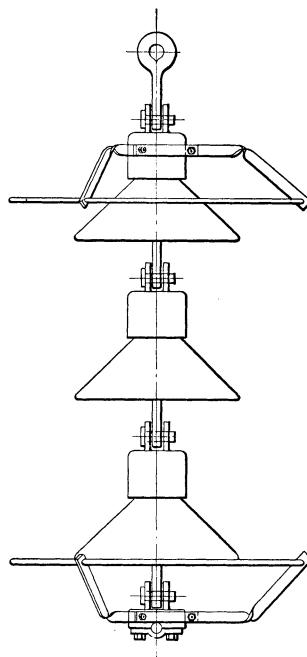
FIG. 17.—Arcing rings applied to a suspension type insulator

In view of the extensive use of suspension insulators, some experimental work has been carried on which indicates the necessity for, and effectiveness of, arcing ring protection on this type of insulator. The arrangement shown in Fig. 17 apparently accomplishes the desired results.
