(*Paper No. 3876.*)

“The Strengthening of the Roof of New Street Station,
Birmingham.”

By WILLIAM DAWSON, M. Inst. C.E.

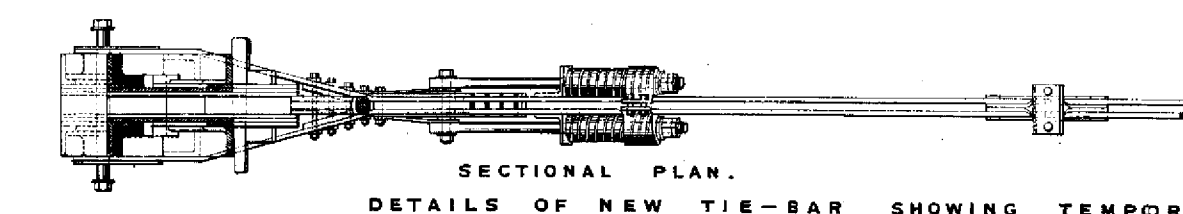
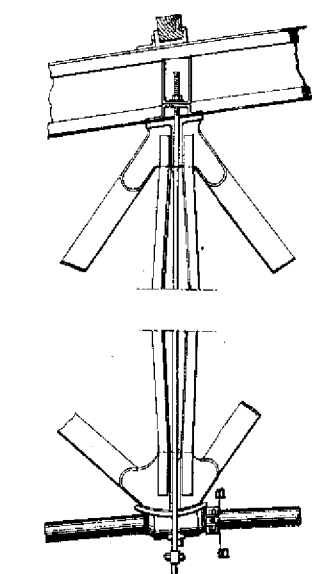
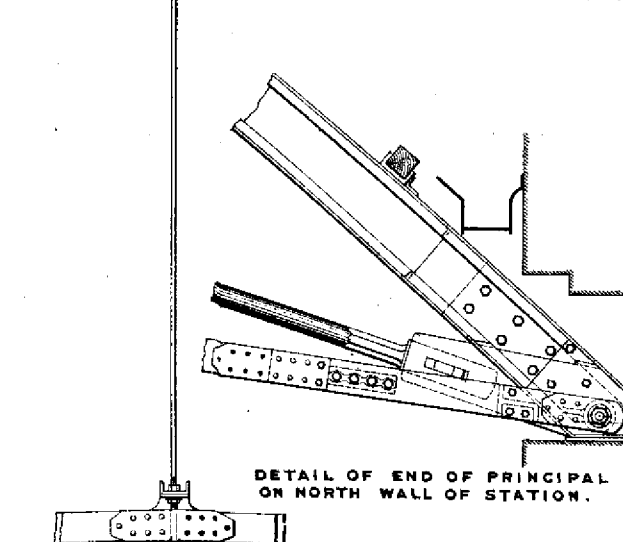
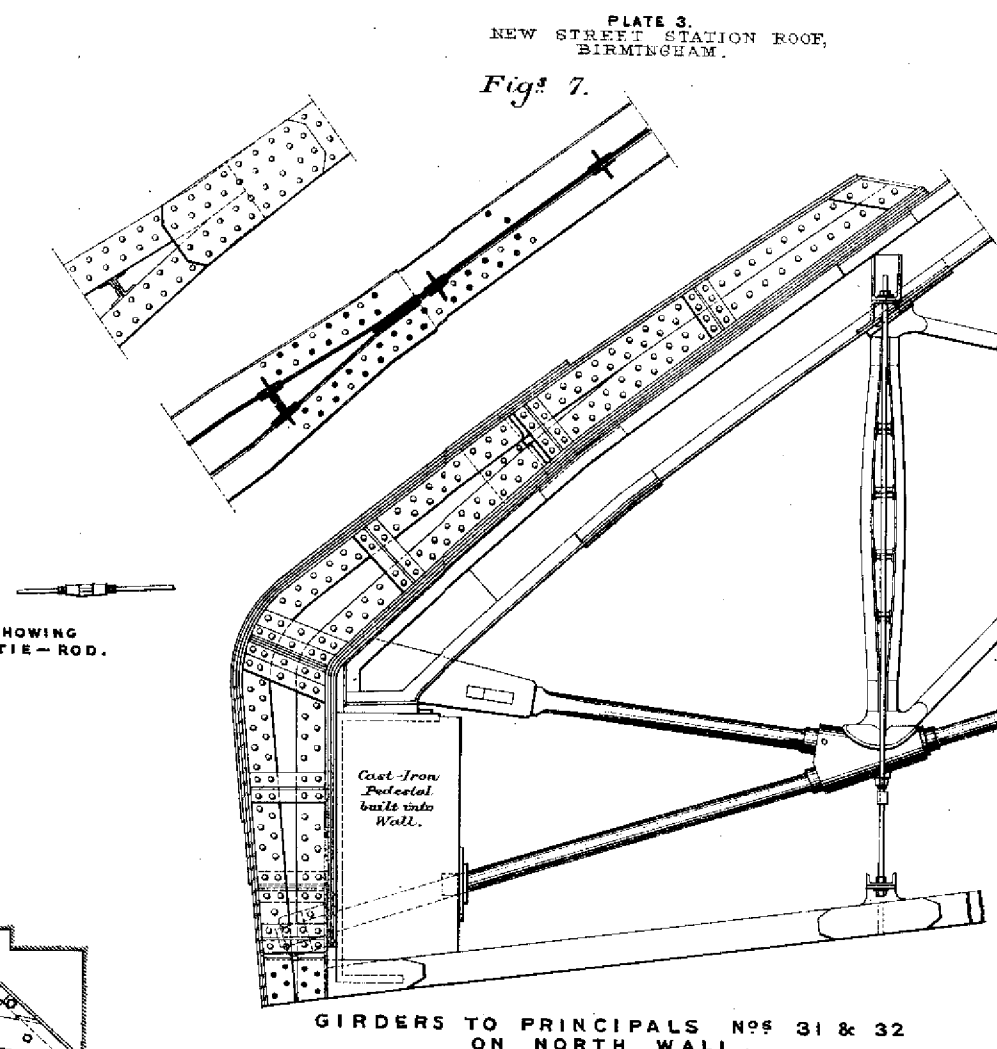
Fig. 7.

When detailed particulars of the principals resting on the garage were obtained, it was found necessary to provide angle-shaped girders to transfer the stress from the new tie-bars to the foot of the principal (Figs. 7, Plate 3). These girders weighed $2\frac{1}{2}$ tons each, and the feet of the old principals had to be underpinned and propped during the time the tie-bars were being fixed.
