**EDEN ISS**

## **D5.3 – Environmental Control Performance**

**WP 5.2 - System & Component Demonstration**

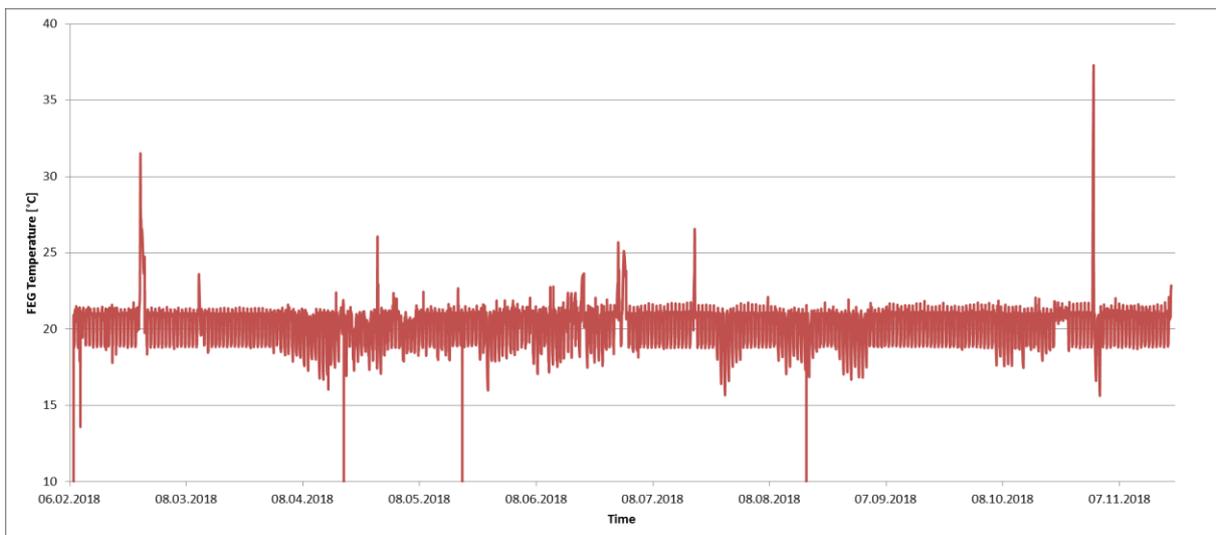
The temperature fluctuates between the photoperiod and the dark period set points. On some occasions the temperature during the photoperiod was well above the set point (e.g. in February, April, June and July). These temperature increases were caused by malfunctions of the thermal control system, see Chapter 2. Another issue was the drop in the temperature during the dark period below the set point. This means, that the AMS and the stand-alone heater inside the FEG were not able to keep the temperature at the set point. During all of these occasions the temperature of the external environment was very low.

Figure 1-1: FEG temperature during the nominal operation phase in 2018.

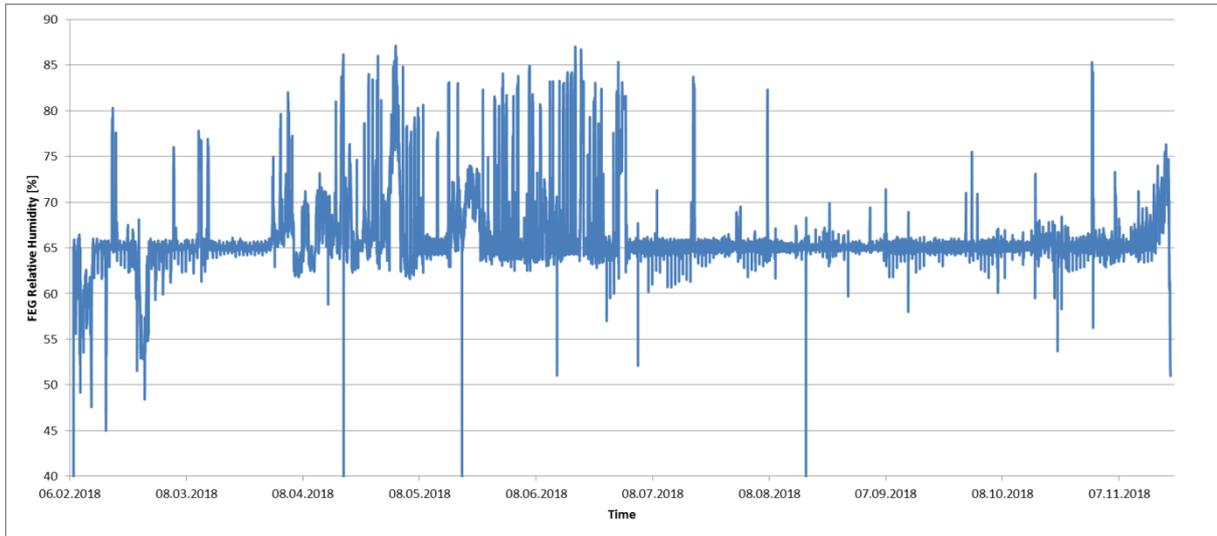
On the relative humidity graph one can see two different periods of behaviour. The first one starts in March and ends end of June. In this period the relative humidity fluctuates a lot and exceeds the set point by more than 10 %. With the beginning of July the behaviour gets more stable. This was the result of difficulties with the TCS and the control and data handling system (CDH). It took several weeks of adjusting the TCS control parameters and also the TCS flow rates in order to stabilize the behaviour of the relative humidity control.

Figure 1-2: FEG relative humidity during the nominal operation phase in 2018.

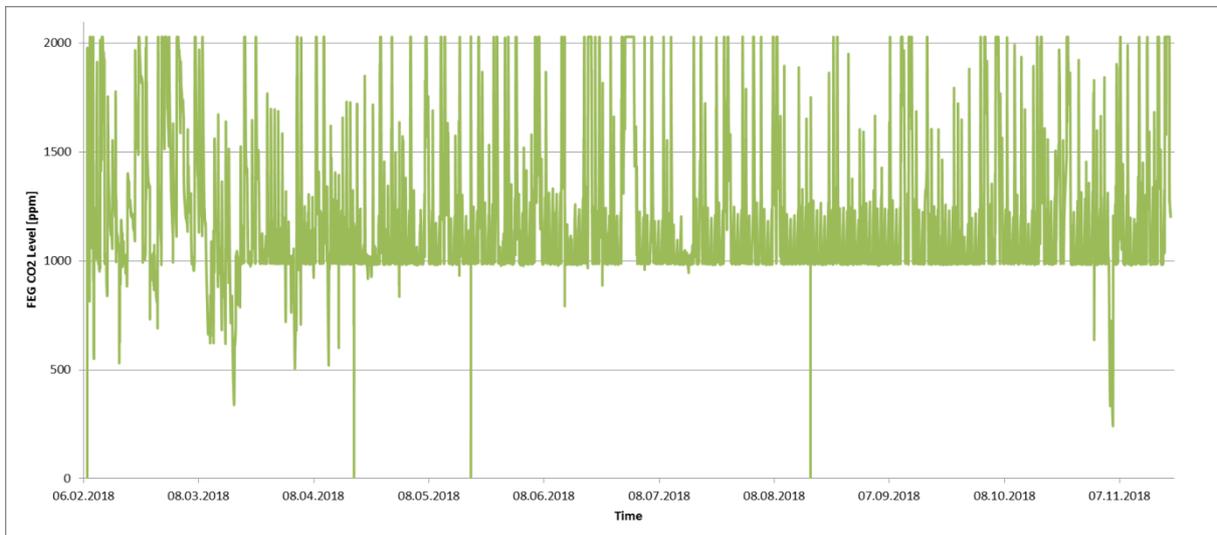
The CO<sub>2</sub> graph shows that the CO<sub>2</sub> level inside the FEG was always above the set point. Due to the influence of the activities of the on-site operator inside the FEG, the CO<sub>2</sub> level was much higher than initially planned.

Figure 1-3: FEG CO<sub>2</sub> level during the nominal operation phase in 2018. (Note: CO<sub>2</sub> sensor range was 0-2000 ppm. Values above 2000 ppm were not measured.)

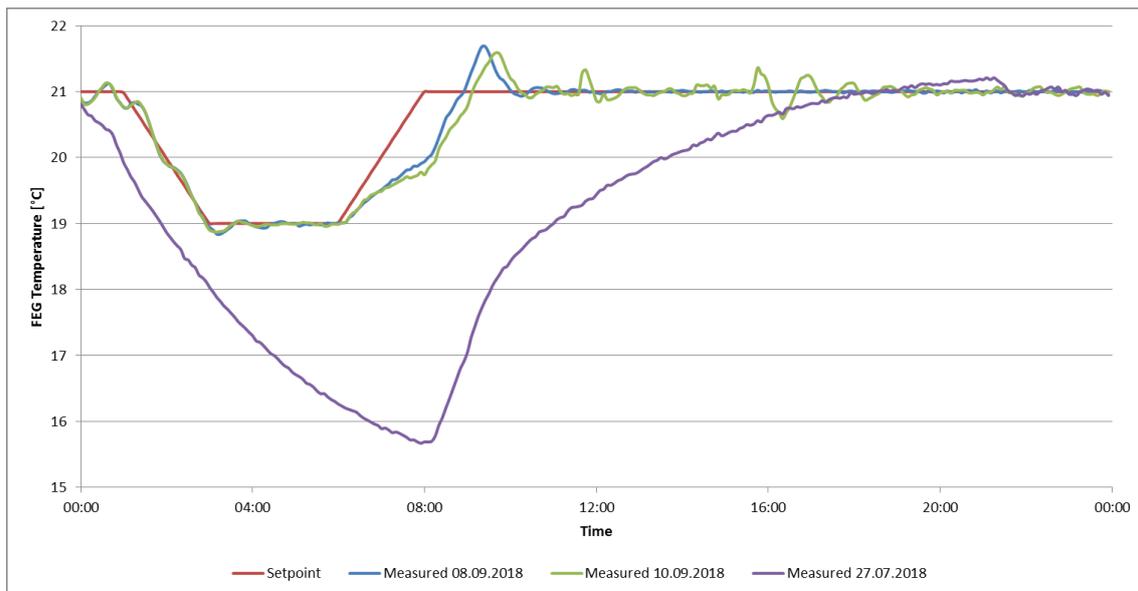
The temperature graphs in Figure 1-4 show that on the two days in September the AMS had no problem in keeping the temperature in the dark period at the set point. On July 27<sup>th</sup> on the other hand the very low external temperatures led to a fast decline of the FEG temperature during the dark period. Even with the lamps going on and all heaters at full capacity the AMS was not able to heat up the FEG to the set point of the photoperiod in a reasonable time.

**Figure 1-4: FEG temperature three daily graphs during the nominal operation phase in 2018.**

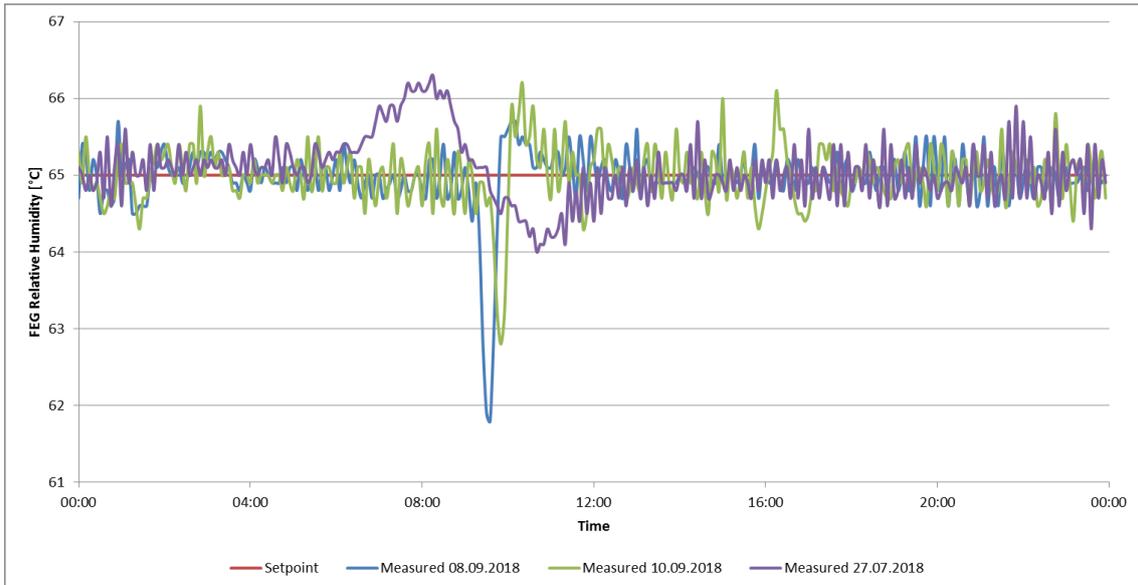
The relative humidity graphs in Figure 1-5 look very similar. The relative humidity increases slightly on the July 27<sup>th</sup> graph during the dark period because of the drop in temperature. When the FEG atmosphere heats up at the beginning of the photoperiod the relative humidity drops for a short period of time. This behaviour was expected, because the relative humidity is a function of the atmosphere temperature.

Figure 1-5: FEG relative humidity level three daily graphs during the nominal operation phase in 2018.

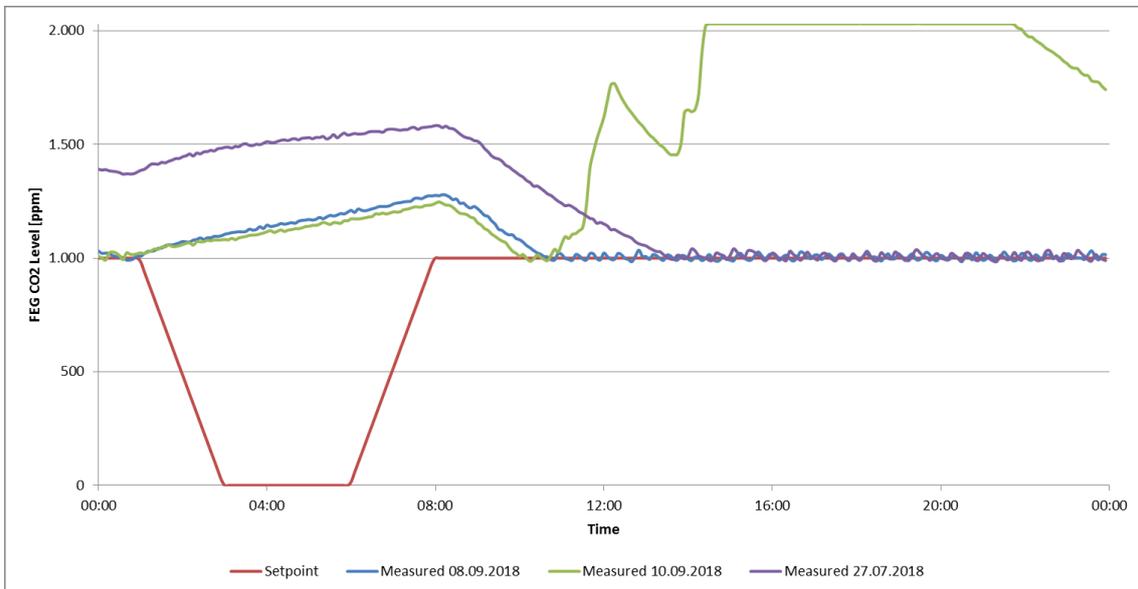
Figure 1-6 shows the CO<sub>2</sub> graphs for the three exemplary days. The CO<sub>2</sub> level rises during the dark period because CO<sub>2</sub> that was not bound during the photoperiod is released by the plants inside the FEG. When there is no human interference (September 8<sup>th</sup> and July 27<sup>th</sup>), the CO<sub>2</sub> level drops until it reaches the set point. Then the AMS pumps some CO<sub>2</sub> into the air streams from the bottles stored on the outside of the MTF. This can be seen in the small fluctuations of the two graphs around the set point. The situation is completely different when there is a human being inside the FEG, which is an additional CO<sub>2</sub> source. In the September 10<sup>th</sup> graph one can see an increase in CO<sub>2</sub> starting at around 10:30 and ending at 12:15. During that time the on-site operator performed some tasks inside the MTF. The operator left the MTF at 12:15 for lunch and came back around 13:40 to continue his tasks. This is the second step increase in CO<sub>2</sub>. The operator remained inside the FEG for a while which increased the CO<sub>2</sub> level well beyond the sensor maximum limit of 2000 ppm. Only at the very end of the day the CO<sub>2</sub> starts to decline below the 2000 ppm mark.

Figure 1-6: FEG CO<sub>2</sub> level three daily graphs during the nominal operation phase in 2018.

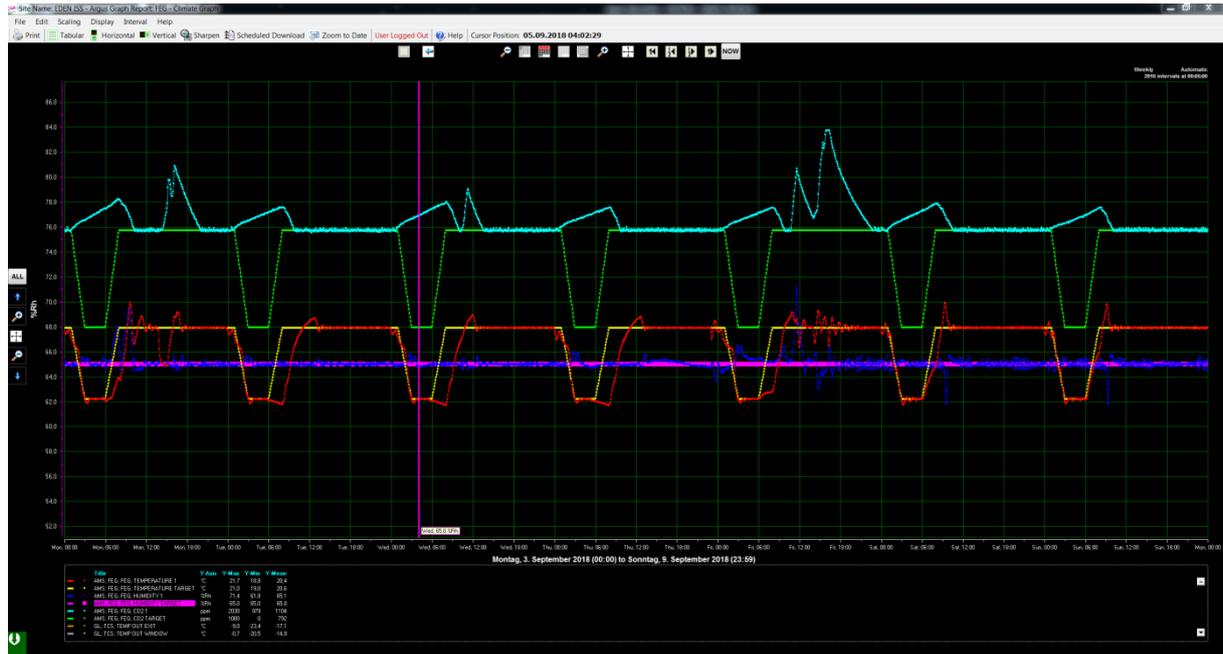
It can be seen in the graphs over one week of Figure 2-1 that the thermal system was capable of controlling the temperatures and relative humidity within the desired range for the climate in the FEG, barring any off-nominal events. In case the outside temperature was really low during the night period (no LEDs turned on) the system needed more time to heat the FEG up again to the desired 21°C day time temperature, but most of the time the behavior was not an issue.

Figure 2-1: FEG Climate Graph (Argus) – showing current temperature (red line), temperature target (yellow line), relative humidity (blue line), relative humidity target (purple line), CO<sub>2</sub> level (light blue line) and CO<sub>2</sub> level target values (green line) for one week of nominal operations.

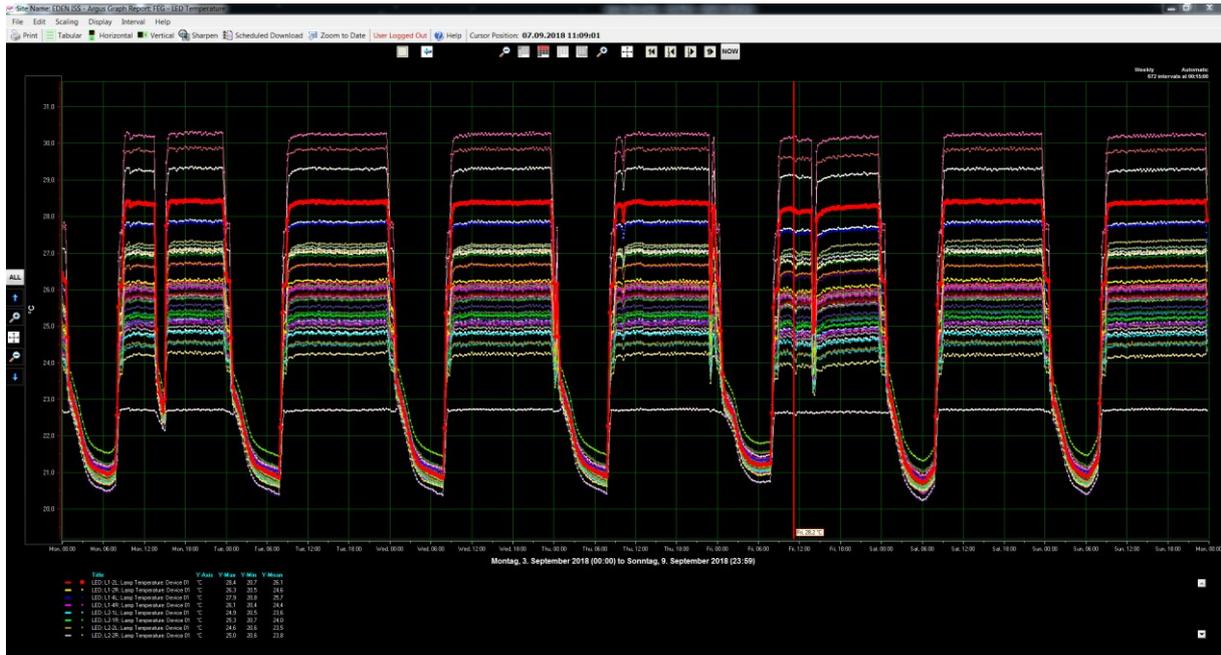
Figure 2-2 shows the day and night cycles over one week of nominal operations for the LED panel temperatures in the FEG. Also here the Thermal Control System was always capable to keep the temperatures at the desired levels and prevent the panel from overheating.

Figure 2-2: LED Panel Temperature Graph (Argus) – showing current temperature values for each LED panel for one week of nominal operations.

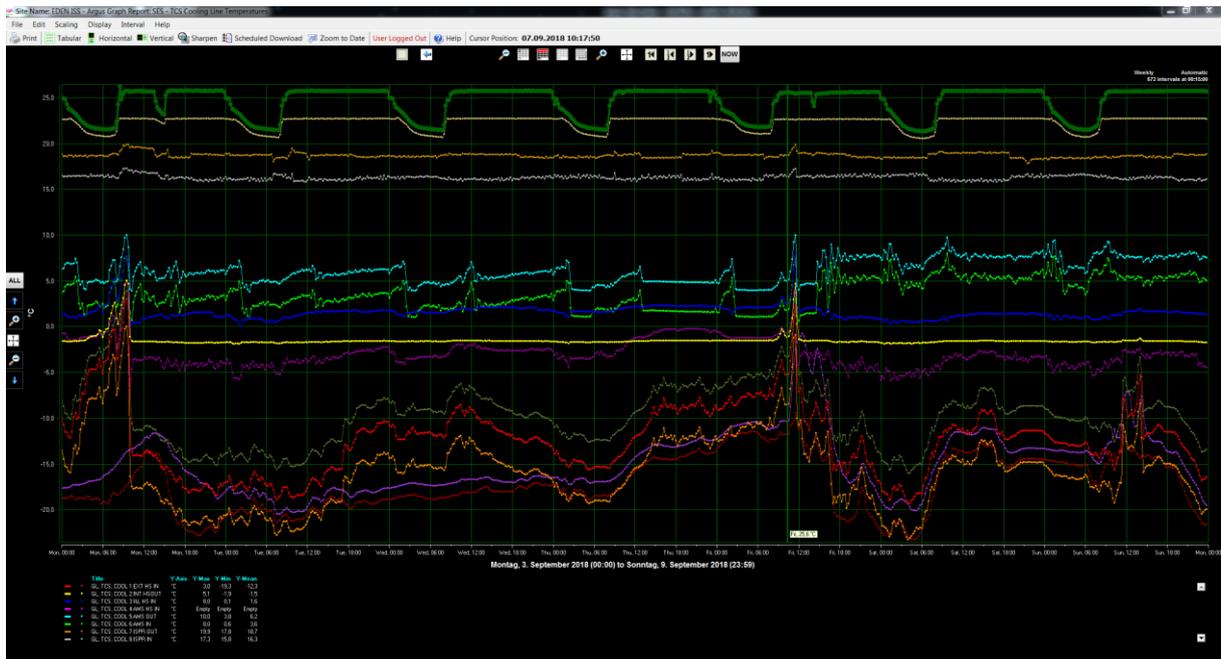
Figure 2-3: Thermal Coolant Temperature Graph (Argus) – showing current temperature values for various cooling line temperatures for one week of nominal operations.
