Project report – AM 4 Industry

LBM Additive Manufacturing Defect Catalogue

Acronym	AM4Industry
Full title	AM 4 Industry - quality assurance and cost models supporting the widespread use of additive manufacturing
Web	www.am4industry.com

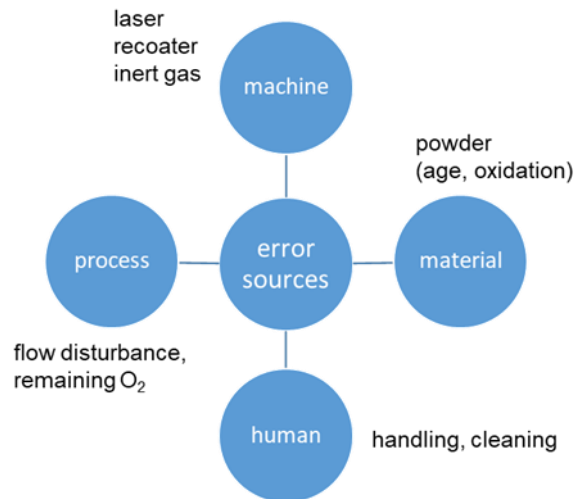
Figure 1: Error sources

Since some errors are very rare (e.g. remaining oxygen and laser power or wavelength too high / too low, bad focusing or x/y-position, galvanometer scanner system too fast / too slow), only those with a higher and middle chance of occurrence were taken into account. This analysis is based on the first model of the EOS M280 machine generation from 2011, which is located at FOTEC.

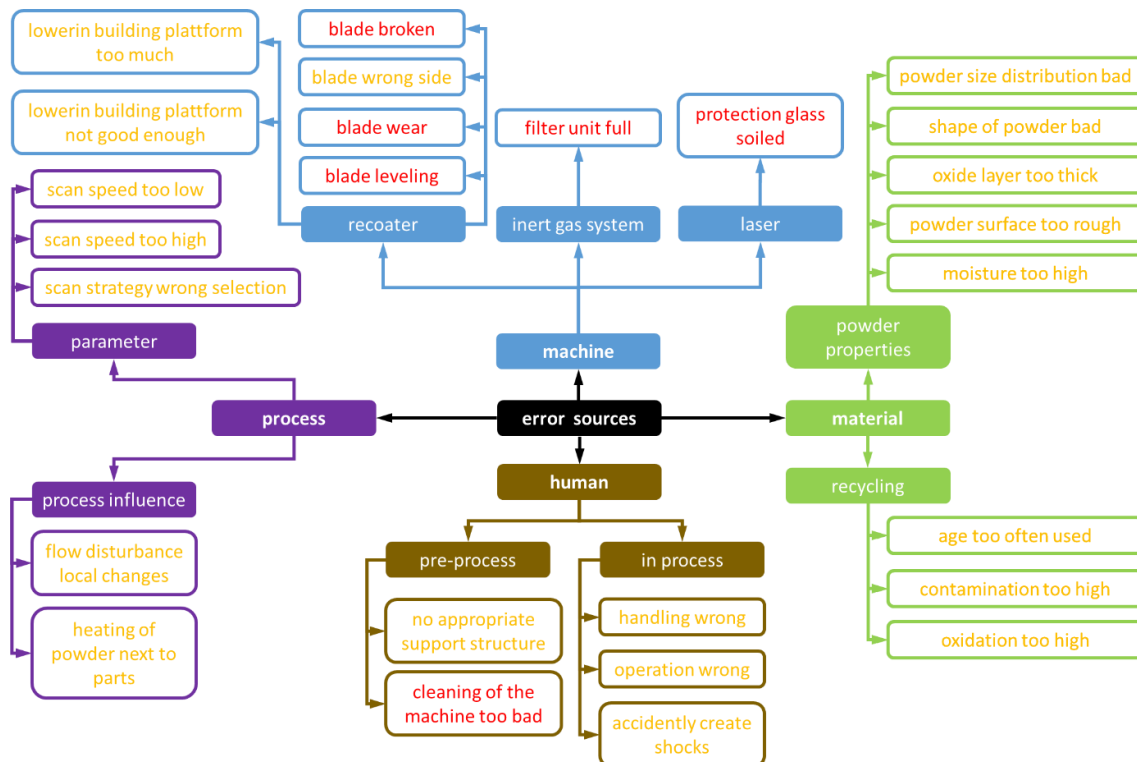
Figure 2: Error sources – detailed

Figure 2 shows common errors on the machine. Those with a higher chance of occurring are marked in red and those with a middle chance of occurrence in orange. As stated before, rare errors (low chance of occurrence) will not be referred to hereafter.

By implementing process monitoring (layer- and melt pool-monitoring systems), some of the errors can generally be detected mid-process. The recoater-based errors shown in Figure 2 can be detected by powder bed layer monitoring, the parameter-based errors (also Figure 2) by melt pool monitoring.

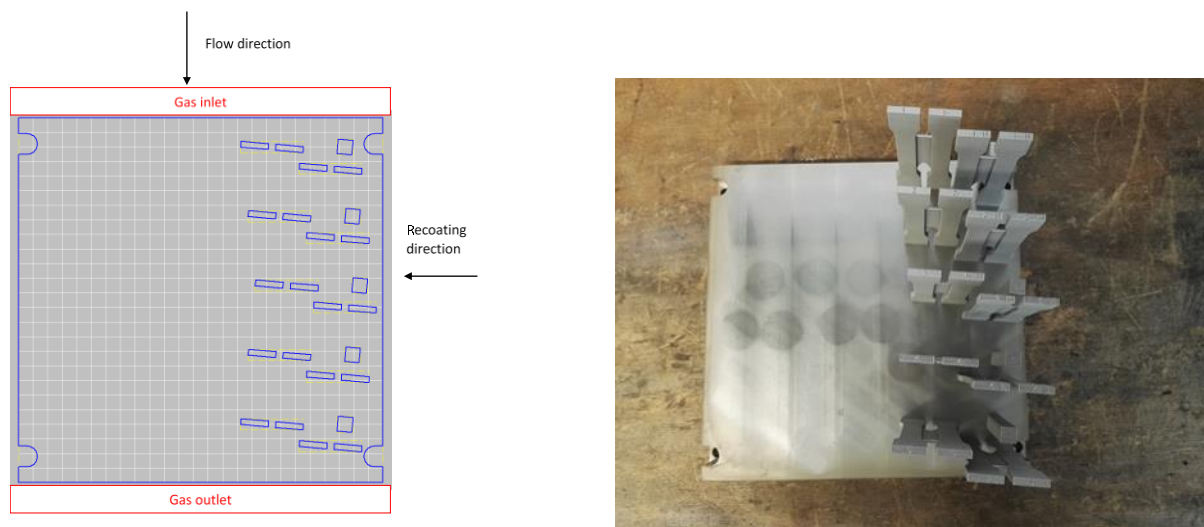
Figure 11: Building job - investigation of the effects of interruptions; 2D view with recoating/gas flow directions and gas inlet and outlet (left) and built job (right)

The effect of a longer pause (leading to markings as in Figure 10) on the mechanical properties was investigated with Ti64 (Ti6Al4V) tensile samples. In order to simulate a building pause, the construction process was manually stopped at a building height of 64 mm (incl. 4 mm support height), i.e. in the middle of the components which were vertically aligned tensile samples of 120 mm length. The delay between stopping and continuing the construction process was ten hours. The samples were heat treated (800°C/4h) after 3D printing.

In the first test, building was continued in the same layer where it had been manually stopped. In the second test, building was continued three layers above (90 μm) to simulate a recoater collision where the actual stop height cannot be determined. In order to evaluate the differences to an error-free building job, a reference component with the same component alignment was 3D printed without interrupting the process.

The result of the tensile tests (according to ASTM E-8) is shown in the following diagram (see Figure 12). Compared to the reference component, there are almost no differences in Young's modulus (E), yield strength (R_p), ultimate strength (R_m) and elongation at break (A). The only striking difference is the standard deviation of elongation at break. Here, the average value is below the reference value. The standard deviations for an interrupted building job are also twice as high as the reference value.

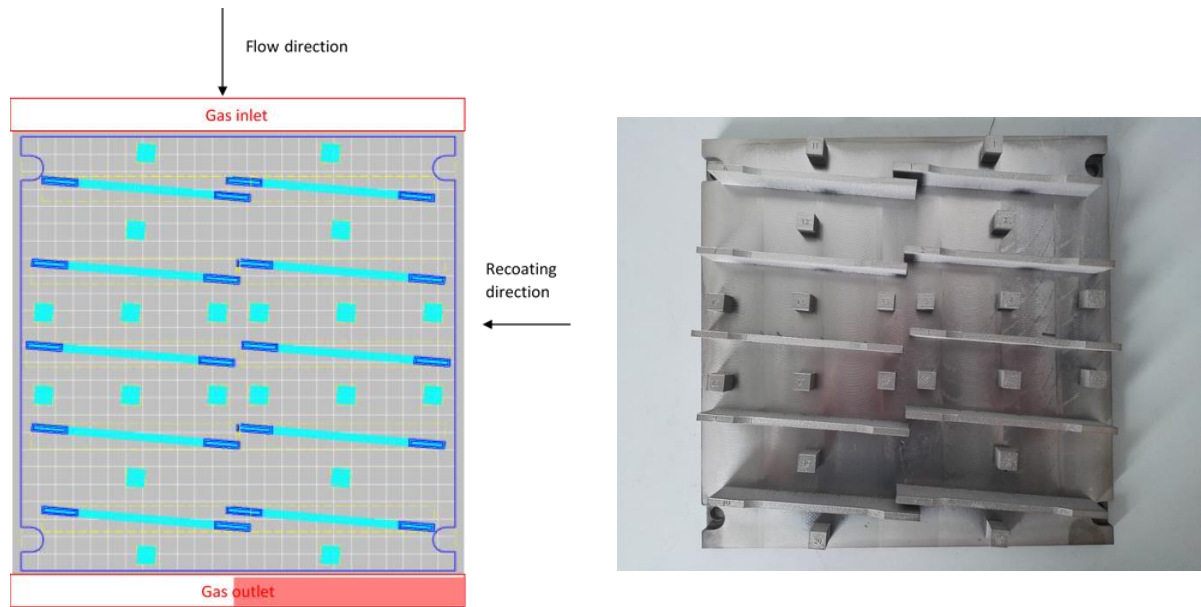
Figure 13: Building job – investigating blocked inert gas flow; 2D view with recoating/gas flow directions and gas inlet and outlet (left); built job (right)

To investigate the effects of inert gas flow blockage and inclusion of weld spatter Ti64 (Ti6Al4V) tensile samples were built. They were aligned horizontally to the building platform. After 3D printing, they were also heat-treated (800°C/4h). A blockage of the inert gas flow was simulated by covering the gas outlet with adhesive tape on the right half.

The tensile test results (according to ASTM E-8) of the blocked nozzle samples actually show some differences to the open nozzle samples.

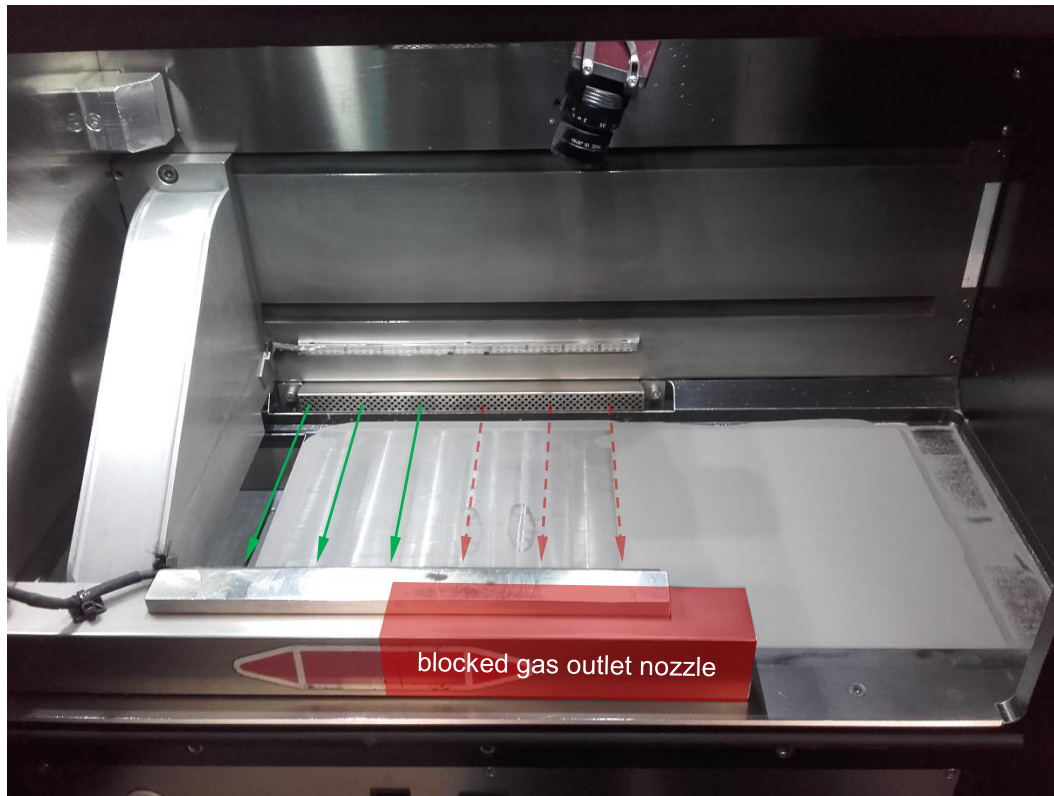
Figure 14: Inert gas flow direction and area of blocked gas outlet nozzle

With longer construction jobs, depending on material, component height and component volume, the inert gas nozzles sometimes get blocked with welding spatter and loose powder. If this happens, stay on the exposed layers of the components. This allows them to be integrated into the remaining component layers during recoating and exposure and avoids a potential component defect.
