Deterioration of a Building through Environmental and Anthropological Causes

A residential house in Sagar Nagar, Visakhapatnam [7], has been identified for the case study. The house is a perfect example of the condition that will be witnessed when maintenance is not done regularly for a building by the occupants. A duplex house, with greater percentage of open spaces in the site, was originally intended to be used as a weekend farm house. Over the years, the building has become prone to various factors leading to its current state. Hence, a study of its current condition would give us results that would be helpful in understanding the problems caused when the maintenance strategies are not followed.

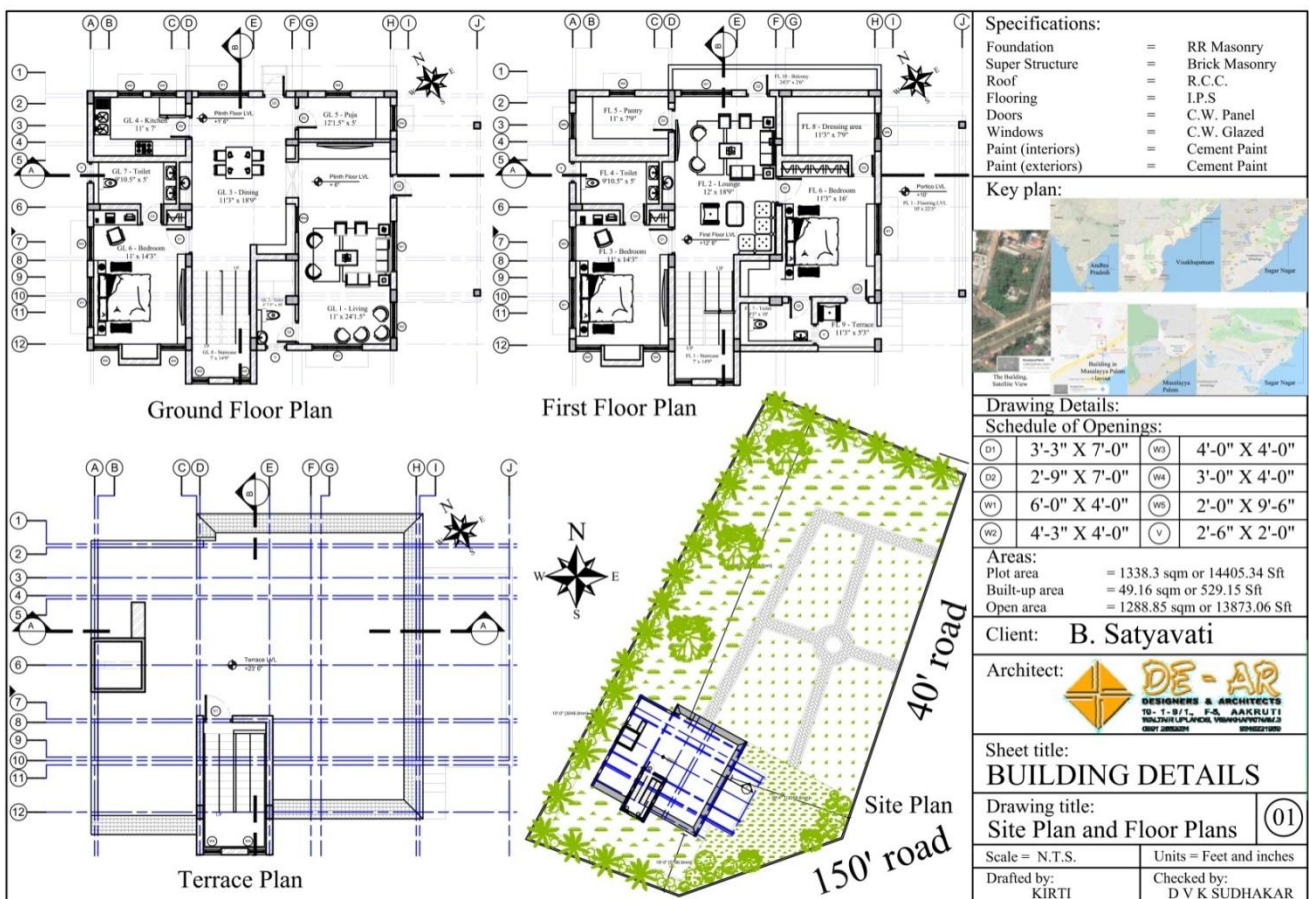
Figure 5 (a)

Figure 5 – (a) Sheet 01: Building drawings (site plan, ground floor plan, first floor plan, terrace plan with key location) of the case study (b) (c) (d) Views of the selected site and the building

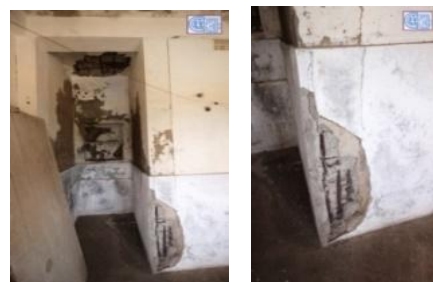
Figure 32 (a) (b)

Figure 32 – (CD 12.3, SD 09.2, PD 22, 23) FL 6: Bedroom, wardrobe area (a) West view (b) West view towards the column (c) West view (d) Ceiling view
Figure 33 – (CD 14, PD 25) FL 9: Terrace – Column – South view
