I.FAST

Survey of AM applications and strategies for repairing components by AM

DELIVERABLE: D10.2

Document identifier:	IFAST-D10.2
Due date of deliverable:	End of Month 24 (April 2023)
Report release date:	30/04/2023
Work package:	WP10: Advanced Accelerator Technologies
Lead beneficiary:	RTU
Document status:	Final

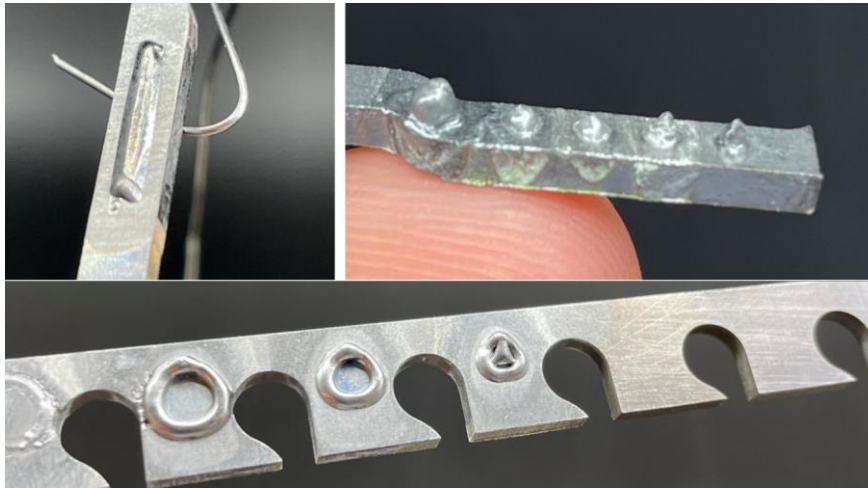
Fig. 25 Different test shapes manufactured by wire DED

Two different repair strategies were tested in process testing: single layer and multilayer. The first approach consisted in depositing material inside the erosion craters in single layer to restore the original electrode morphology. Single dots, tracks, and domes consisting of multiple concentric rings were deposited on tantalum test pieces (Fig. 25) varying the main process parameters.

During the tests several samples were cut and their grain structure observed. For wire process, results showed distinct oxidation layer in all samples and also small uniform porosity in deposited area with several large inclusions on deposition boundary. Grain size differs from sample to sample, but no single-grain structures were observed, therefore hardness is estimated in range, which would allow for mechanical material removal in later stages. Metallographic analysis of powder samples showed distinct lack of fusion – explained by that samples cannot be preheated by laser in this process because laser is turned on after the powder flow has already been established. Different from wire process, here there was no uniform porosity – only some large inclusions and individual pores. Grains in this process were also bigger than in wire process.

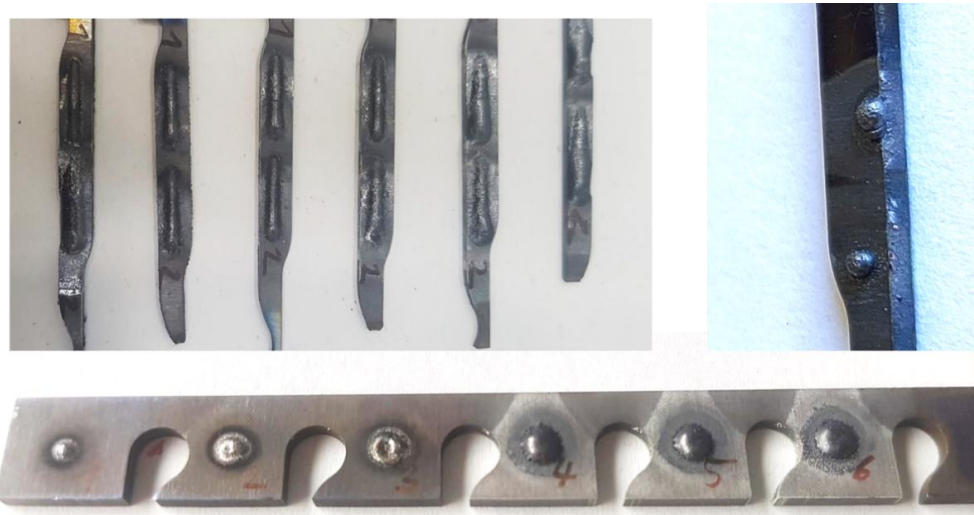
Fig. 26 Different test shapes manufactured by powder DED

The powder-based repair process was performed using a COAX14 annular gap nozzle and a Laserline LDF laser with 1080 nm wavelength. The feedstock material was the AMtrinsic® 99.9% pure tantalum powder supplied by Taniobis, having spherical morphology and 10-63 µm particle size. Initial parameter test results can be seen in Fig. 26

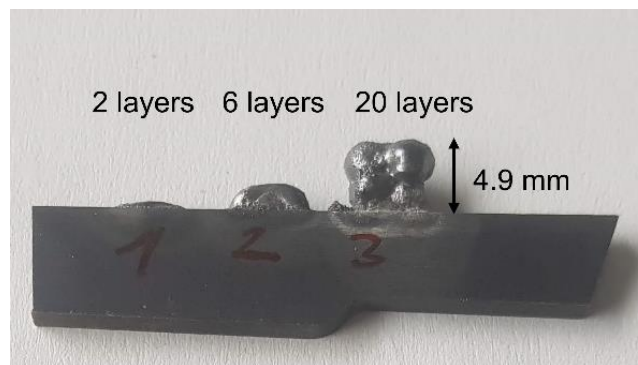
Fig. 27 Multilayer deposit made by powder DED

The second strategy was to cut off the damaged portion of the electrodes (i.e., the head) and print a new one in place, which would ask for several layers to be printed on top of each other with parameters shown in Table 2. Multilayer tests were conducted with powder-based DED using the parameters optimised from the previous trials. However, after depositing the first ten layers, the material begun to flow and the desired geometry could not be achieved (Fig. 27).

Neither an interlayer cooling time of 30 s nor keeping the interlayer temperature below 250 °C could prevent this phenomenon. Because of these unpromising results, this approach was discarded.
