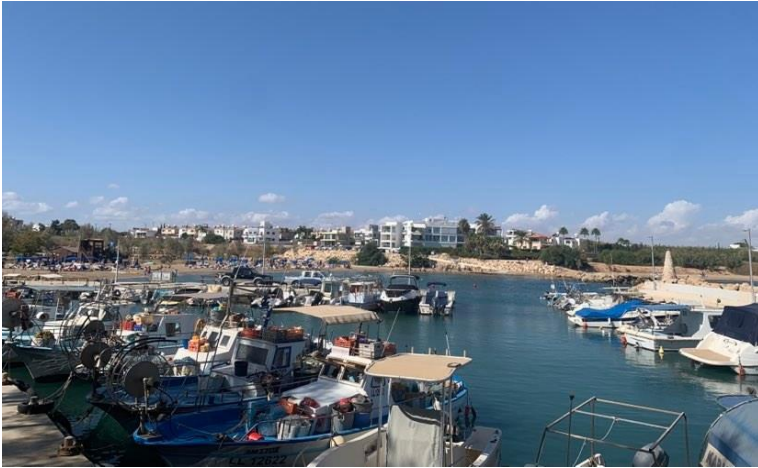
**Figure S3.1:** The fishing shelter of Agia Triada (images captured during site visits in Autumn 2021): (a) Overview of the port; (b) Detail of the protection works.

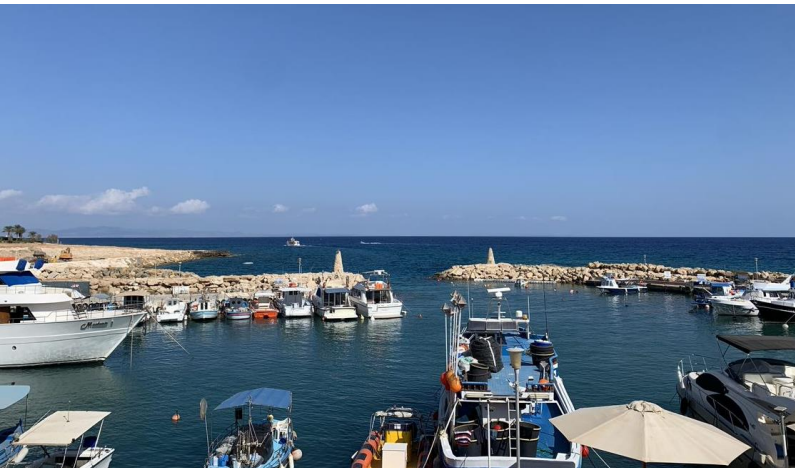
**Figure S3.2:** The fishing shelter of Paralimni (images captured during site visits in Autumn 2021): (a) Overview of the port; (b) Detail of the protection works.

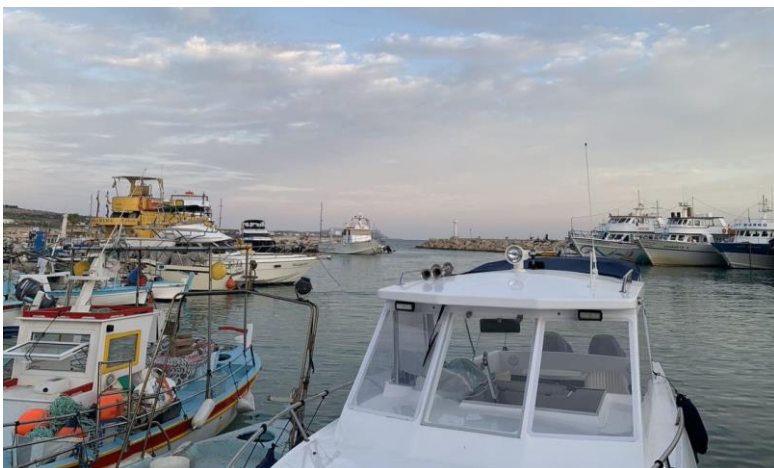
**Figure S3.3:** The fishing shelter of Agia Napa (images captured during site visits in Autumn 2021): (a) Overview of the port; (b) Defects (cracking) detected at the quay wall.

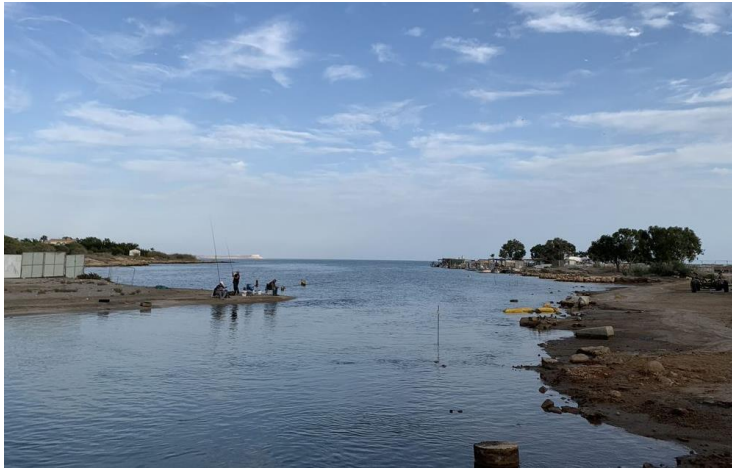
**Figure S3.4:** The fishing shelter of Liopetri (images captured during site visits in Autumn 2021): (a) Overview of the port; (b) Construction works in the area of the shelter.

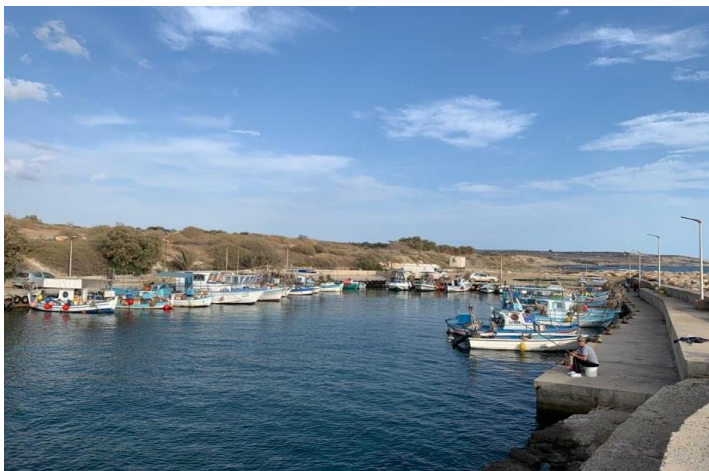
**Figure S3.5:** The fishing shelter of Xylophagou (images captured during site visits in Autumn 2021): (a) Overview of the port; (b) Defects (cracking) detected at the concrete wharf.

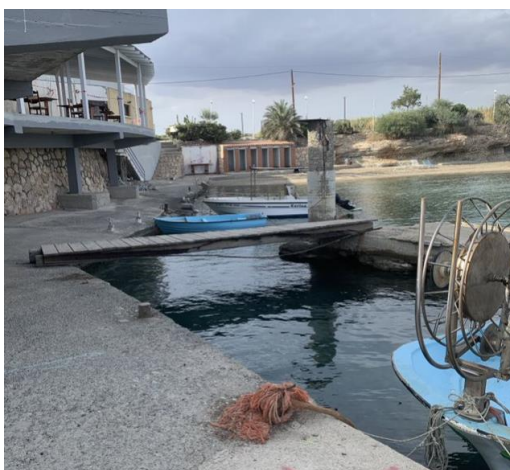
**Figure S3.6:** The fishing shelter of Ormideia (images captured during site visits in Autumn 2021): (a) View of the port facilities; (b) Construction works in the area of the shelter.

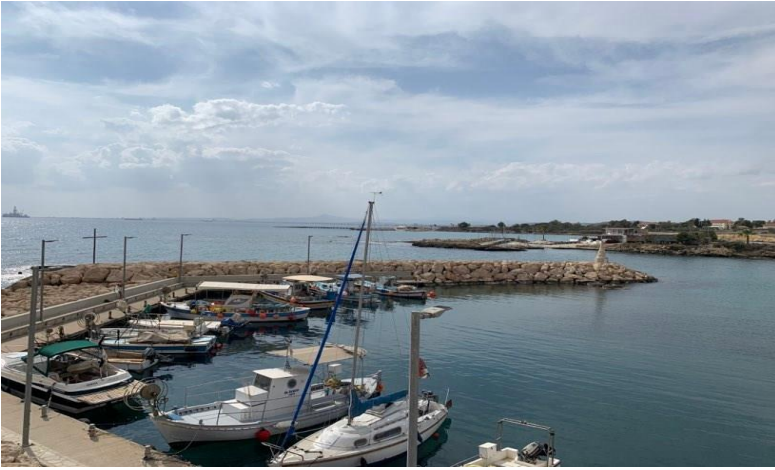
**Figure S3.7:** The fishing shelter of Xylotympou (images captured during site visits in Autumn 2021): (a) Overview of the port; (b) Failure of the boat slip.

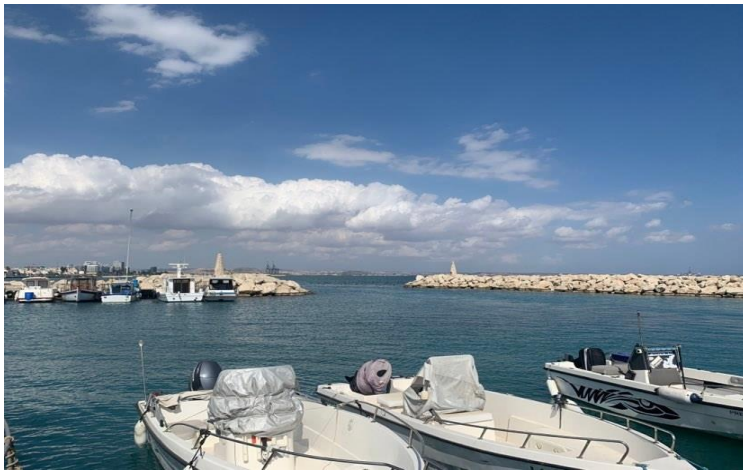
**Figure S3.8:** The fishing shelter of Larnaca (images captured during site visits in Autumn 2021): (a) Overview of the port; (b) View of the protection works and the berthing area

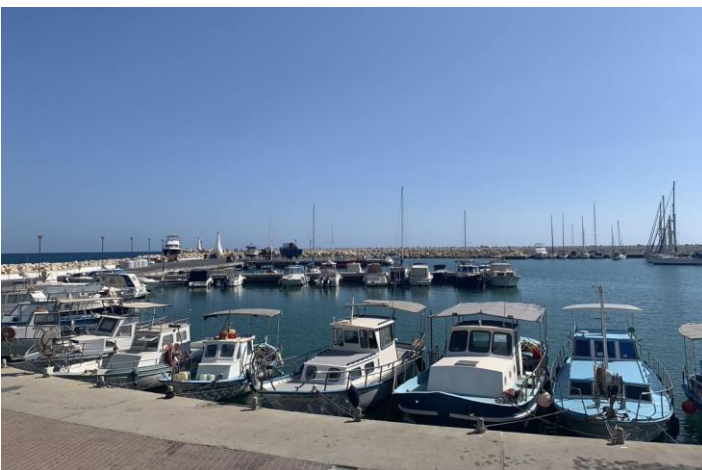
**Figure S3.9:** The fishing shelter of Zygi (images captured during site visits in Autumn 2021): (a) Overview of the port; (b) View of the protection works.

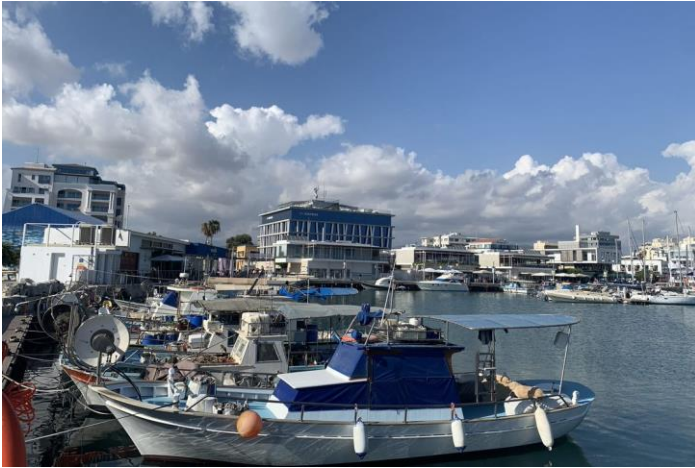
**Figure S3.10:** The fishing shelter of Limassol (images captured during site visits in Autumn 2021): (a) Overview of the port; (b) View of the protection works.

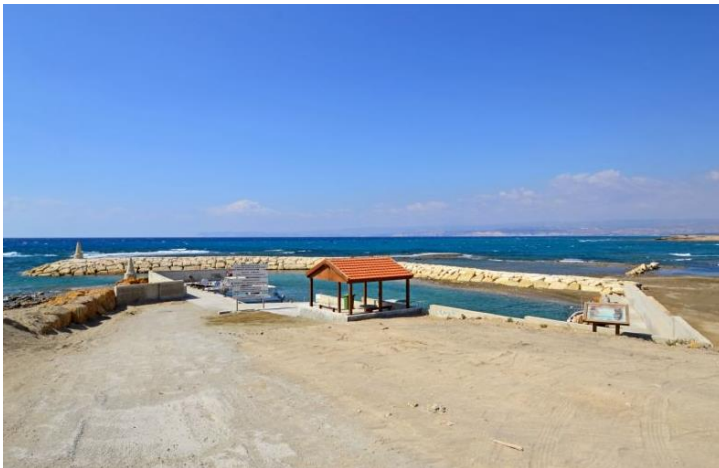
**Figure S3.11:** The fishing shelter of Akrotiri (images captured during site visits in Autumn 2021): (a) Overview of the port; (b) View of the berthing area.

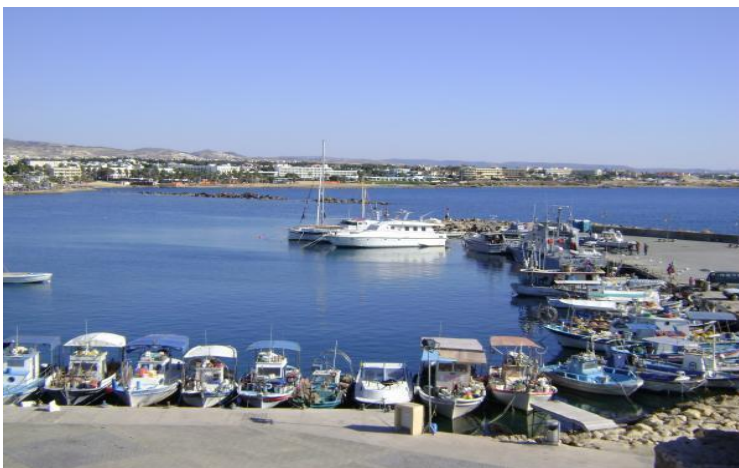
**Figure S3.12:** The fishing shelter of Paphos (images captured during site visits in Autumn 2021): (a) Overview of the port; (b) Defects (spalling) detected at the quay wall.

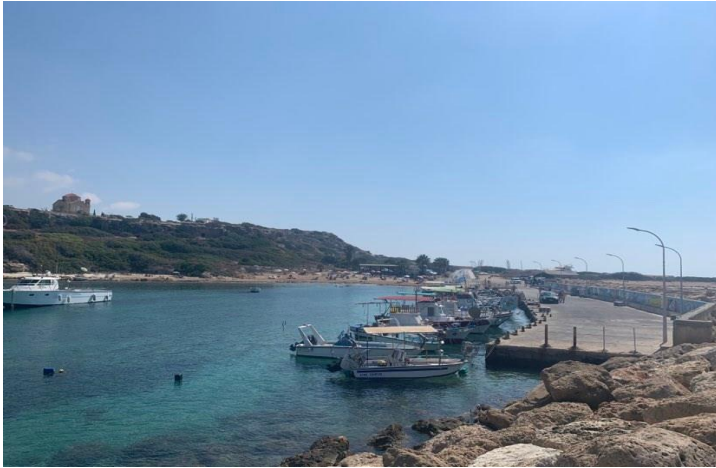
**Figure S3.13:** The fishing shelter of Agios Georgios (images captured during site visits in Autumn 2021): (a) Overview of the port; (b) Wave overtopping observed at the area of breakwater.

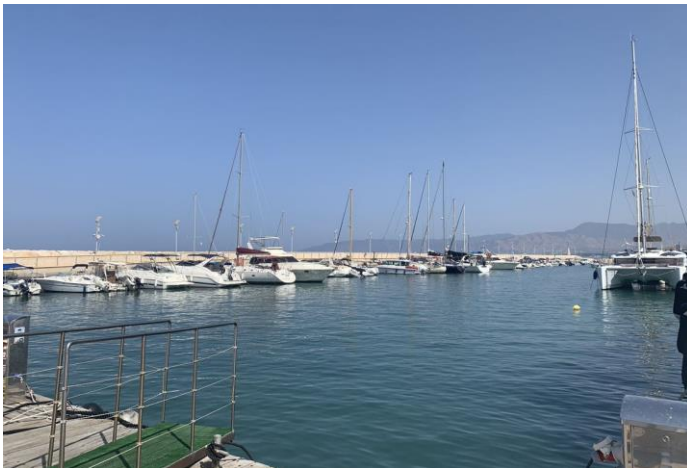
**Figure S3.14:** The fishing shelter of Latsi (images captured during site visits in Autumn 2021): (a) Overview of the port; (b) View of the protection works.

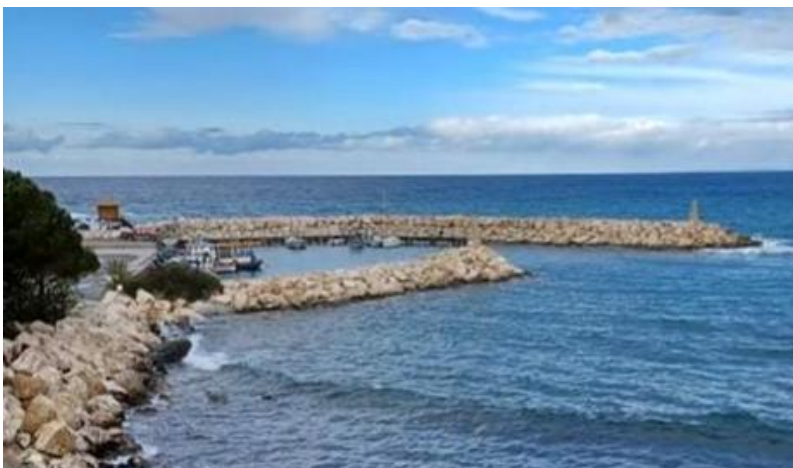
**Figure S3.15:** The fishing shelter of Pomos (images captured during site visits in Autumn 2021): (a) Overview of the port; (b) View of the protection works.

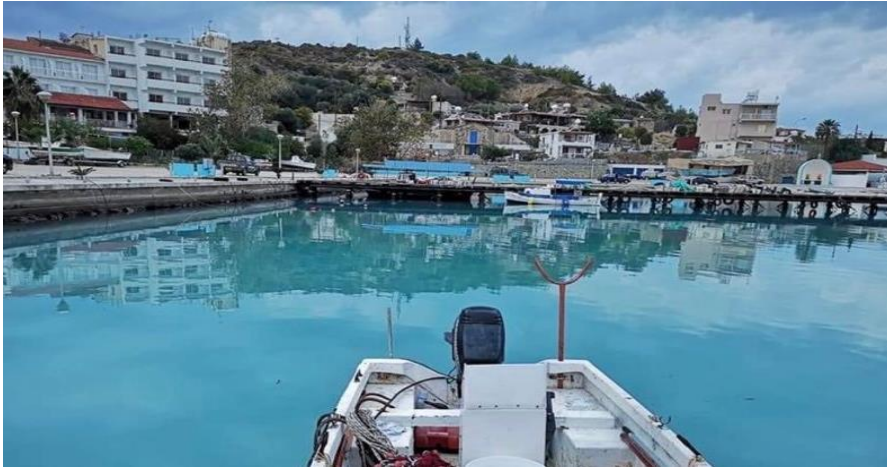
**Figure S3.16:** The fishing shelter of Pyrgos (images captured during site visits in Autumn 2021): (a) View of the port; (b) View of the berthing area.
