FRACTURE ANALYSIS OF THE HYDRAULIC TRUCK CRANE ATLAS 3006

Conference Paper · June 2014

Fracture Analysis of the Hydraulic Truck Crane ATLAS 3006

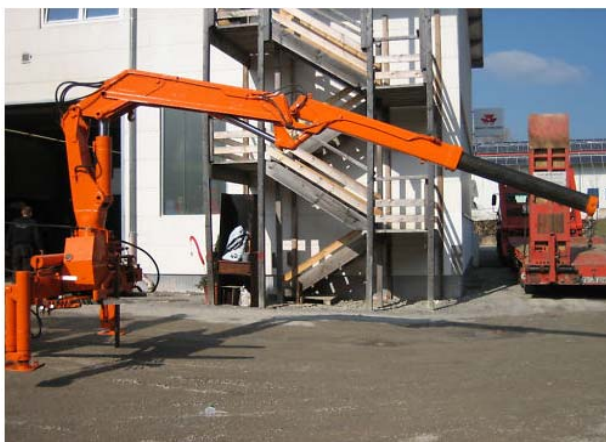
Figure 1. Hydraulic truck crane Atlas 3006

After more than 12 years of crane exploitation, during a regular overhaul, certain damages at the first jointed segment of the crane were noticed. This damage is at the point of connection between the hydrocylinder and the segment (detail "A" - Figure 2).

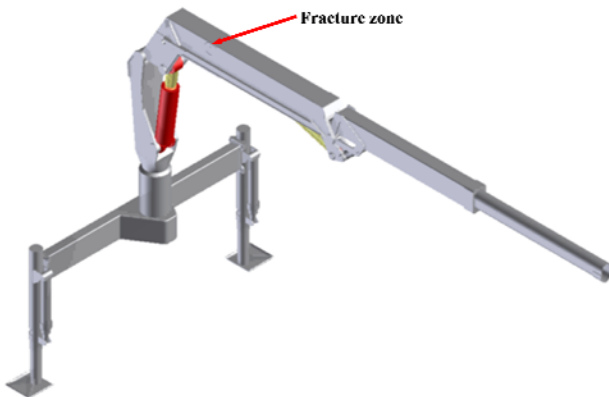
Figure 4. Model of the hydraulic truck crane ATLAS 3006

The analysis of the stress state of the hydraulic truck crane ATLAS 3006 was carried out by applying the finite element method (FEM). The model was formed on the basis of catalogue documentation and the additional measurements performed at the crane itself (Figure 4).

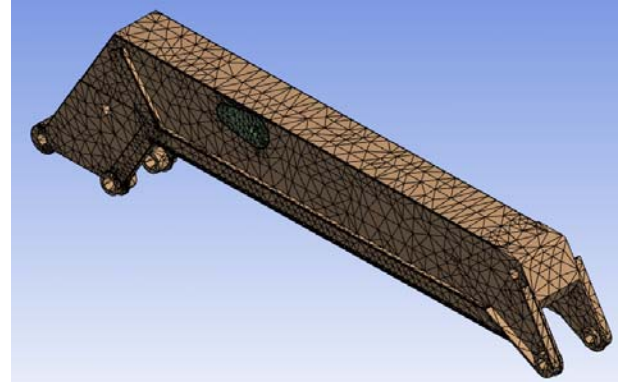
Figure 5. First segment of the boom of the hydraulic truck crane ATLAS 3006

The 3D model of the hydraulic truck crane was built by synthesis of all structural parts (Figure 4). The model represents a continuum discretized by 10-node tetrahedral elements for the purpose of creating an FEM model (64036 nodes and 33060 elements). The first segment of the jointed boom of the truck crane was particularly taken out and analysed (Figure 5).

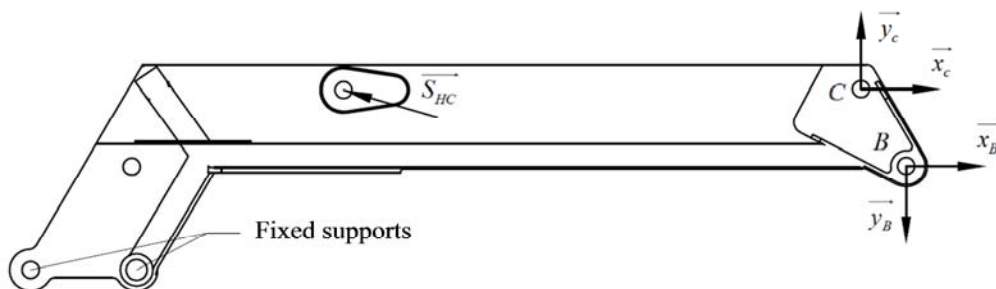
Figure 6. Scheme of loading of the first segment of the boom in the hydraulic truck crane ATLAS 3006

The manufacturer's data about the value of maximum load and the data about the mass of crane elements were used for the analysis of loads of the hydrocylinder support for lifting the second segment. The scheme of loading of the first segment of the crane boom is shown in Figure 6.

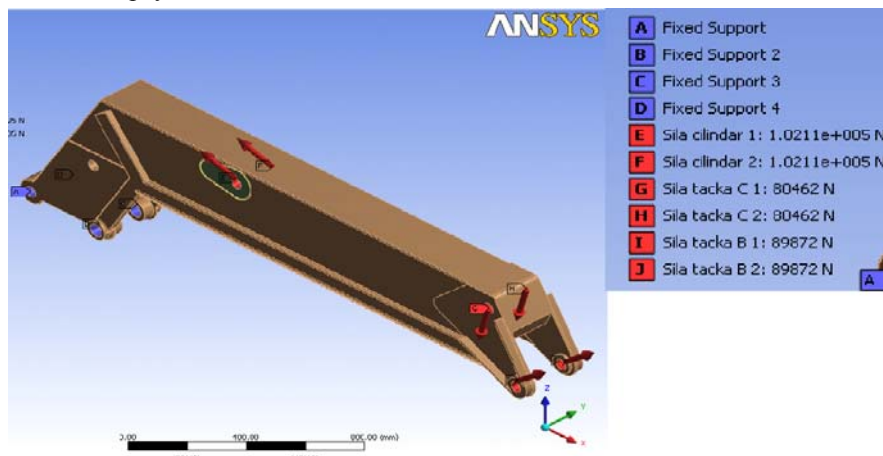
Figure 7. Scheme of loading of the first segment of the boom in the hydraulic truck crane ATLAS 3006

The obtained values of loads were used in the calculation model created in the software package ANSYS (Figure 7).
