Experimental study of the effect of pre-bond contamination with de-icing fluid and ageing on the fracture toughness of composite bonded joints

Abstract

The scope of the present work is to experimentally investigate the effect of pre-bond contamination with de-icing (DI) fluid and the combined effect of DI fluid and hygrothermal ageing on the fracture toughness of carbon fibre reinforced plastic bonded joints. These scenarios could occur in the implementation of an adhesively bonded patch repair in a composite aircraft structural part. To this end, mode I and mode II fracture toughness tests were conducted on contaminated specimens and mode II fracture toughness tests on contaminated/aged specimens. Three levels of contamination with a de-icer were considered. The hygrothermal ageing conditions applied until saturation are 70°C/85% relative humidity. The experimental results reveal a detrimental effect of DI fluid on both mode I and mode II fracture toughness of the bonded joints. With increasing the contamination level, the mode I and mode II critical energy release rates decrease. Under mode I loading, the specimens failed mainly in light-fibre-tear mode, while under mode II loa

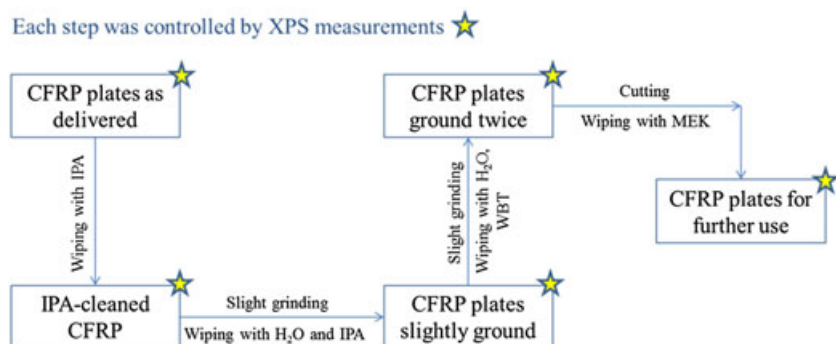
FIGURE 1 Scheme for cleaning of as-received CFRP plates. CFRP, carbon fibre reinforced plastic; IPA, isopropanol; MEK, methyl ethyl ketone; XPS, X-ray photoelectron spectroscopy. [Colour figure can be viewed at wileyonlinelibrary.com]

To prepare the clean reference samples from the delivered plates, the following steps were performed, and each step was monitored by X-ray photoelectron spectroscopy (XPS) analyses (Figure 1).

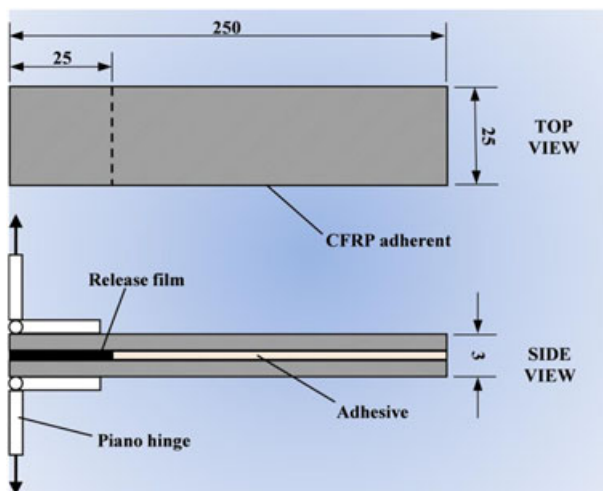
FIGURE 2 Schematic representation of the DCB specimen. DCB, double cantilever beam; CFRP, carbon fibre reinforced plastic. [Colour figure can be viewed at wileyonlinelibrary.com]

The Airbus specification²³ AITM 1-0053 defines a method to determine the mode I fracture toughness energy G_{IC} of CFRP bonded joints. The double cantilever beam specimen is used, which consists of rectangular adherents bonded along their length incorporating a region of nonadhesive release film at one end for the introduction of the initial crack in the bondline (Figure 2). Load was applied in the double cantilever beam specimen via metallic piano hinges bonded to the adherents at one end. To avoid any influence of the incorporated release film, the specimen was preloaded until an initial crack length of 10 to 15 mm was achieved. The pre-cracked specimen was then loaded continuously by opening forces until a total propagated crack length of 100 mm was achieved. After that, the test was stopped, and the specimen was unloaded.

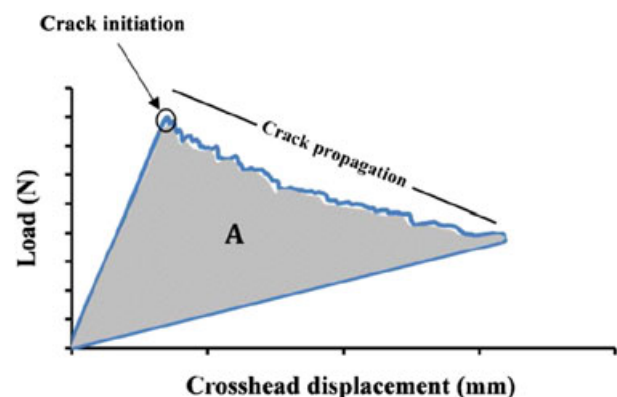
FIGURE 3 A typical load-displacement diagram of the mode I fracture toughness test. [Colour figure can be viewed at wileyonlinelibrary.com]

The area method was applied to interpret the data recorded during the mode I tests. The crack extension is related directly to the area enclosed between the loading and unloading curves as shown in Figure 3. The mode I critical energy release rate G_{IC} is derived as²³

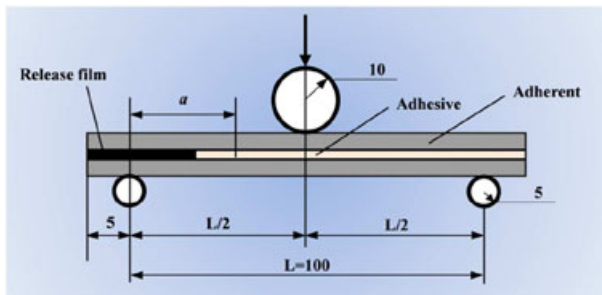
FIGURE 4 Schematic representation of the End Notched Flexure specimen. [Colour figure can be viewed at wileyonlinelibrary.com]

Figure 4 illustrates a schematic representation of the ENF test. A pre-cracked specimen is loaded in a 3-point bend fixture until the crack propagation onset. The pre-crack is embedded through width at the end of the specimen to accommodate the sliding deformation of the adherents that result from the flexural loading.²⁸ To provide crack growth stability, the initial crack length was considered to be equal to 70% of $L/2$.^{4,29} The load applied to the specimen and the crosshead displacement of the test machine were recorded continuously during the test.

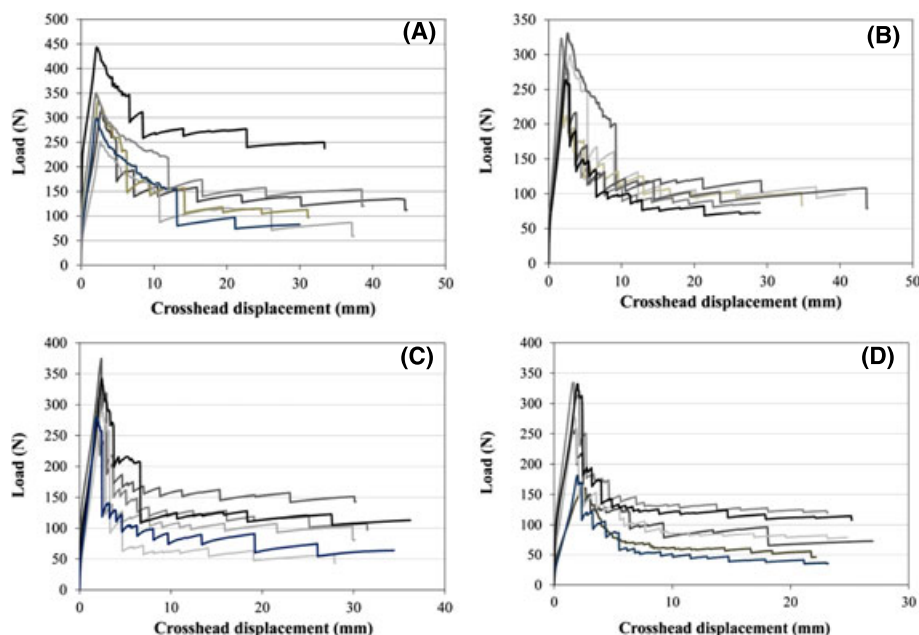
FIGURE 5 Experimental mode I load-displacement curves of A, REF B, DI-1, C, DI-2, and D, DI-3 specimens. [Colour figure can be viewed at wileyonlinelibrary.com]

The experimental load-displacement curves of the mode I tests of the different DI fluid concentration levels, including the reference one, are plotted in Figure 5. It is observed that all specimens exhibited an unstable crack growth. The G_{IC} values of the specimens are presented in Figure 6. The results indicate a negative effect of DI fluid as G_{IC} is reduced for all

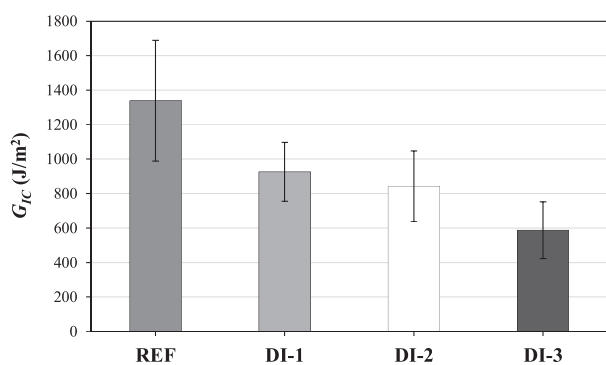
FIGURE 6 Average G_{IC} values comparison

3 contamination levels. Specifically, for DI-1, the average G_{IC} values show an almost 30% reduction compared to the reference category, for DI-2, the average G_{IC} is reduced further to 37%, while for DI-3, the G_{IC} fracture toughness of the joints

degrades significantly by 56% designating the detrimental effect of DI fluid on the bond performance. The rather big scatter of G_{IC} values is attributed to the complexity of adhesion mechanisms and failure mechanisms (unstable crack propagation and varying failure mode) and possibly to the non-uniformity of contamination.^{1,8}

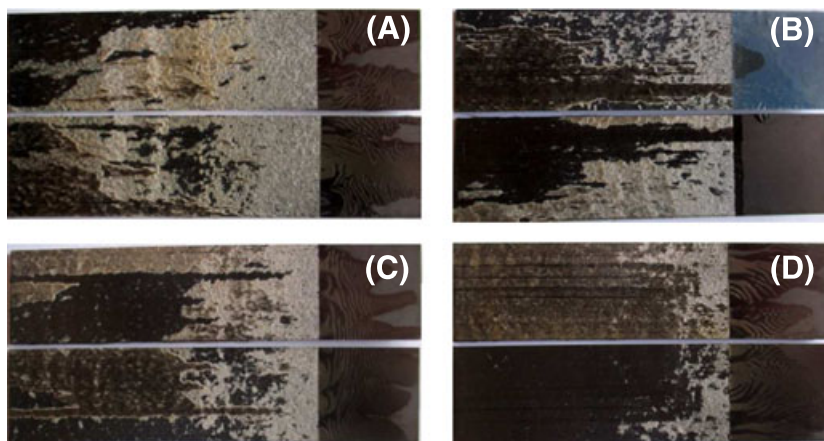
FIGURE 7 Representative fracture surfaces of the A, REF, B, DI-1, C, DI-2, and D, DI-3 specimens loaded in mode I. [Colour figure can be viewed at wileyonlinelibrary.com]

In Figure 7, photos of the fracture surfaces, showing the main failure modes observed in the mode I tested specimens, are illustrated, and in Figure 8, the percentages of the different failure modes are compared for the different sample sets. In the reference samples, a mixed-mode failure was observed (Figure 7A) with the dominant failure being the light-fibre-tear failure at a percentage of 50%, while the cohesive failure was observed at 35% of the surface area and the adhesive failure at 15%. The adhesive failure results show a large scatter, which is attributed to the fact that not all 6 specimens presented homogeneous failure; 3 samples presented

adhesive failure at a percentage less than 4%. The phenomenon of the non-uniform failure mode amongst samples of the same set is present in the contaminated samples sets also, revealing the complexity of crack propagation in the mode I fracture toughness tests. In the DI-1 samples (Figure 7B), the cohesive failure was reduced to 11.7%, while a larger surface failed adhesively (26%), indicating the reduction in bond strength. Light-fibre-tear failure remained the dominant failure in the DI-2 samples with a value of 63%. Finally, in the DI-3 set (Figure 7D), adhesive and cohesive failure modes were reduced drastically to 0.25% and 5%, respectively, while 90% of the surface area failed in light-fibre-tear mode. It is worth mentioning that one of the specimens presented fibre-tear failure. The increase of the light-fibre-tear and fibre-tear failure, as a result of the increased contamination level, indicates that the DI fluid has a deleterious impact mainly on the CFRP adherents and more specifically, on

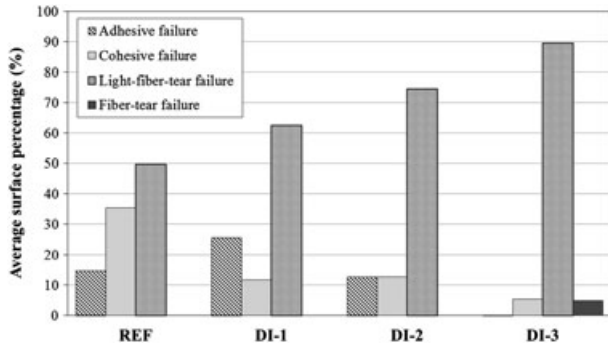
FIGURE 8 Average percentages of the failure modes presented in the mode I tested joints

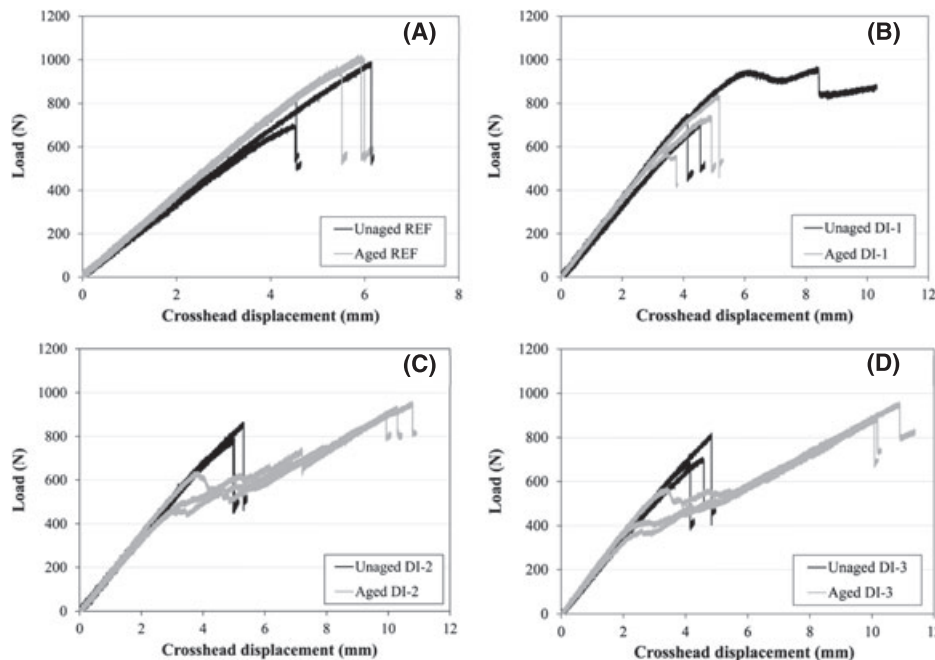
FIGURE 9 Experimental mode II load-displacement curves of A, REF, B, DI-1, C, DI-2, and D, DI-3 aged and unaged specimens

The experimental load-displacement curves of the aged and unaged ENF specimens are presented in Figure 9. The curves of the unaged specimens show an initial linear behaviour of the specimens followed by the region where matrix cracking started to accumulate at the adherents until macroscale failure of the outer layers of the adherents as a result of compression. Usually, the load increases until crack initiation, and after that, the load continuously drops. However, in the present study, the crack propagation onset was observed long before the load drop point, which hindered the precise crack propagation onset determination. This is due to the small adhesive thickness compared to the laminate thickness.³² When the crack reaches the middle point of the ENF specimen, the load starts to increase because of the development of compressive stresses near the crack tip, which obstruct further crack propagation.^{27,29}

The comparison of experimental load-displacement curves of the reference aged and unaged samples (Figure 9) shows no significant influence of hygrothermal ageing under the specified temperature and moisture conditions. On the contrary, there is slight evidence that hygrothermal ageing increased the stiffness of the joint as a result of polymer matrix plasticization. However, the G_{IIC} value of the aged reference (A-REF) samples is drastically reduced by 65% compared to the unaged reference samples (Figure 10). This phenomenon is also observed in the aged/contaminated specimens and is attributed to the fact that the crack propagation onset for the G_{IIC} determination is observed at the specimen side where the moisture concentration is higher. Additionally, the crack propagation occurred near the adhesive region and diffusion through the adhesive is regarded as the primary

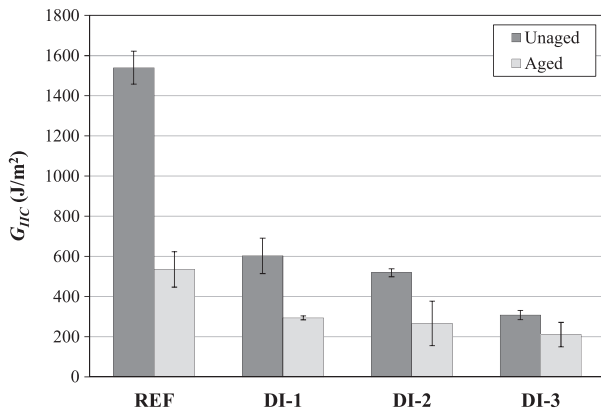
FIGURE 10 Average G_{IIC} values comparison

The G_{IIC} values of the unaged and aged specimens are presented in Figure 10. As in mode I, the impact of runway DI fluid on the mode II fracture toughness of the unaged specimens is detrimental. The increase of contamination level causes a further reduction of G_{IIC} . Specifically, for DI-1, a reduction of 61% is observed regarding the reference values,

for DI-2, the corresponding value is 66%, while for DI-3, the reduction reaches 80%.

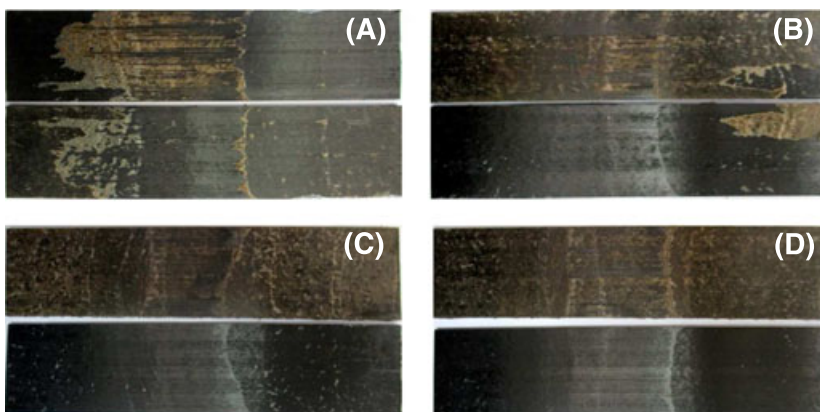
FIGURE 11 Representative fracture surfaces of the A, REF, B, DI-1, C, DI-2, and D, DI-3 specimens loaded in mode II. [Colour figure can be viewed at wileyonlinelibrary.com]

Representative failure surfaces of the unaged specimens, which were tested in mode II loading, are presented in Figure 11. The percentages of the different failure modes are compared for the different sample sets in Figure 12. Mixed-mode failure was observed for all scenarios. For the reference samples (Figure 11A), the dominant failure mode was the light-fibre-tear failure at a percentage of 81% indicating that the adhesive bond is stronger than the adherent in mode II loading. For the DI-1 scenario (Figure 11B), the dominant mode remains the light-fibre-tear failure (85%), while for the DI-2 (Figure 11C) and DI-3 (Figure 11D) scenarios, the adhesive failure increases (56% and 78%, respectively) indicating a reduction in the bondline performance due to the medium and high level of contamination. In conclusion, with increasing the contamination level, there is a transition from light-fibre-tear failure to adhesive failure, which is a clear sign of degradation of shear strength of the adherent/adhesive interface due to the presence of DI fluid. This reduction in bond strength could be attributed to the fact that the contamination of the adherents with DI fluid leads to poor adhesion between the adhesive and the adherent (formation of weak bonds). These defects are called kissing bonds

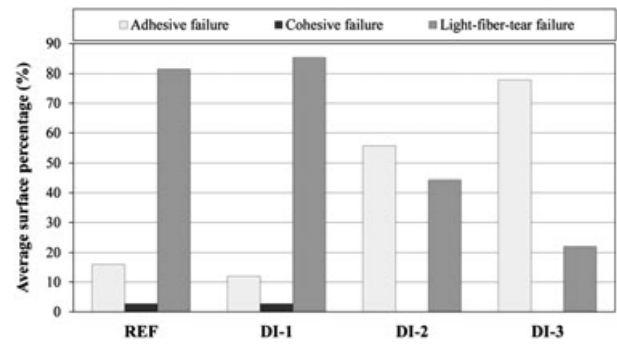
FIGURE 12 Average percentages of the failure modes presented in the mode II tested joints

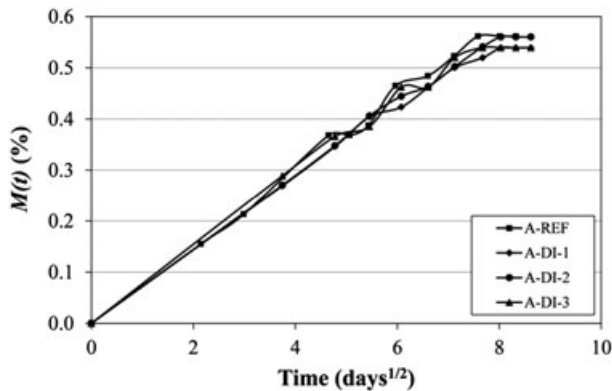
FIGURE 13 Variation of normalized weight gain $M(t)$ regarding exposure time t

Figure 13 plots $M(t)$ regarding exposure time for the different scenarios. The diffusion parameters derived using Equations 3 and 4 for the different cases are listed in Table 3. The final water uptake is between 0.54% and 0.56%, similar for all cases.

D can be used to compare the diffusion rate within the material system. In DI-1 and DI-2 contamination levels, D is reduced, indicating an increase in the joint's resistance to moisture absorption due to presence of DI fluid. This is probably because at low concentrations of DI fluid (DI-1 and DI-2), moisture diffusion is hindered by the thin layer of KF formed on the CFRP adherents. However, at high concentrations of DI fluid (DI-3), the KF layer is thicker and acts more like an absorbent material rather than a protection film, thus causing an increase of D .

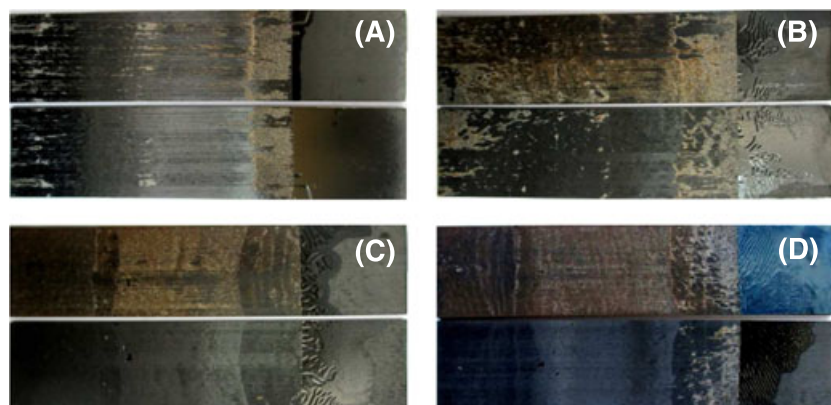
FIGURE 14 Representative fracture surfaces of the aged A, A-REF, B, A-DI-1, C, A-DI-2, and D, A-DI-3 specimens loaded in mode II. [Colour figure can be viewed at wileyonlinelibrary.com]

access route for moisture to enter the joint.¹³ Evidence for the above statements is also provided by the increased percentage of adhesive failure mode (Figures 14 and 15), which indicates a degradation of the chemical bonds across the interface due to the interaction with water.¹³ The comparison between the unaged and aged reference curves indicates that for the A-REF samples, the degradation of the adhesive itself is the dominant factor in the adhesive failure mode, while for the A-DI samples, where the curves present an earlier fracture, it seems that the adherents have been also influenced, thus leading to adhesive failure. Specifically, the G_{IIC} value of the A-DI-1 scenario was reduced by 81% compared to the unaged reference samples, while for the A-DI-2 and A-DI-3 scenarios, the reduction was 83% and 86%, respectively. Comparing the effect of DI fluid with the combined A-DI effect, it is clear that the latter is much more severe.

Representative failure surfaces of the A-DI specimens, which were tested in mode II loading, are presented in Figure 14. The percentages of the different failure modes are compared for the different sample sets in Figure 15. The A-REF samples presented a light-fibre-tear dominant failure mode in a percentage of 77.5%, A-DI-1 failed mainly adhesively (65%), while the dominant failure mode for the A-DI-2 and A-DI-3 was adhesive failure (67% and 83%, respectively) revealing that the combined DI fluid contamination and hygrothermal ageing leads to a greater degradation of the bondline integrity. By comparing Figures 12 and 14, it is shown that there is the same trend regarding the effect of DI fluid, however, ageing seems to reduce the percentage of light-fibre-tear failure and enhance the percentage of adhesive failure, which is a clear sign of degradation of adhesive properties due to water uptake.

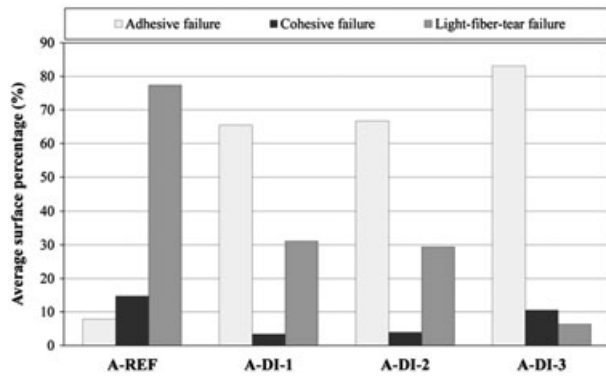
FIGURE 15 Average percentages of the failure modes presented in the mode II fractured joints after hygrothermal ageing
