Image Distortion Correction Method of 2-MHz Side Scan Sonar for Underwater Structure Inspection

Abstract—The 2-MHz Side Scan SONAR (SSS) attached to the boat for inspection of underwater structures is affected by shaking. It is difficult to determine the exact scale of damage of structure. In this study, a motion sensor is attached to the inside of the 2-MHz SSS to get roll, pitch, and yaw direction data, and developed the image stabilization tool to correct the sonar image. We checked that reliable data can be obtained with an average error rate of 1.99% between the measured value and the actual distance through experiment. It is possible to get the accurate sonar data to inspect damage in underwater structure.

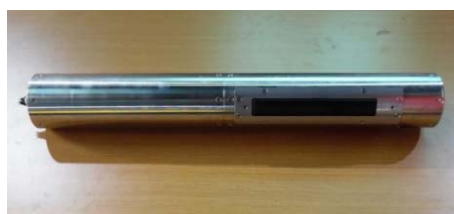
Fig. 4 2-MHz SSS

the field. The developed 2-MHz SSS is shown in Figs. 3 and 4.

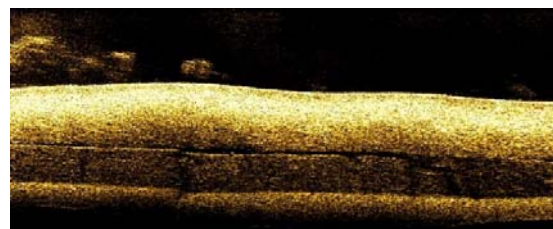
Fig. 8 2-MHz Sonar data after correction

The block joint of the gravity type quaywall structure was scanned using the developed 2-MHz sonar as shown in Fig. 7. As mentioned above, since the boat and the sonar are all acting together, it is seen that the shape of the gravity type block is distorted because of the shaking caused by the rolling phenomenon of the boat by the wave and the operation of inexperienced boat drivers. The roll, pitch and yaw directions obtained from the motion sensor were analyzed, and the data were subjected to image stabilization. As a result, the corrected data were obtained as shown in Fig. 8. It is confirmed that the

joint shape of the block is corrected to a straight line shape.

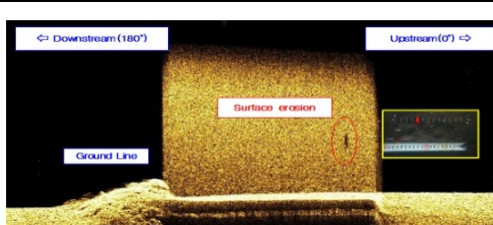
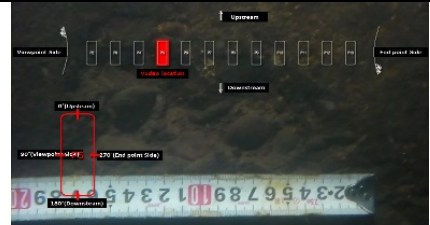
TABLE III
COMPARISON OF SONAR DATA AND DAMAGE THROUGH MOTION SENSOR

Case	Bridge location	PostScan confirmation video	Diver confirmation video	Error factor

Damage occurred P5- 270° (End point side)	Difference length (L=0.21m) Depth of water :3.0m	#3. Difference length (L=0.20m) Depth of water :3.0m	
				The whole average 1.99%
				5%
				0%

Fig. 6 shows the towfish with the motion sensor and the field survey logarithm. Table III is one of the samples and shows the sonar data corrected by the motion sensor and the damage comparison method.
