Bonneville Power Administration's Wood Pole Management Program

Mark Newbill
Natural Resource Specialist

ABSTRACT

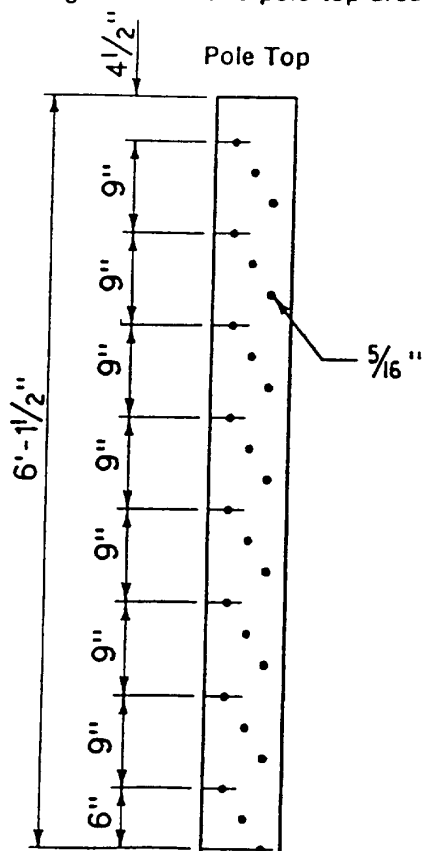
Fig. 1. The through-boring pattern for groundline and pole top areas.

All poles will be 'through-bored' (a design modification which bores a series of holes completely through the pole) in both the top crossarm and groundline areas (Fig. 1). This is one of several design strategies available for improving the preservative penetration in Douglas-fir poles. Other available methods include deep incising, radial boring, and kerfing. Through-boring, however, is the only method which provides 100% preservative penetration into the otherwise untreatable Douglas-fir heartwood. The performance of this product has been outstanding. BPA adopted this practice in 1966,

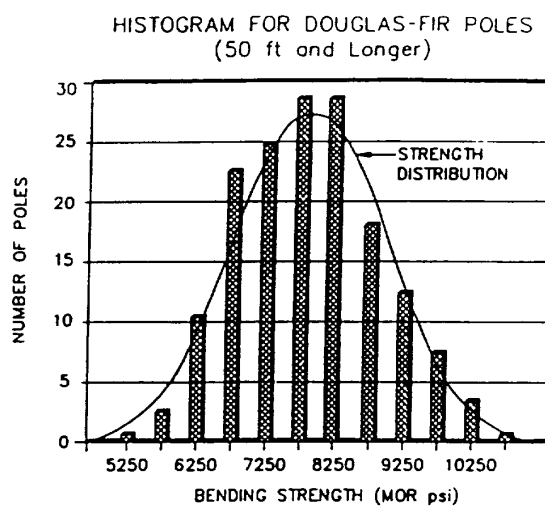
Fig. 2. Bending strength histogram for Douglas-fir poles.

The most frequently asked question about through-bored poles concerns possible strength effects, and a look at past research provides a clue to the concern. Through-boring was developed in the late 1950's. At that time, several research attempts were underway to address concerns with strength. The research found strength reductions ranging from 3-15 %. This is not surprising, since researchers used the ANSI 05.1 mean value for Douglas-fir bending strengths as the baseline of comparison (Fig.2).

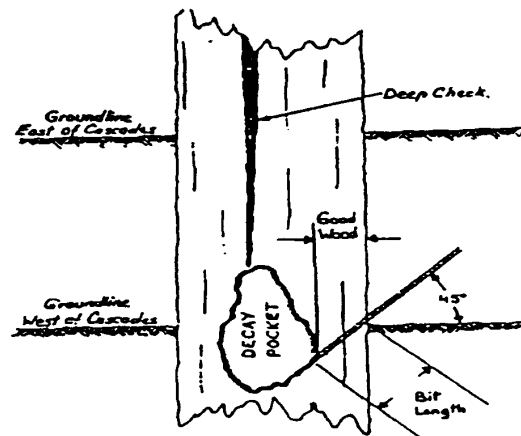
Fig. 3. Location of groundline butt-inspection for west and eastside locations.

Groundline Inspection: West of the Cascades, drill a hole at a downward sloping 45° angle at groundline. To look for internal decay (Fig. 3), drill the hole into one of four different pole quarters with a 9/16-inch diameter X 18-inch long ship auger type bit.

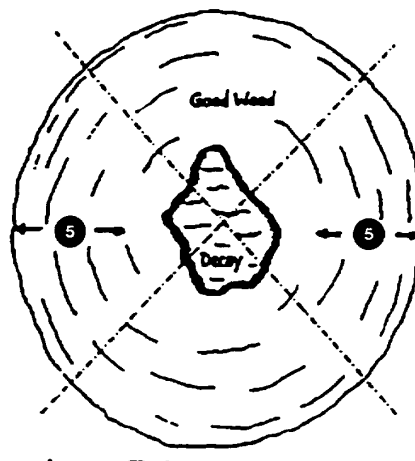
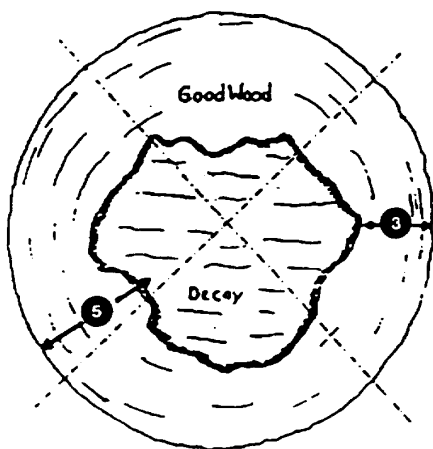
Program for Reinspection

- If the decay is limited to a small area, or all 4 quarters have more than 5 inches of sound wood as shown, then fumigate and reinspect the pole every 5 years.

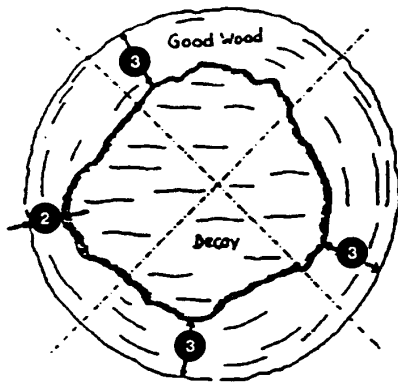
Routine Replacement or Reinforce

- If all 4 quarters have less than 5" but more than 3" of sound wood as shown, fumigate above the decay pocket and replace or reinforce with a steel stub within 3 years.
