# Results of Televiwer Logging in Well K-18 in Krafla High Temperature Area, NE-Iceland

Prepared for IMAGE

ÍSOR-2014/066

December 2014

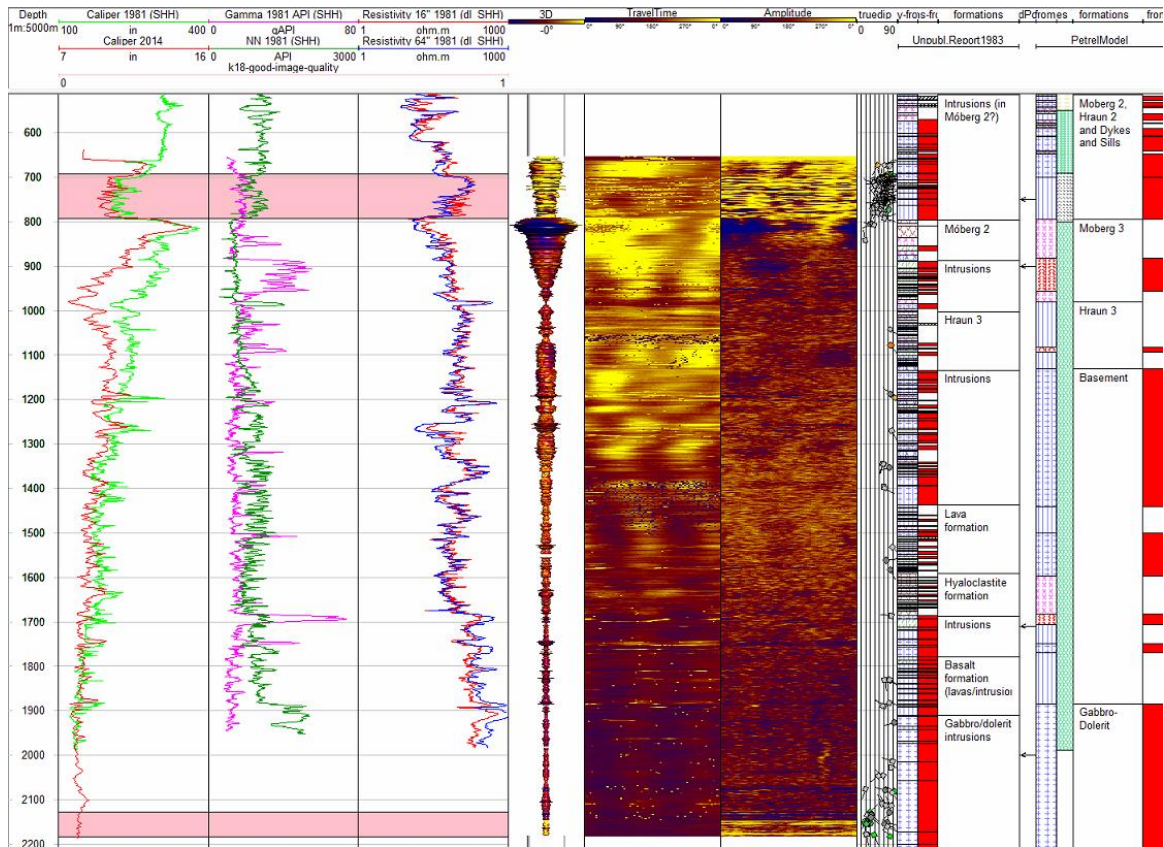
**Figure 3.** Overview of the density of interpreted fractures („truedip“) in comparison with intervals of good image quality (strong acoustic signal), identified with pink color.

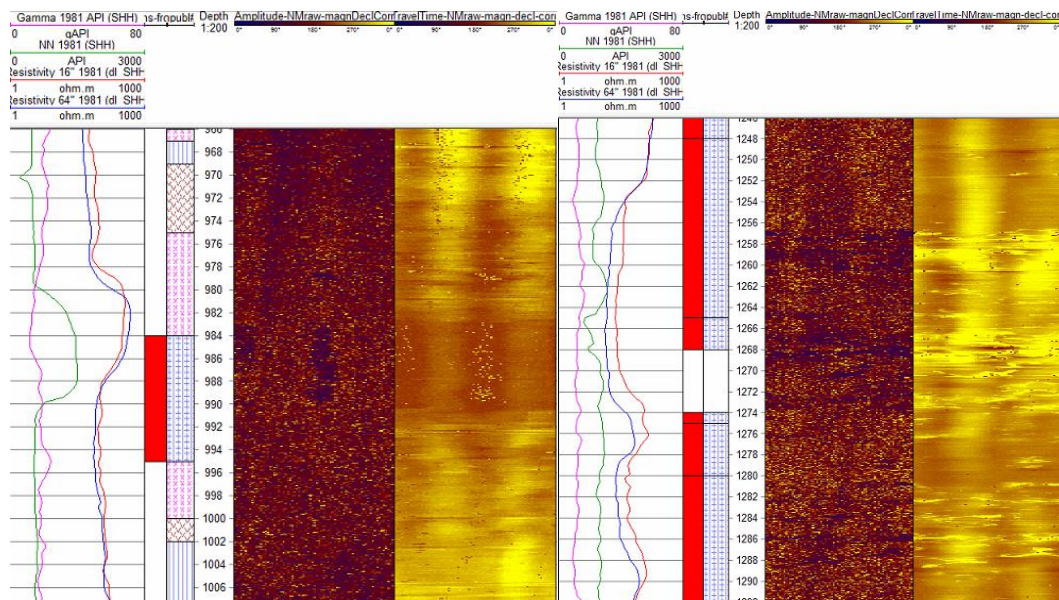
**Figure 9.** Left: a change is observed at ~983–991 m depth, probably representing an intrusion analysed in drill cuttings at 984–995 m and also indicated by lithology logs at similar depth. Right: a change at ~1258–1275 m within dolerite. The color of the dolerite is dark-green to grey-black at 1258–1275 m according to drill cutting analysis, while it is light-green to green above and below this interval. Changes are also detected in lithology logs at this interval. Note that the depth scale here is 1:200.

Changes were detected in the image logs at two locations within the interval of weak acoustic signal, which are believed to be related to changes observed in drill cuttings and in lithology logs. These are very obscure in both cases, thus orientations could not be determined. The upper is observed at ~983–991 m depth (Figure 9, left), and is

considered to represent an intrusion into basalt breccia, detected in drill cuttings (Stefánsson et al., unpubl.) and also indicated by the lithology logs at similar depth. The lower change is observed within dolerite at ~1258–1275 m (Figure 9, right). At similar depth, decrease is seen in resistivity logs, increase in caliper, and some fluctuations in the neutron log (which could be related to changes in caliper). Furthermore, the color of the dolerite is dark-green to grey-black at this interval, but light-green to green above and below (Stefánsson et al., unpubl.).
