Co-UDlabs

Building Collaborative Urban Drainage research
Labs communities

D7.4 Report on the development of mechanistic models to simulate deterioration of drainage assets

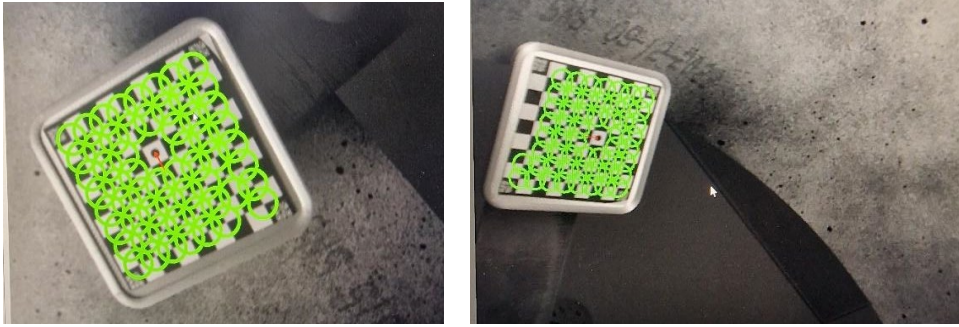
The camera array geometry is calibrated before any in-pipe measurement can be taken. This is achieved by taking multiple synchronised images of a calibration target of known dimensions. By moving the target around the field of view and varying the spatial attitude, each camera's view can be cross referenced and an accurate geometry for the camera array is established. This can be done before or after installation into the pipe, access space permitting. Figure 2 shows calibration target images being accepted for calibration by the DIC software. Green circles highlight points of geometric confidence. In an offline system multiple images need to be taken, and sub-standard images discarded manually to ensure accurate calibration.

Figure 2. Calibration images for the DIC system, taken inside of a 300mm dia concrete pipe with bespoke calibration target

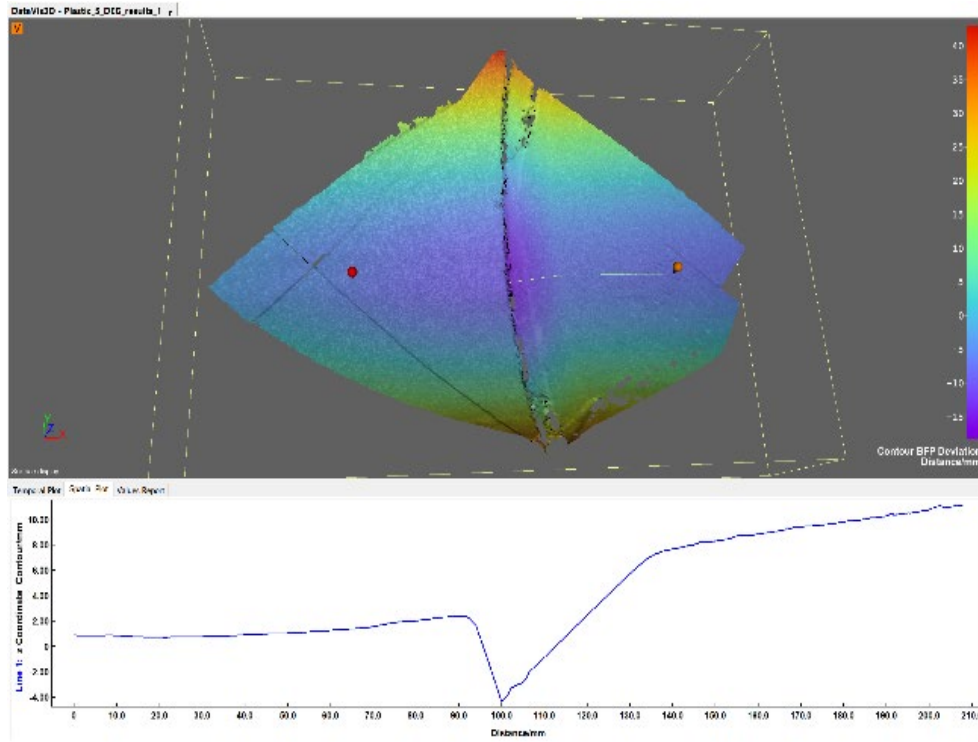
Images taken from within the IKT pipes were processed with their calibration files to resolve pipe geometry and surface profiles in Dantec Dynamics Istra4d software. From these evaluations various line and point gauges can be applied to extract information as required. To assess the articulation across a pipe joint a gauge line is placed along the pipe axis across the joint to create the baseline x-axis with the z-axis being normal to the pipe surface. This line will contain spatial data for pipe walls at either end and typically an area of noise or blank data corresponding to the occlusion / discontinuity at the joint. Using one pipe as a baseline the angle between the two pipe walls can be calculated. With the current optical array up to a 15cm gauge line is typically available for analysis considering the field of view of the cameras and variable quality of images, giving a ~70mm gauge line for evaluation of each pipe wall. Results show this scale to be adequate for rigid materials such as Concrete and Clay, but gross angular displacement in Plastic pipes are underestimated near joints where load stresses contribute to local material

deformation (Figure 4a and 4b). DIC successfully captures the deformation as it presents at these scales at a high accuracy.

Figure 4a. Typical output of line gauge assessment – Clay 2°. Screen shot from Dantec Dynamics Istra4D software. Colour indicates level in the z axis, if x axis is taken as the axial direction

The DIC displacement results of the surface across the joints were used to estimate angular displacement on a transect that was perpendicular to the radial position of the joint - see Section 3, Figures 4a and 4b. This estimated internal angular displacement was compared with the external angular displacement. Table 2 shows the results for the measured external and internal angular measurements for the vitrified clay and PVC pipe results. This table clearly shows that the vitrified clay external and internal angular displacements are practically the same and the results for the PVC pipe show that once the external angle is 2° or greater the value of the internal articulation becomes more stable.

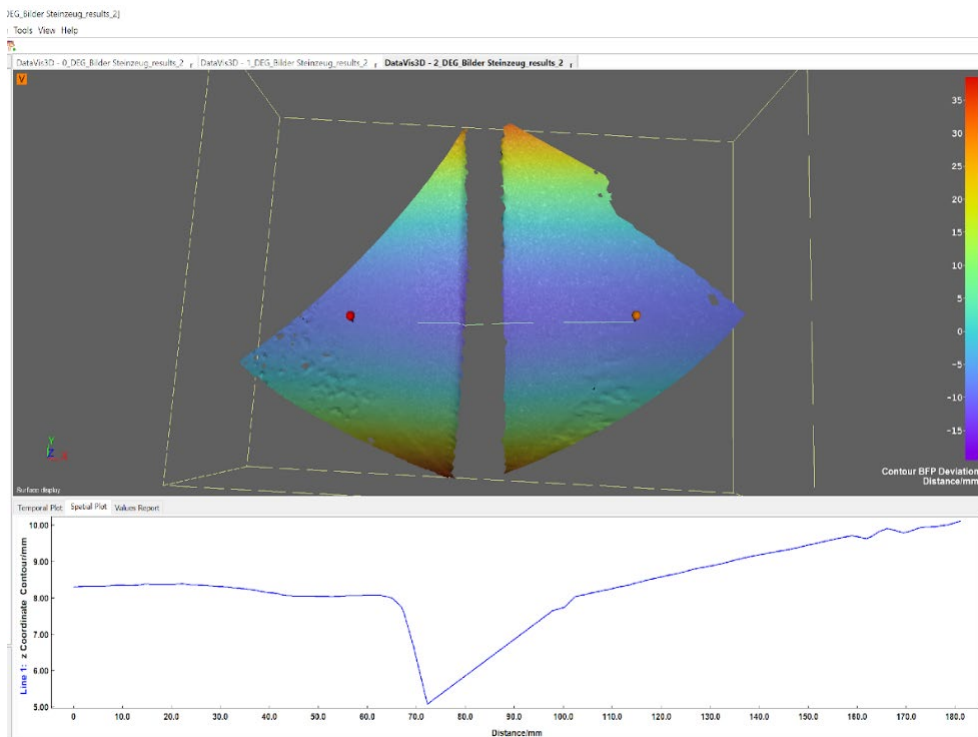
Figure 4b. Typical output of line gauge assessment – Plastic 5°. Screen shot from Dantec Dynamics Istra4D software. Colour indicates level in the z axis, if x axis is taken as the axial direction

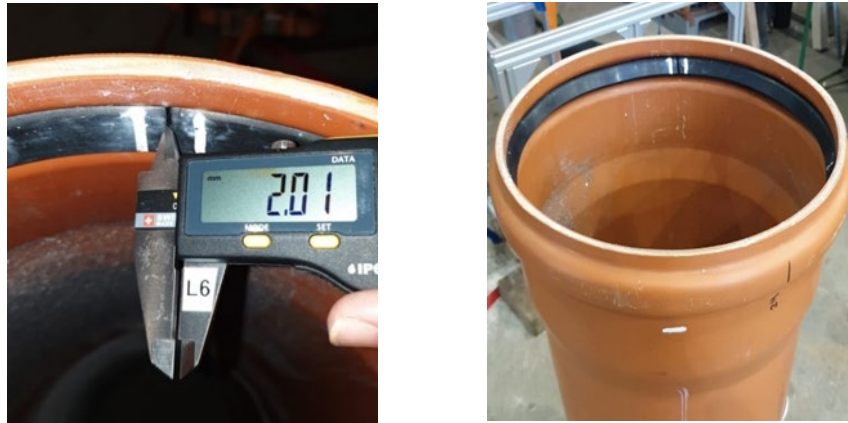
A “small” linear defect was created in the seal at the joint of the PVC pipe. The size of the defect corresponds to the width of the blade of the knife used to create the defect. The defect was approximately 0.4 mm in width see Figure 10, left. The damaged seal is located in the pipe floor (6 o'clock), water levels of 6 and 18 cm were set. Exfiltration was observed at angles between 0° to 2°, with the amount ranging from a negligible rate at 0° angle to 0.004–0.029 l/min as the pipe was articulated up to a 2° angle. At higher angles of 3° to 6°, there was no observed exfiltration. In tests with the damaged seal in the pipe's transom area (3 o'clock), no exfiltration was detected either at these higher angles - see Appendix A1.

*Figure 10. Left: crack measured with an electronic caliper.
Right: location of damaged seal in PVC pipe at 6 o'clock*

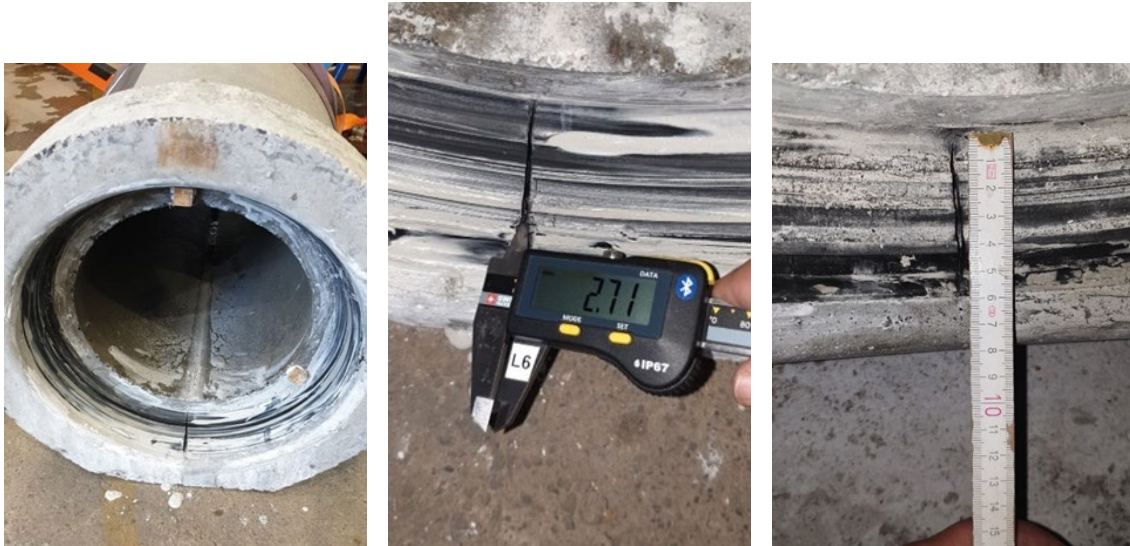
A “small” linear defect was created in the seal at the joint of the concrete pipe, the size of the defect was approximately 0.4 mm in width, however cutting through the elastic seal resulted in a wider defect, approximately 2.7mm in width - see Figure 11. Initially, tests were carried out on seals with a defect located in the pipe floor at 6 o'clock. In the 6 cm water level tests, there was almost no exfiltration at angles of 0° to 2°. At angles between 3° and 5°, exfiltration rates of 0.006 l/min to 0.175 l/min were measured. At a water level of 18 cm in the pipe, the exfiltration rates were between 0 and 0.328 l/min at angles of between 1° and 5°. The pipe connection was watertight when the pipes were not angled (0°). Compared to the PVC pipes, the angle already ends at 5°, as the pipes slid apart at higher values and thus no further investigations would have been possible. If the small crack is located in the area of the pipe abutment (3 o'clock), a comparable exfiltration behaviour to the previously described tests can be seen at a water level of 18 cm (corresponds to 3 cm coverage). No water escaped at angles between 0° and 3°, and at 4° and 5° the exfiltration rate was between 0 and 0.2 l/min. At a water level of 24 cm, water leakage of 0.47 l/min was measured only at an angle of 5°. See Appendix A2.

Figure 11. Left: defect in seal at 6 o'clock. Centre: measurement of the width of the crack (2.7 mm). Right: length of the defect in the seal 59mm

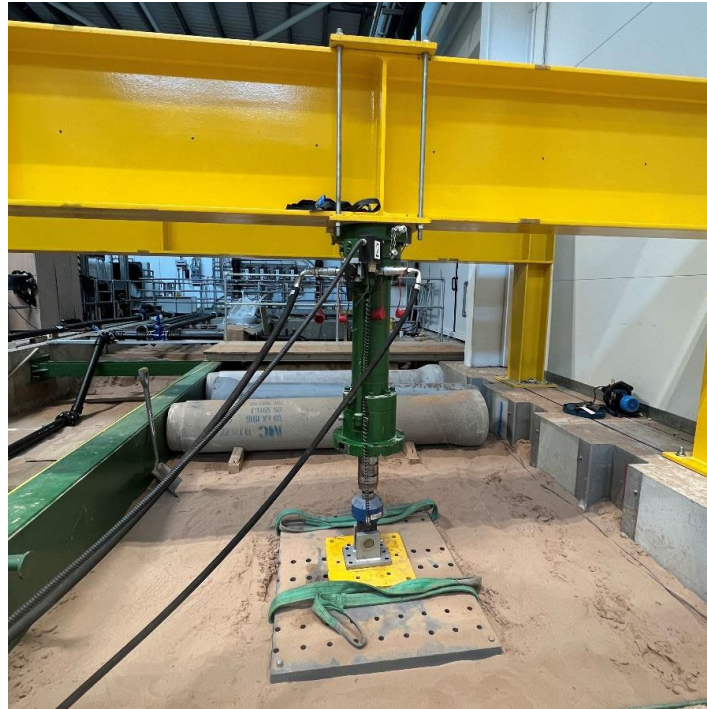
A small number of experiments were carried out at USFD. These tests were undertaken using a 300mm diameter concrete pipe and were done to examine the influence of the surrounding material on observed exfiltration rates. The buried configuration is shown in Figure 4a and 4b. The bedding material was 19mm clean crushed stone which is a common pipe bedding material in the UK. During the experiment, a dynamic actuator was used to load the soil above a joint of the concrete pipe. The loading actuator was mounted on a fixed frame and the actuator applied a predetermined load to a stiff steel plate (0.9m x 1.0m) placed on the soil surface. The loading frame ensures that the actuator is fixed in place during loading. The load is controlled by computer software that allows different load profiles to be applied. In these tests a sinusoidal load profile with an amplitude of 110kN and a frequency of 4 Hz was applied to simulate the effect of a heavy goods vehicle travelling at 80 km/hr. The loading system is shown in Figure 13.

Figure 13. Automated loading system applying 110 kN cyclic load above a buried pipe joint

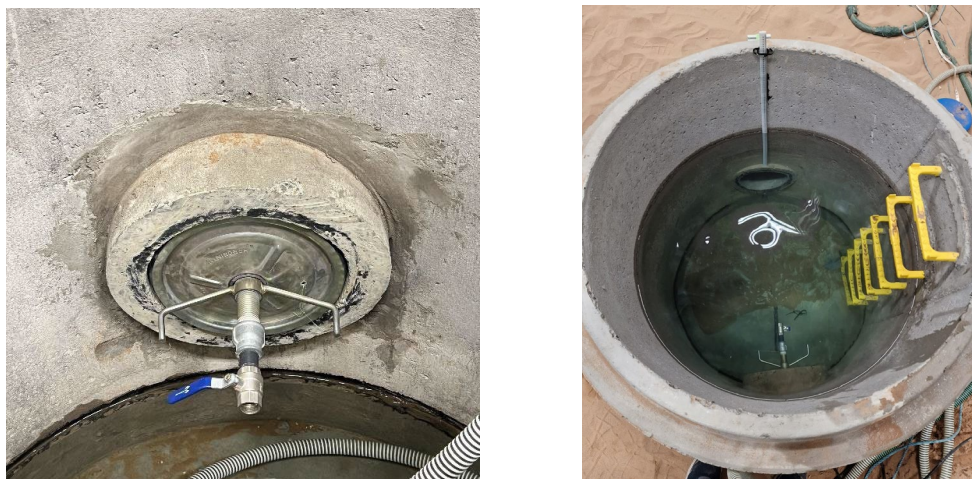
To measure the exfiltration rate from the buried 300 mm diameter concrete pipe the ends of the pipe in manhole 4 (upstream) and manhole 6 (downstream) – see Figure 5a were sealed using rigid watertight pipe stops and Manhole 4 was filled with water (Figure 14) so that the initial water level was 420mm above the pipe soffit. This water level then fell due to exfiltration from the pipe section with the loaded joint. By timing of the change in water level with time using images captured by a video camera meant that it was possible to estimate exfiltration rates as the water level dropped. The exfiltration rate values in this report correspond with water levels at the pipe soffit.

Figure 14. Manhole 4 (upstream) sealed; water level high at start of exfiltration test
