Mining and Metallurgical Section.

RECENT DEVELOPMENTS IN THE MANUFACTURE AND APPLICATIONS OF WIRE-GLASS.

BY FRANCIS SCHUMANN.

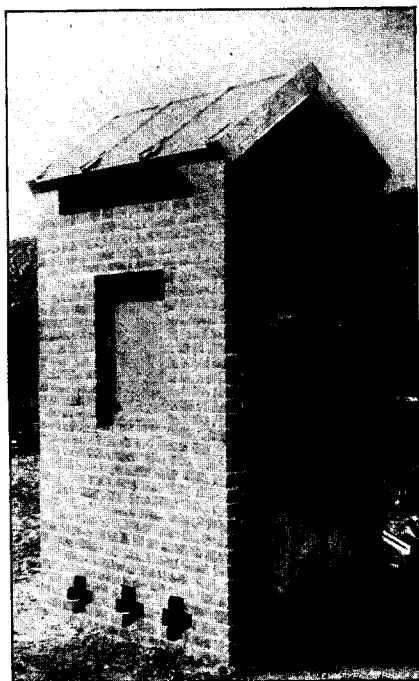
FIG. 1.—Test-house at starting fire.

Figs. 1 to 8 illustrate a test of the fire-resisting qualities of wire-glass, made under the supervision of Secretary Chas. A. Hexamer and Inspector Wm. McDevitt, of the Philadelphia Fire Underwriters' Association, on April the 30th, 1896.*

Fig. 1 shows the test-house immediately after lighting the fire and closing the door.

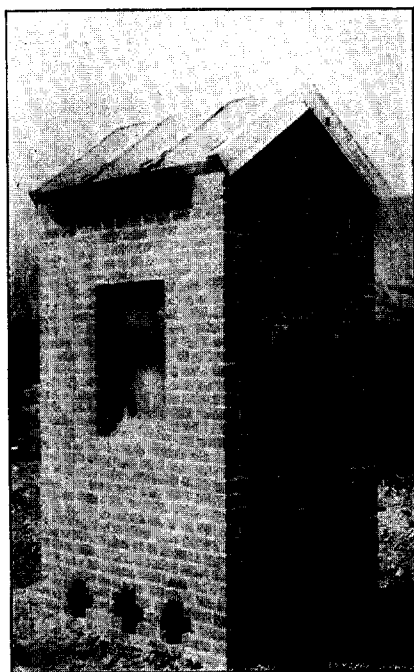
FIG. 2.—Two minutes after lighting fire.

Fig. 2 is a view taken two minutes after lighting the fire. The smoke had blackened the glass of the door and cracked the glass in the window. The half of skylight glazed with $\frac{1}{4}$ -inch wire-glass is on the same side as the window, and shows in this picture.

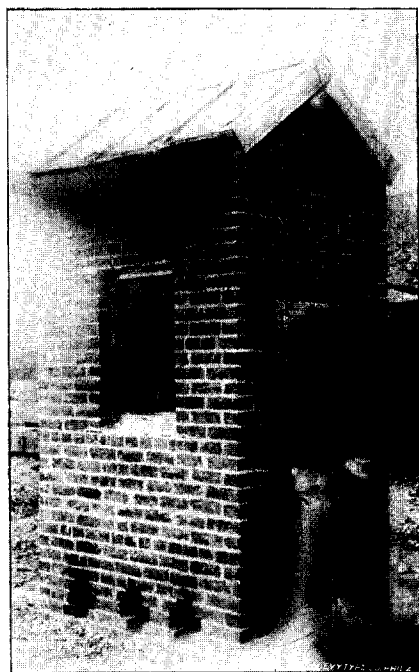
FIG. 3.—After three minutes.

Fig. 3 is a view taken three minutes after starting fire. The heat is sufficient to warp the wire-glass. The plain glass on the other side of the skylight had just commenced to break and fall.

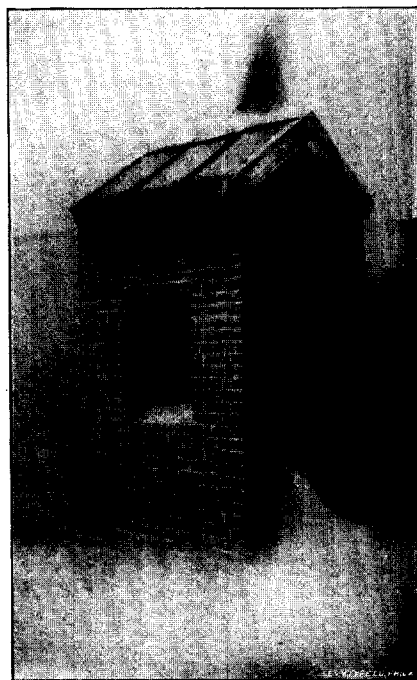
FIG. 4.—After fifteen minutes.

Fig. 4 shows the condition of things fifteen minutes after starting fire. There is evidence of considerable increase in the intensity of the heat, and evident charring of the wood in the frame and door incased in tin.

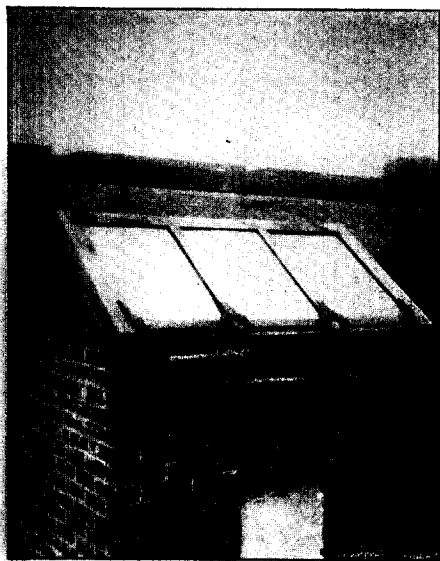
FIG. 7.—After water had been thrown on skylight. Fire at greatest intensity.

Fig. 7 is a view taken after water had been thrown on the skylight while the fire was at its greatest intensity. The walls had cracked, and the plain glass was partly melted, as is seen in the opening at the opposite side of the building. The wire-glass in the window below, owing to the absence of clips, had curved outward at the top. The door was still intact and in position.

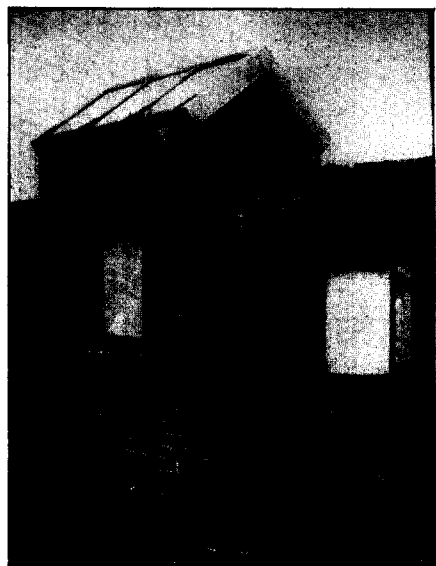
FIG. 8.—Test-house at close of experiment.

Fig. 8 is a view taken after the fire had been extinguished and water had been thrown on the glass with a hose. All of the wire-glass was intact. The panel of the door is seen with the tin covering ripped off, showing the charred condition of the wood inside, but which still retained its form.
