Damage progression analysis in a historical timber framed wall under cyclic loads through an image-based tracking method

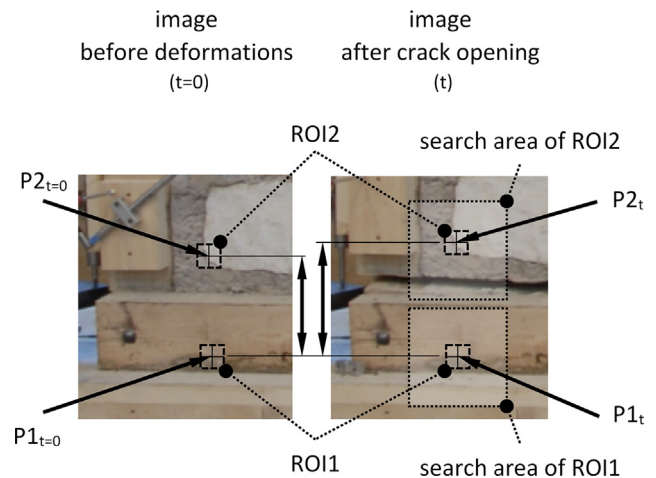
Fig. 3. Principle of the "virtual transducer" determining crack width after stress test: ROI – regions of interest corresponding to parts of image possessing unique pattern, *P* – coordinates of points corresponding to the centre of ROI, search area of ROI – the selected part of image where best fitting position of ROI is searched.

Custom software for pre-processing and analysis of the acquired images was developed in LabView 2016 (National Instruments, USA). Image and lens distortion corrections were performed before analysis by implementing a point coordinates calibration tool. The numerical tool applied for tracking the objects on the image was IMAQ_Find_Pattern_4 that bases on the pyramidal matching algorithm. The algorithm uses normalized cross-correlation and consists of two stages: learning and matching. It extracts grey value and/or edge gradient information from the source image during the first (learning) stage. Afterward, the pattern matching procedure extracts part of the searched image and locates regions with highest cross-correlation values. In this research, a manually selected Region-of-Interest (ROI) was extracted from the wall image before deformation. In the following step, the ROI position was matched on the rectangular search area defined on the corresponding wall image after deformation. The results of this search are both, a score (cross-correlation coefficient) and coordinates of the best corresponding ROI within the fitting rectangle. The score indicates similarity between the sought ROI and the detected region. The grayscale value pyramid numerical algorithm allows sub-pixel determination of the best corresponding ROI coordinates, thus increasing reliability of analysis and allowing detection of minor displacements. It is important to properly select points of interest *P* to assure some unique variance within the ROI image (i.e., high-contrast irregular patterns) and therefore increase the similarity score between sought and identified ROIs. Fig. 3 illustrates the principle of the "virtual transducers" method implemented here, where the width of the opening between the timber frame and mortise is identified. The size of the ROI implemented in this research is 11x11 pixels. It is possible to increase the analysis speed by limiting the search area of the ROI. For this reason, only a part of the investigated image is measured minimizing the number of computational operations and consequently CPU time.

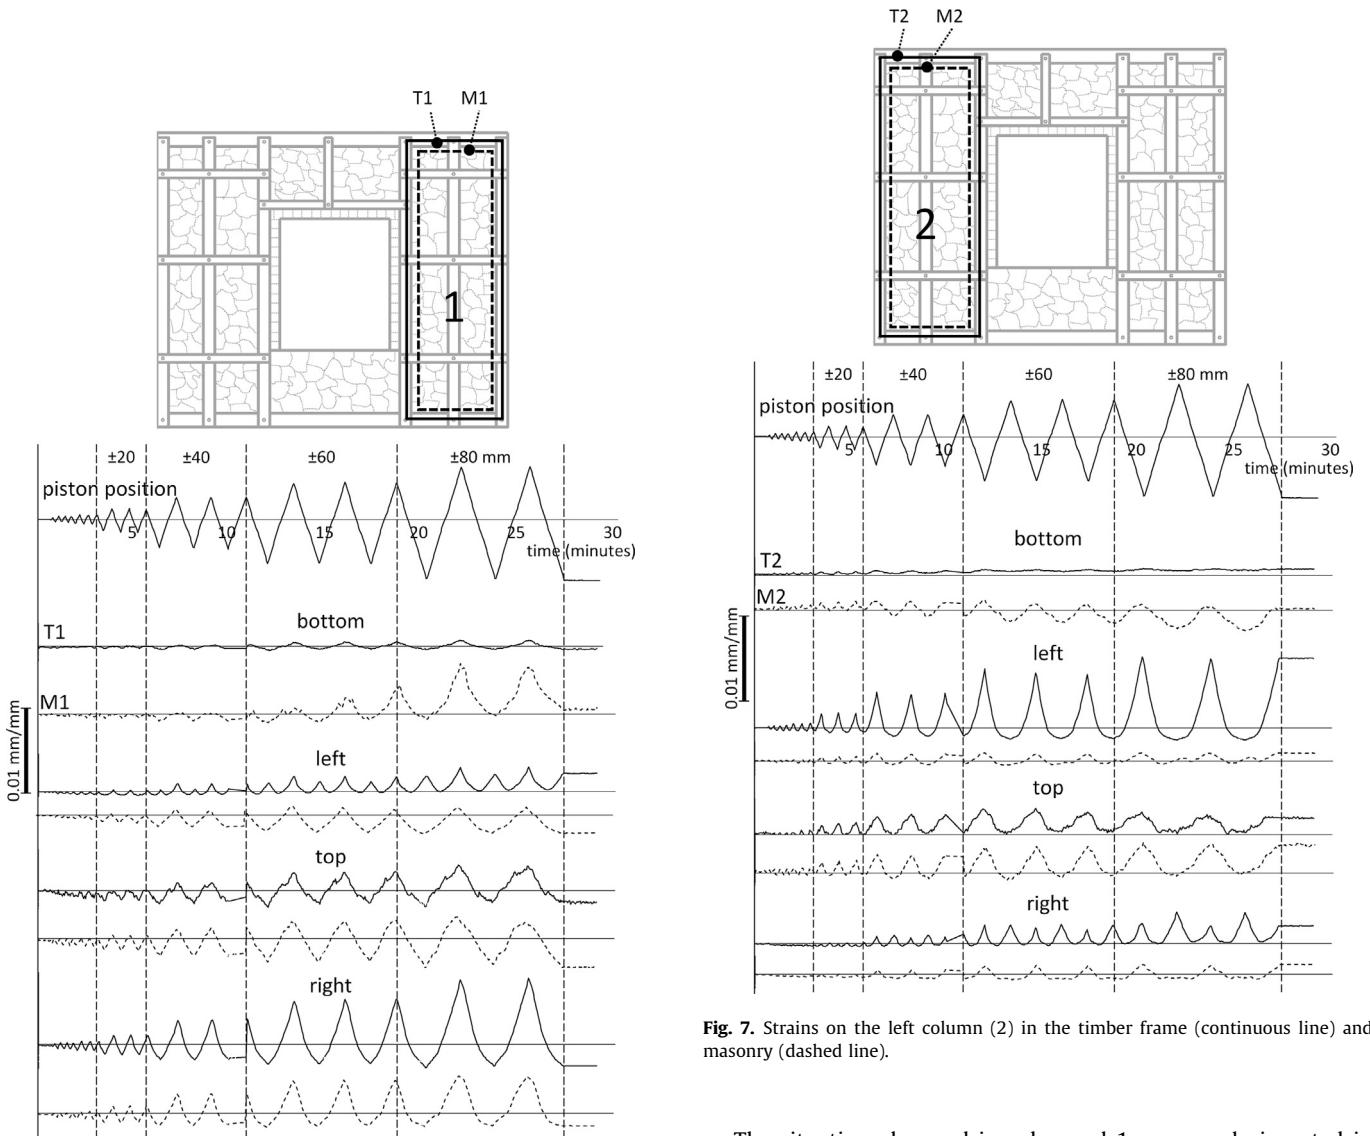
Fig. 6. Strains on the right column (1) in the timber frame (continuous line) and masonry (dashed line).

Fig. 7. Strains on the left column (2) in the timber frame (continuous line) and masonry (dashed line).

Figs. 6–9 show the calculated strain values of the edges of the polygonal bases in each wall sub-panel during the loading cycles. The strain cycles in the right edge of the timber frame (post) and in the masonry were synchronous and increasing for increasing values of set displacement (Fig. 6, sub-panel 1). At the internal post (left) of sub-panel 1, an intermediate strain cycle occurred during pushing (from the first cycle of 40 mm displacement), while the masonry exhibited positive strain values during pulling. Moreover, values of strain in the left post are mainly negative for the masonry, while they are all in the positive field in the frame from the first 60 mm cycle. Absolute strain values, measured at the external post of sub-panel 1 for the 80 mm cycles are 400% higher than those measured at the internal post. In the right post, positive values (corresponding to the pulling action of the actuator) are higher than negative values, and for each cycle, values in the frame are higher than in the masonry.

The situation observed in sub-panel 1 was nearly inverted in sub-panel 2 (Fig. 7). The timber frame's external post exhibited strain values 200% to 600% higher than the masonry.

Strain in the horizontal segments of the polyline inscribing sub-panel 1 (Fig. 6) was concordant in the masonry and in the frame with almost correspondent values in the upper segments, except for the final six negative cycles. Instead, values at the masonry close to the bottom segment started to increase in the last four pulling cycles, reaching a difference of 800% from values recorded in the frame in the last cycle.

A similar behavior was observed in sub-panel 2 (Fig. 7). In this case, the lower horizontal timber member did not show strains during the cycles, while the masonry portion exhibited increasing negative strain values during pulling.

The external posts of both lateral sub-panels 1 and 2, exhibited higher strain rates since they were unrestrained on one side. The internal posts of the piers in sub-panels 1 and 2 behaved unexpectedly (i.e., intermediate peaks were observed). This was because the movements of the two lateral sub-panels were partially restrained by the unframed masonry portion (sub-panel 4). While both, the frame and the masonry, followed the movement of the actuator in the direction of the unrestrained side (pushing for sub-panel 1 and pulling for sub-panel 2), the strain in the frame was the inverse of the actuator action towards the restrained direction, while the masonry followed the actuator. This can be explained by the presence of the sub-panel 4, which pushed the post back in the opposite direction of the actuator.

As a general observation, the strains charted in the panel diagrams were not coincident between the timber frame and the masonry infill, even when they show a similar trend (Fig. 6, right and top; Fig. 7, top portion; Fig. 8, right edge). This observation leads us to deduce that the masonry infill has become detached from the timber frame. In this case, the motion in the infill followed the timber frame but with some delay, since part of the energy transmitted by the actuator was used to fill the gap. Action was then transmitted to the rest of the masonry after the initial gap was filled.

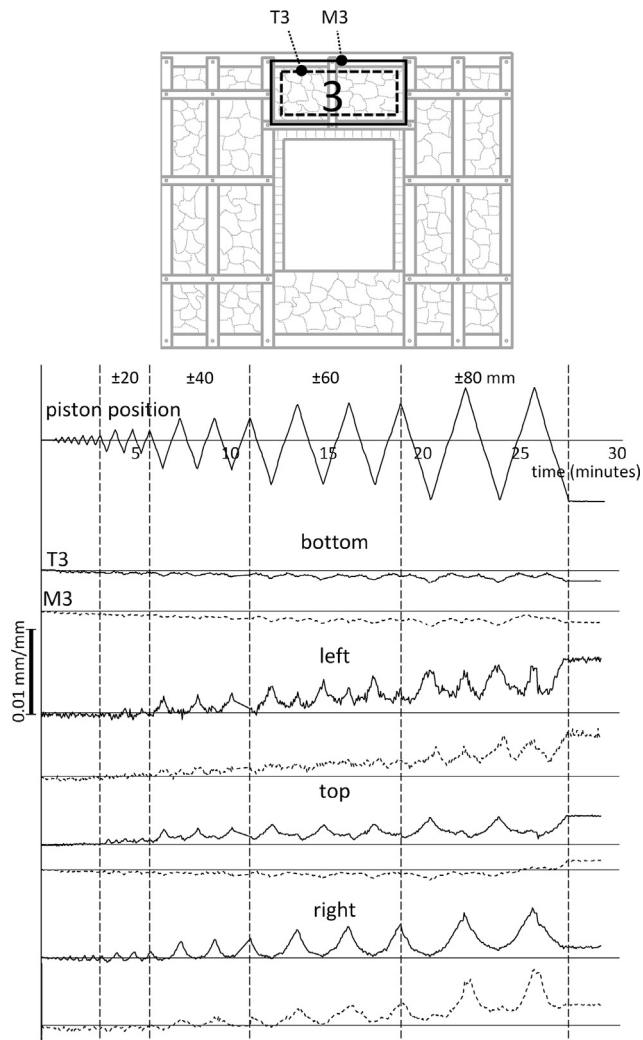
Fig. 8. Strains on the spandrel (3) in the timber frame (continuous line) and masonry (dashed line).

In the spandrel (sub-panel 3 – Fig. 8), increasing strain values were observed on both vertical edges. The strain diagram was approximately flat for the bottom edge of the spandrel both in the timber and masonry portions. This was likely because this portion of the wall, joined at the extremes to the internal posts, followed the movement of the lateral sub-panels through rigid rotations at the joint with no development of strains. To prove this assumption, further analysis of the rotation at this connection follows in next sections of this manuscript (Rotations) and Fig. 11. The timber element at the top edge of the spandrel exhibited a cyclic response, while the corresponding masonry portion did not show significant strains. This was caused by an almost immediate detachment of the masonry block from the top plate, which caused the whole infill portion to rest on the header above the opening. In contrast, the timber portion, which was part of the top plate and was a continuous member for the entire width of the wall, exhibited comparable behavior in each of three sub-panels (1, 2, 3).
