COMPRESSION AFTER IMPACT OF CARBON/GEOPOLYMER SANDWICH PANELS

Martin Kadlec¹, František Martaus² and Robin Hron³

¹VZLU – Czech Aerospace Research Centre, Beranovych 130, 199 05 Prague, Czech Republic
Email: kadlec@vzlu.cz, Web Page: <http://www.vzlu.cz>

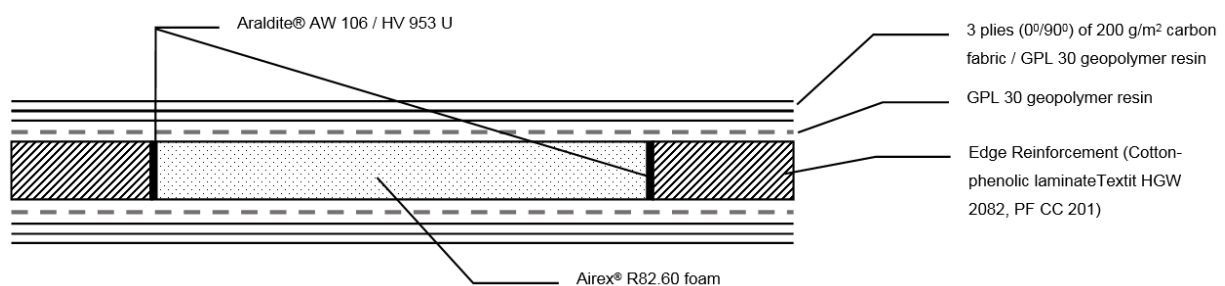
Figure 1. Lay-up of the sandwich specimen with carbon/geopolymer skin and foam core.

Two types of panels were tested. First, standard sandwich panels were manufactured from foam core and carbon fibre/geopolymer skins with lay-up according to Fig. 1. The skin consisted of 3 plies of 200g/m² carbon fabric and GPL 30 (VZLU original formula) geopolymer resin. The laminate was cured under vacuum bag at room temperature (RT) for 18+ hours at vacuum of min. -80 kPa. The core was made of the thermoplastic polymer foam Airex R82.60 which was bonded to the edge reinforcement for the purpose of the edgewise loading during the compression test. The bonding of the sandwich core with the skins was done using adhesive GPL 30 at RT for 18+ hours at vacuum of min. -80 kPa. Specimens with dimensions of 150 x 100 mm were extracted from the panels. Then, integrated procedure of surface treatment using neat Dynasylan 40 agent for 48 hrs at 100 °C to improve resistance against environmental effects and post-curing of test specimens was done. Half of the panels were conditioned in hot/wet environment (70°C/85%r.h.) for two weeks.

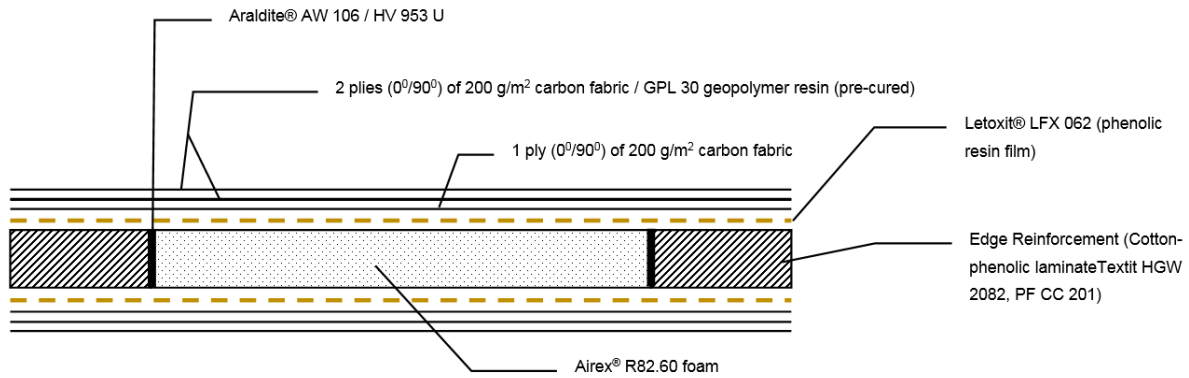
Figure 2. Lay-up of the sandwich specimen with carbon/geopolymer/phenolic film skin and foam core.

Second, hybrid sandwich panels were manufactured from foam core and carbon fibre/geopolymer/phenolic film skins with lay-up according to Fig. 2. The skin consisted of 2 plies of 200g/m² carbon fabric and GPL 30 geopolymer resin and one ply of 200 g/m² carbon fabric with LFX 062 phenolic resin film (adhesive layer). The curing parameters were similar to standard panel. The bonding of the sandwich core with the skins was done using adhesive Letoxit LFX 062. Surface treatment, specimen dimensions and conditioning were similar to standard panels.

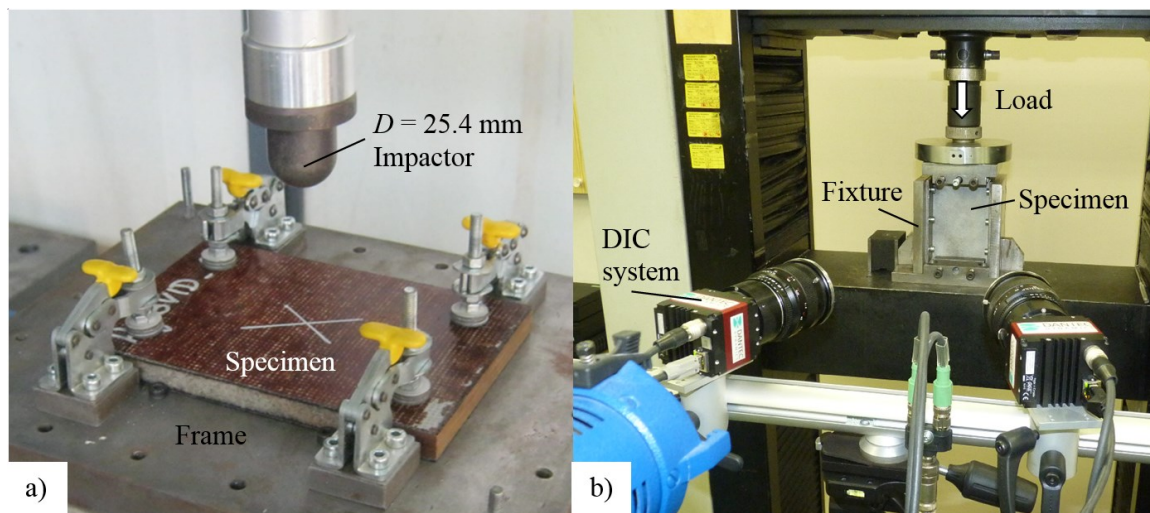
Figure 3. Impact test set-up and compression testing of a specimen with a pattern used for digital image correlation.

The drop weight impact tests were carried out in accordance with ASTM D7136M [12] with two levels of impact energy to apply both VID (visible impact damage) and BVID (barely visible impact damage). Using an impactor diameter of 25.4 mm (Fig. 3a), dents with 0.5 mm depth as BVID and 1.5 mm as VID were created. It corresponded to impact energy of 1.2 J and 2.7 J, respectively. For hybrid skin sandwich, the energies were higher: 2.1 J and 3.6 J, respectively. Then the specimens were loaded by compression according to ASTM D7137M [13] in room temperature conditions (Fig. 3b). For each configuration (reference, BVID, VID), 3 specimens were tested.

Digital image correlation (DIC) makes it possible to measure the displacement fields of a planar surface. A photogrammetric Dantec Q-400 system consisting of two 16 Mpixel cameras was used to monitor the deformation state during loading (Fig. 3b.) The middle region of one side of a specimen was monitored to obtain full-field strain measurements. The displacements of points distributed over the surface of the object were calculated from the grey-level analysis of the images. The image correlation technique can work correctly only with objects with a surface with a sufficiently random texture which was created using a chalk coating and black spray. The proper illumination was provided by a 250 W halogen lamp with heat-reflecting filters.

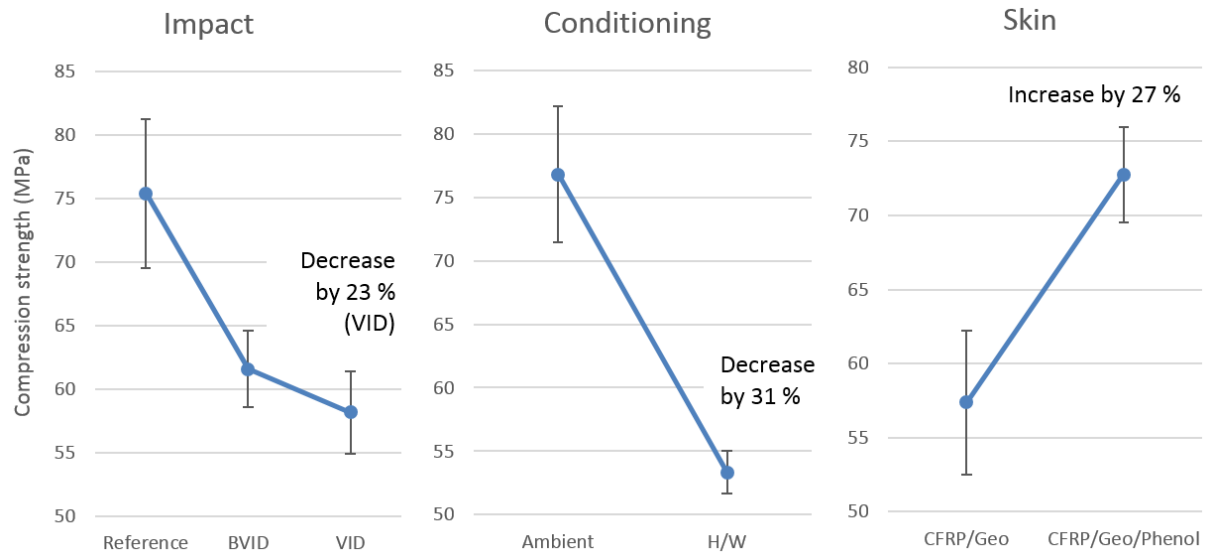
Figure 4. Term effect plot of three main factors.

No interaction between the factors was found significant; therefore, all the main effects can be averaged and shown in the term effect plot in Fig. 4. The BVID impact significantly decreased the strength by 18%. The VID caused further decrease (23% in total). This is a common result for the laminates where even the small energy causes significant inner damage (delaminations, matrix cracking). The hot/wet environment decreased the strength even more than impact and caused a drop of 31 % in the strength. This is generally caused by the weakening of the fibre/matrix interface by the conditioning. The weak interface cannot prevent the microbuckling failure of the skin fibres and causes premature failure. Finally, the hybrid skin with phenolic resin film was found to significantly enhance the strength by 27%. It shows that the performance of bonding of the skin to the core has significant effect on the overall sandwich strength.

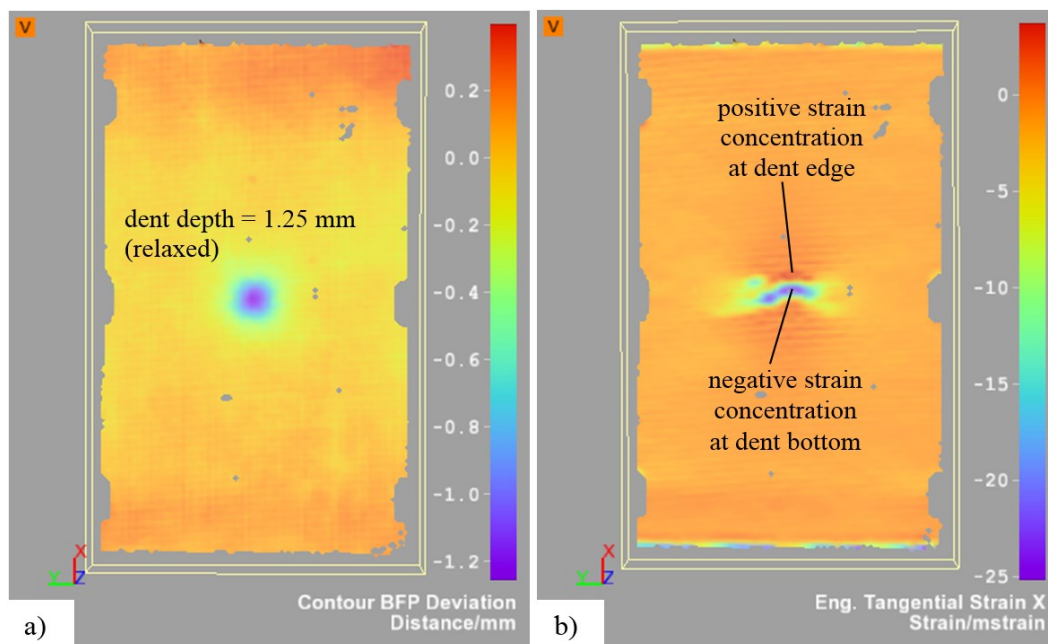
Figure 5. Specimen surface measurement using DIC: a) Dent depth map (unloaded) and b) Strain map in load direction with strain concentration caused by the dent (global strain = -1.5 mm/m at 11.6 kN)

The optical measurement was used for both dent profile evaluation and strain monitoring during loading. Fig. 5a shows surface deviations revealing the dent shape. The dent depth was evaluated as 1.25 mm for a VID impacted specimen. It was a relaxed depth as the dent depth just after impact was measured as 1.61 mm on the same specimen. The relaxation is usual for polymer matrix laminates. The result in Fig. 5b is related to the critical deformation state that exists immediately before a major crack occurs and thus significantly affects the strain fields. It shows a strain field in the loading direction that is concentrated at the impact dent and elongated in the horizontal direction. The measured local compressive strain at the dent bottom is marked in this figure. A small positive strain was also observed at the dent edge. This behaviour was observed also on laminates in Ref. [8].
