# Observation and Study of Landslides Affecting the Tangier – Oued R'mel Motorway Segment

**Abstract**—The motorway segment between Tangier and Oued R'mel has experienced, since the beginning of building works, significant instability and landslides linked to a number of geological, hydrogeological and geothermic factors affecting the different formations.

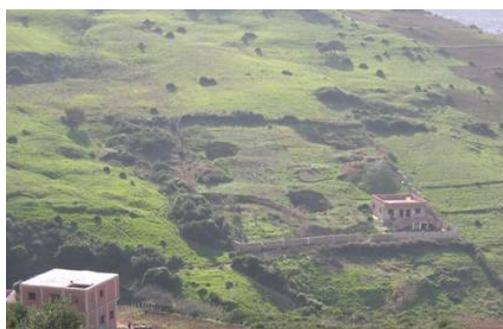
This is the case is most frequently observed on the project area. Fig. 2 shows a representative case of landscapes encountered in the case of a pelitic substratum (Here Sector Ksar).

Fig. 2 Solifluction between Ksar and Oued

The hummocky slope aspect does not prevent the development of vegetation. The main cause of the solifluction formation comes from the presence of water in the surface layers which are made of very plastic clays, the ultimate product of weathering of the underlying mudstones.

The thickness of the layers movement generally does not exceed those of clay formations covers (maximum 2-3 m).

Stabilization of such slope passes including a drainage layer (using spurs, masks, trenches) and recovery.

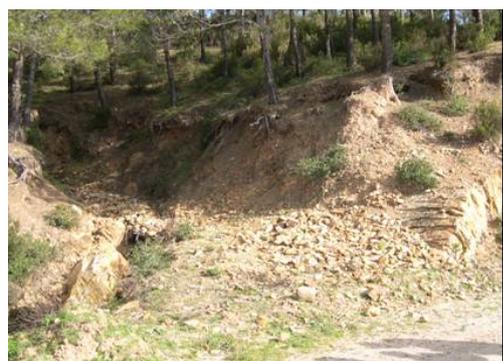
Fig. 3 Gully in a trough in the sandstone - Lachbâa

Fig. 3 shows the typical shape of a large gully erosion in the sandstone beds. During important rainfalls, water runs off the soil and is collected in the ravines of this type. The weathered sandstone blocks are pushed down slope because of the kinetic energy of the water, caused by the steep slope, together with a large volume of water (depending on the watershed) in motion. After some time, the bed of the trough stabilizes the massive sandstone unaltered. Erosive cycle will resume once the new bed is altered during a stormy new episode.

A gully can be stabilized by:

- Limiting the rate of runoff by creating slope failure in the ravine;
- Facilitating the infiltration of precipitation sumps or drainage trenches; [5].
- Developing evapotranspiration with a resistant plant tissue;
- Evacuating faster precipitation in watertight concrete example ditches.

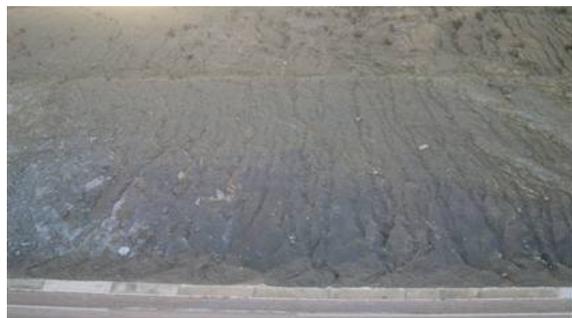
Fig. 4 Gully in road embankments in mudstones - Oued R'mel

Fig. 4 shows another form of typical pelitic gully areas. As mudstones are slightly permeable materials, the entire (or almost) precipitation will flow on the surface. The pelites deteriorate outdoors in fine materials to very fine (GTR class: A1, A2 or A3). With slope, water carries these clays altered at the foot of slope and leaves flow paths that can be deep (here: about 20 to 50 cm between the peak and the bottom of ravines).

Gully is detected on a specific topographic base (approximately 1/1000th). Note the need for significant rainfall events and runoff velocities sufficient to cause soil particles (more or less large). This is regressive and can cause landslides or casting.

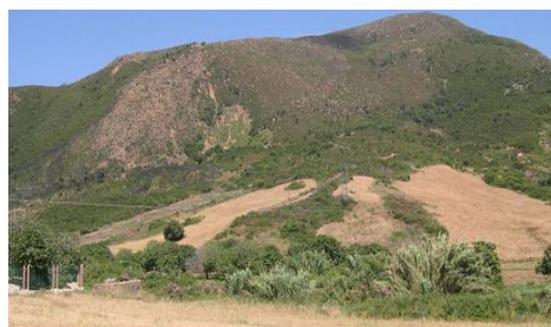
Fig. 5 presents the case of landslide identified on the geological map. It is an old slide (known fossil) which can move again according to changes in hydrogeological conditions, mechanical characteristics, evolution of the mechanical characteristics of materials and other factors such as topographic changes during earthworks.

Fig. 5 Landslide interesting pouring - Valley Ksar es Shrih

The fracture surfaces in this case may be quite deep (generally greater than 5 m but sometimes beyond 10 m deep).

Slip Photography featured on 4 would be difficult to stabilize. Because the strain rates are very low (stabilization phase,) a solution would be there to limit overload and do not alter the hydrogeological conditions, unless to improve them. However, in the absence of a sufficient decrease in the observation of this shift, the bias was to remove the route of this area.

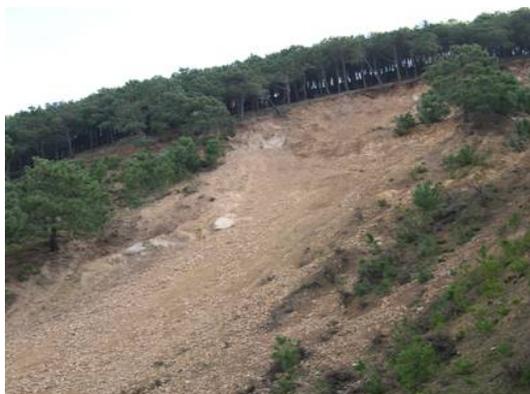
Fig. 6 shows the final form of slope instability: rock falls. The blocks come from regressive erosion of an outcrop, consisting here of sandstone. Blocks down the slope and are classified grano-foot slope. [6].

Fig. 6 Scrap blocks and talus cone - Lachbâa

The areas affected by this phenomenon have a steep slope, and thus are very limited. They can easily detect the landscape.

Two types of protection are possible for this problem:

- Passive protection: creating barricade traps, rocks and / or installation of net Anti-Submarine (usually called ASM)
- Active protection: periodic purge, protection of the cliff

In the case of this project, passive solutions have been favored with the creation of traps stones and barricades.
