## Assessing the influence of sustainable trail design and maintenance on soil loss

Jeffrey L. Marion <sup>a,\*</sup>, Jeremy Wimpey <sup>b</sup><sup>a</sup> U.S. Geological Survey, Virginia Tech, 310 W. Campus Dr., 304f Cheatham, Blacksburg, VA 24061, USA<sup>b</sup> Jeremy Wimpey, Applied Trails Research, State College, PA 16803, USA

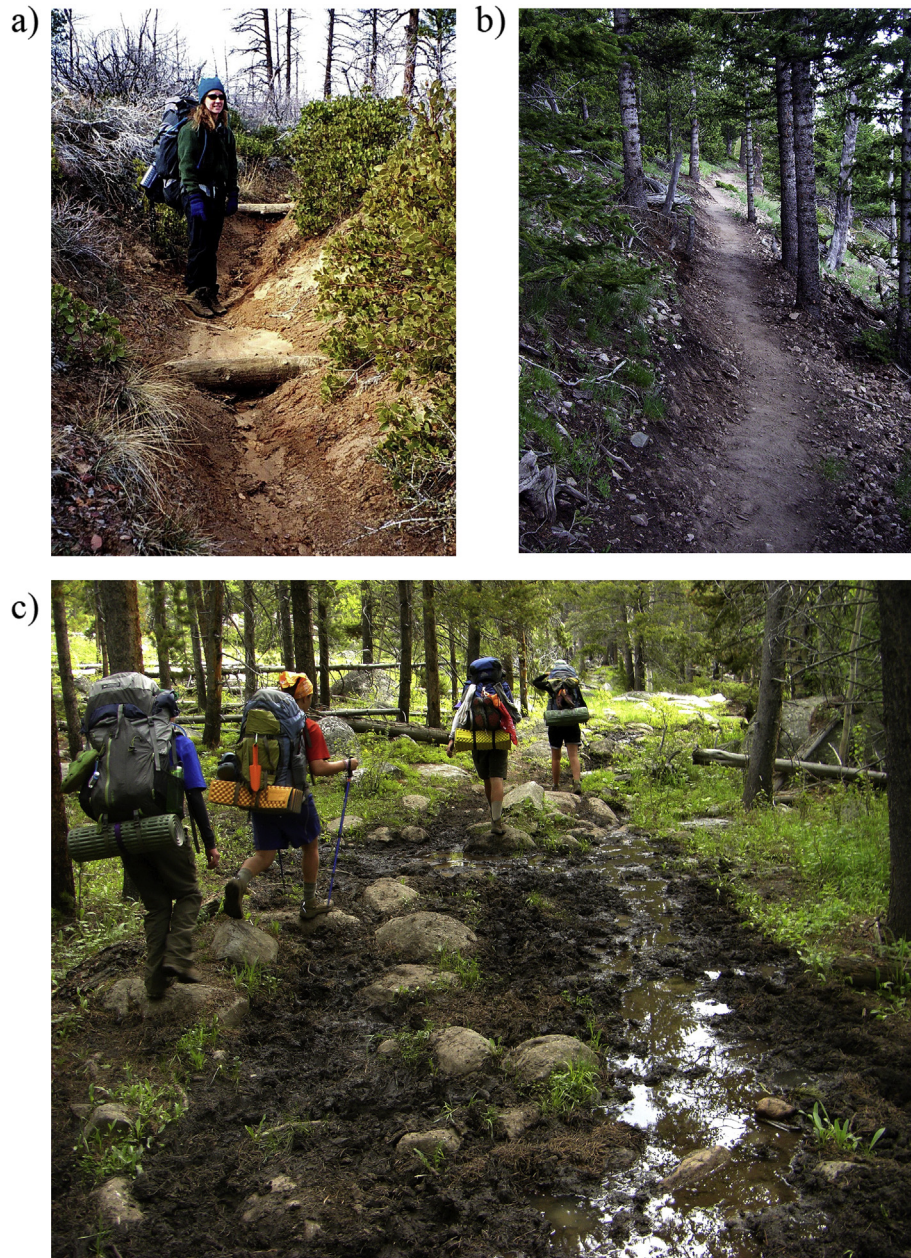
**Fig. 2.** a) Steep fall-line trails (TSA <22°) erode rapidly. b) Side-hill contour-aligned trails (TSA >69°) resist widening, muddiness, and soil loss. c) TSA is less influential in flat terrain where trail widening and muddiness are common problems. Photos by Jeff Marion.

Regression modeling by Olive and Marion (2009) determined that TSA has “a major and robust influence” on trail soil loss, with fall-aligned trails significantly more susceptible to soil loss. TSA’s influence on soil loss was more significant than trail grade, with regression modeling revealing a diminished but still significant “trail grade” influence after TSA was added to the regression model. Results from statistical modeling of soil loss supported earlier speculation by Leung and Marion (1996) that: “the importance of slope alignment angle increases in its significance as trail grade increases.” The authors also found that horse and ATV use caused significantly greater trail damage by erosion on trails closely aligned to the fall-line than either hiking or mountain biking, with a suggestion to keep horse and ATV trail alignments greater than 48°. In summary, these studies reveal that increasing TSA values contribute to increasing trail sustainability, minimizing soil loss, muddiness, and tread widening. Furthermore, the positive influence of higher TSA values increases with increasing landform grade (less muddiness, trail widening, and soil loss), while the negative influence of lower TSA values increases with increasing trail grade (steeper fall-aligned trails erode more quickly) (Fig. 2).

Proudman, 2000; IMBA, 2004; Parker, 2004) (Fig. 2b). Authors most commonly recommend out-sloping treads to the downhill side 2–3% for hiking trails and 5% for mountain biking trails to promote tread drainage (Minnesota DNR, 2007). However, all tread shapes constructed to shed water rarely maintain their constructed profiles over time: tread compaction, soil displacement from traffic, soil erosion, and the development of a berm along the lower trail edge soon act to keep water on the trail (Parker, 2004). Rocky tread substrates help to retain self-draining tread shapes over time but an appropriate density of grade reversals or the construction and maintenance of tread drainage features is additionally necessary.

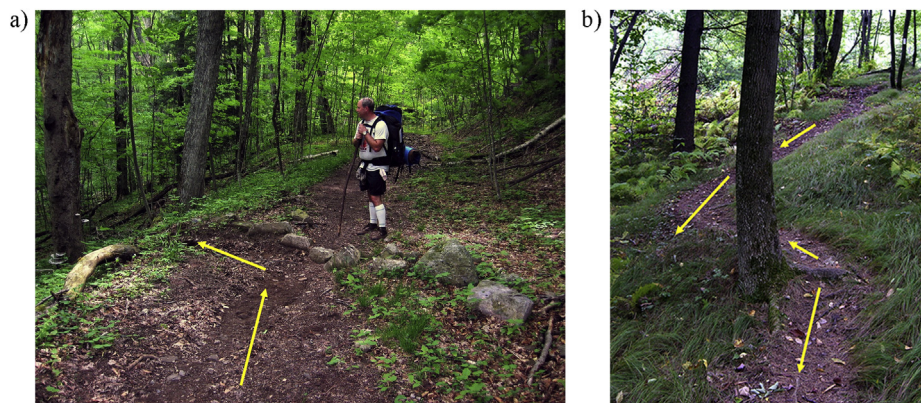
**Fig. 3.** a) This rock water bar is preceded by a ditch to drain water from the trail. b) Grade-reversals temporarily reverse the grade of the trail so that all water drains off; these rarely require maintenance. Photos by Jeff Marion.

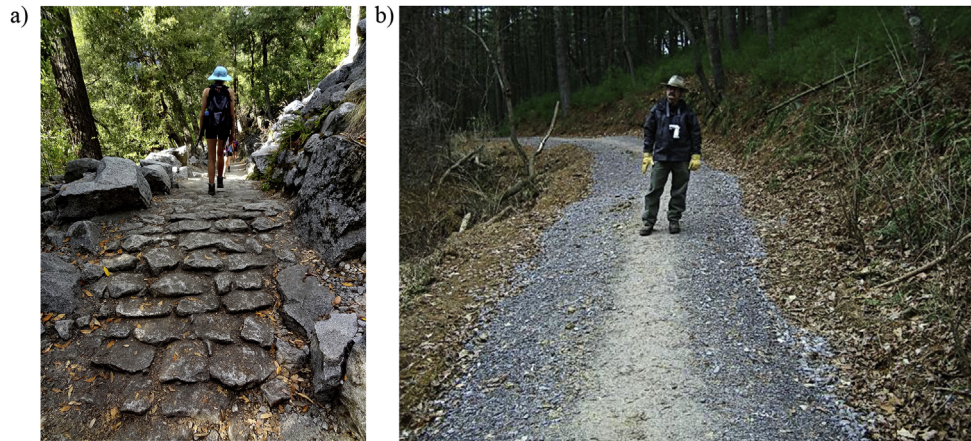
**Fig. 4.** a) Trails that must support heavy traffic, particularly by horses, can be armored with embedded rock (stone pitching). b) Crushed rock (gravel) also supports heavy traffic, though is more easily displaced when wet. Photos by Jeff Marion.

When trail design is constrained or insufficient to create a sustainable trail, managers can apply trail construction and maintenance practices, including application of stonework or gravel to harden trail treads (Fig. 4). Research has shown that trail substrates with a high rock or gravel content are less susceptible to soil erosion and better able to sustain heavy traffic, particularly by horses (Bryan, 1977; Weaver and Dale, 1978). A four-year study of primitive forest roads used for logging and recreation found that non-graveled roads lost 112 metric tons/ha/year of substrates while gravelled roads lost only 13.5 metric tons/ha/year (Kochenderfer and Helvey, 1987). Tread substrates with substantial rock and gravel content are also less easily displaced by recreational traffic, and these materials can act as filters, retaining and binding finer soil particles (Aust et al., 2004).

Various types of well-anchored rockwork, including tread armoring (stone pitching) and rock steps, are common tread hardening techniques used to deter erosion on steeper trail grades (Demrow and Salisbury, 1998; Footpath Trust, 1999) (Fig. 4a). This practice replaces erodible substrates with rockwork on wet or steeply graded trail segments particularly prone to erosion. No studies evaluating the long-term efficacy of employing rockwork to limit trail erosion could be found.
