SAFELY CONDUCTING AIRPORT SURFACE TRAJECTORY-BASED OPERATIONS

Denise R. Jones, Lawrence J. Prinzel, III, Randall E. Bailey, and Jarvis J. Arthur, III

National Aeronautics and Space Administration, Hampton, VA

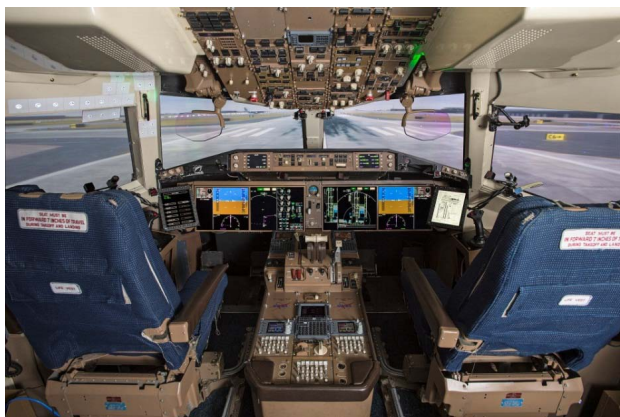
This research was conducted in the Research Flight Deck (RFD) simulator at NASA Langley Research Center (LaRC) (Figure 1) which is a high-fidelity, six degrees-of-freedom motion-based large commercial aircraft simulator with full-mission capability and advanced glass flight deck displays. Operations were conducted at the Memphis International (KMEM) airport. The out-the-window (OTW) scene included realistic taxiways and runways with appropriate markings, airport lighting, and other aircraft in simulated visibility conditions and provided approximately 20/40 visual acuity with a collimated 200° horizontal by 40° vertical field of view at 26 pixels per degree resolution.

Figure 1. RFD Flight Deck

As shown in Figure 1, the simulator had four large main instrument panel displays referred to as: (left to right) pilot's Primary Flight Display (PFD),

pilot's Navigation Display (ND), co-pilot's ND, and co-pilot's PFD. Each display panel had 13.25 inch x 10.5 inch viewable area at 1280 x 1024 resolution.

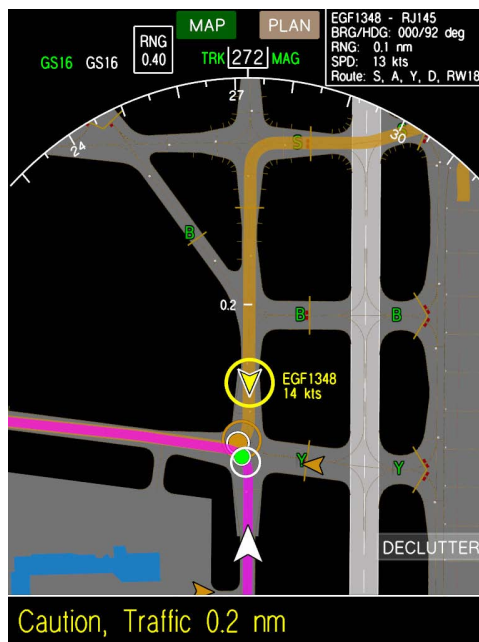
Caution alerts were generated for conditions that required immediate flight crew awareness and subsequent flight crew response. A caution alert was displayed on the AMM as an enlarged yellow traffic symbol surrounded by a yellow circle for the relevant traffic, an identification tag and ground speed in knots, and a yellow line around the relevant runway, if applicable. An alert message (“Caution, Traffic”) was displayed at the bottom of the AMM in yellow text along with the estimated distance to the traffic. An audible annunciation was also made (“Caution, Traffic, Caution, Traffic”) (Figure 2).

Figure 2. AMM Showing Caution Alert

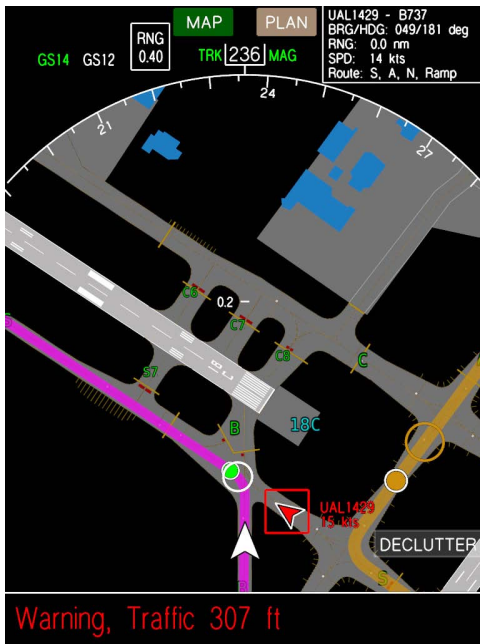
Warning alerts were issued for conditions that required immediate flight crew awareness and immediate flight crew response. Warning alerts could occur without preceding caution alerts. A warning alert was displayed in the same manner on the AMM as a caution alert, except the warning was associated with the color red, a square was used to surround the traffic symbol, and the alert message was “Warning, Traffic” (Figure 3).

Figure 3. AMM Showing Warning Alert
