Title: EXPERIMENTAL TESTS FOR THE CHARACTERIZATION OF SISAL FIBER
REINFORCED CEMENTITIOUS MATRIX FOR STRENGTHENING MASONRY STRUCTURES

EXPERIMENTAL TESTS FOR THE CHARACTERIZATION OF SISAL FIBER REINFORCED CEMENTITIOUS MATRIX FOR STRENGTHENING MASONRY STRUCTURES

Abstract

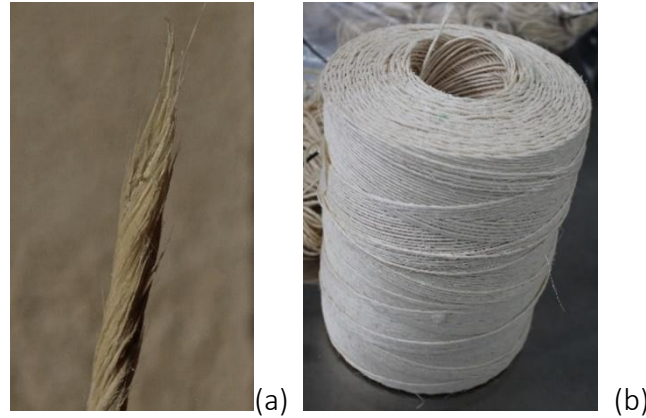
Sisal yarns from Tanzania were used (Fig. 1a): the yarn is composed by twisted filaments of long fibers.

Fig. 1 Detail of a sisal yarn (a) and yarn roll (b)

The specimens were obtained by cutting 500 mm length samples from the sisal roll (Fig. 1b). The samples were conditioned 15 days into an alkaline solution with calcium hydroxides and pH 12.5 to stabilize the cellular structure and the tensile response [22].

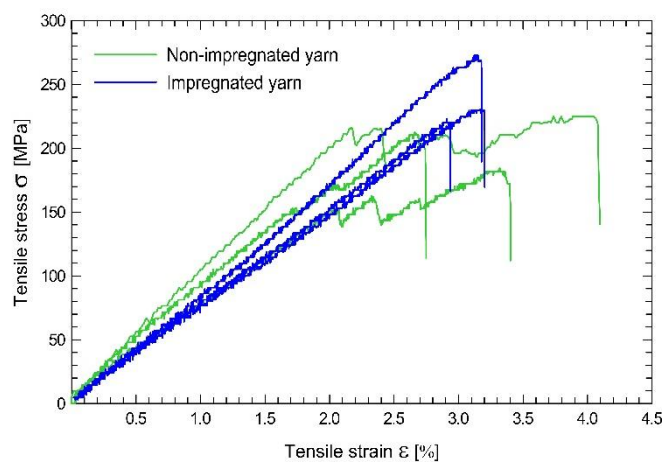
The stress-strain curves of natural yarns are plotted in Fig. 2, in green color: they show an initial linear elastic branch and a second non-linear phase associated to the progressive rupture of the fibers, due to an uneven stress distribution. The results are similar to those obtained by De Carvalho Bello and Cecchi [22], with an average of 437 N maximum tensile load (CoV 9.5%). The calculated tensile strength thus results equal to 209.1 MPa.

The blue stress-strain curves in Fig. 2 refer to impregnated yarns and evidence an elastic brittle behavior, with an average tensile maximum load of 500 N (CoV 11.4%), an average axial stiffness of 16412 N (CoV 11.6%) and mean ultimate strain 3.07% (CoV 4.9%). The average tensile strength resulted of 239.7 MPa, referring to the cross-section of the non-impregnated yarn (A), and of 92.6 MPa, using the area of the impregnated one (A_{eq}).

Fig. 2 Tensile tests on sisal yarns: non-impregnated (green) and impregnated (blue) yarns stress-strain curves (the stresses are calculated considering a non-impregnated yarn cross-section of 2.09 mm^2)

Considering the results of non-impregnated yarns, the impregnated ones presented a higher resistance (about +14%): actually, the impregnation allowed a more uniform distribution of the stresses between the fibers, avoiding their gradual failure.

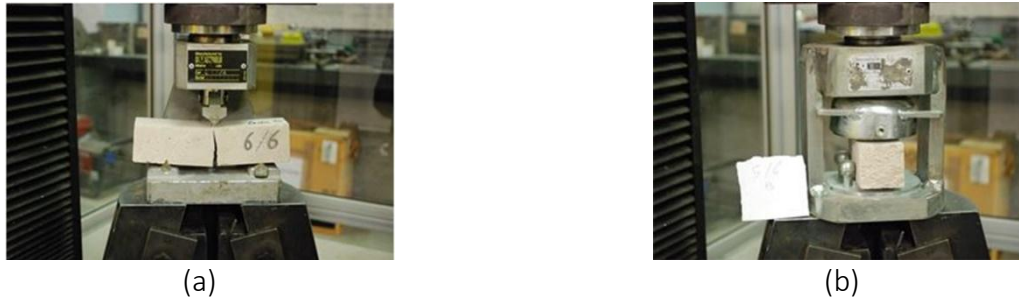
Fig. 3 Flexural (a) and compressive (b) tests on mortar prismatic specimens

accordance to EN 1998-1:2004 standard [26]. The mortar mechanical characterization was set by compressive and flexural tensile tests on six prismatic samples ($40 \times 40 \times 160 \text{ mm}^3$), tested after about 60 days air curing, in accordance to EN1996-1-1:2005 standard [27] (Fig. 3). Samples provided an average mass density of about 1624 kg/m^3 . The average strengths obtained are 13 MPa (CoV 1.8%) and 3.5 MPa (CoV 3.5%) for the compressive and the flexural tensile strengths, respectively.

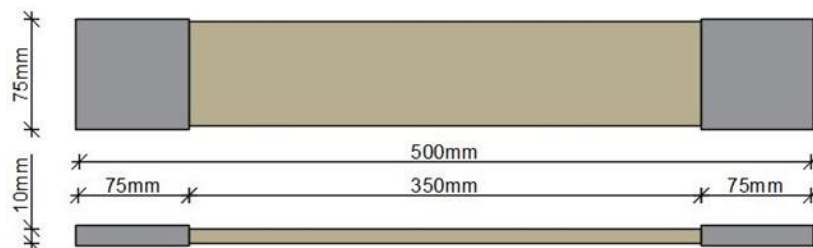
The specimens were prismatic samples of mortar with a layer of sisal yarns embedded. The prisms dimensions were 75mm width, 500mm length and 10mm thick (Fig. 4). The reinforcement is constituted by 5 impregnated yarns disposed in the longitudinal direction and placed in the middle of the specimen thickness.

Fig. 4 Sisal-FRCM specimen geometry: frontal and lateral view

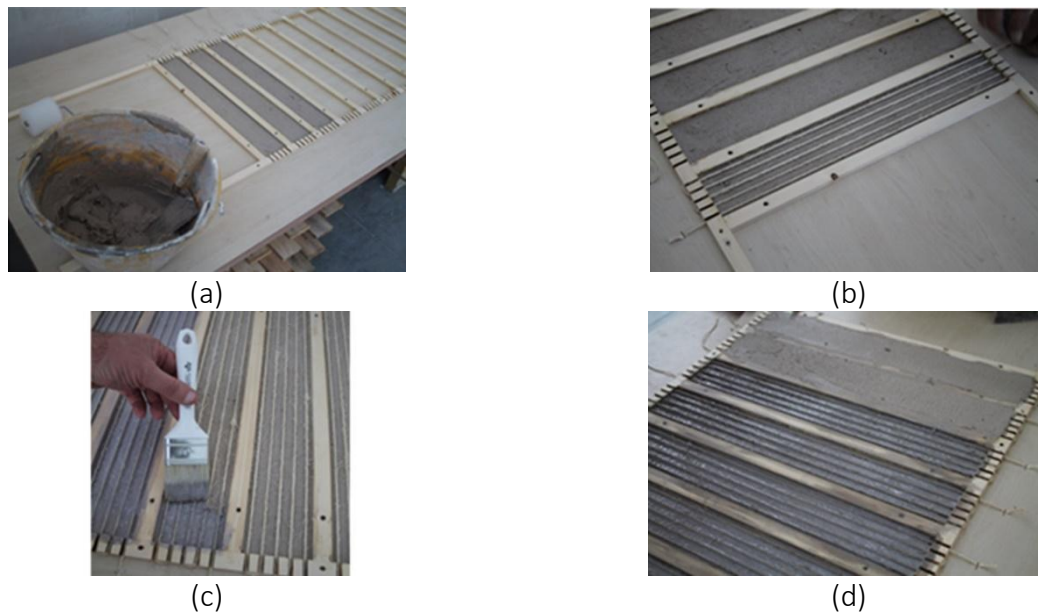
Fig. 5 Sisal-NFRCM samples manufacturing for tensile tests: application of the first layer of mortar (a), positioning of the sisal yarns (b), impregnation of the yarns with the adhesive promoter (c) and application of the second layer of mortar (d)

The specimens were produced with particular attention to the alignment of the yarns, to avoid parasitic stresses during test execution. Fig. 5 illustrates the specimens manufacturing process, with the first half thickness layer of mortar, about 5 mm thick (a), the sisal yarns disposed in the longitudinal direction (b), the manual impregnation with the adhesion promoter (c) and the last half of mortar, about 5 mm thick (d). It is worth to note that, in actual applications on existing masonry walls, this type of reinforcement should reasonably be composed of bidirectional yarns (arranged as a textile or a mesh). Thus, transversal yarns can somehow improve the anchorage performances of the longitudinal ones to the matrix, depending on the consistency of the intersection between yarns (e.g. simple weft-warp weaving or making knots). However, since this was a preliminary characterization study, the contribution of the transversal yarns was prudentially neglected.

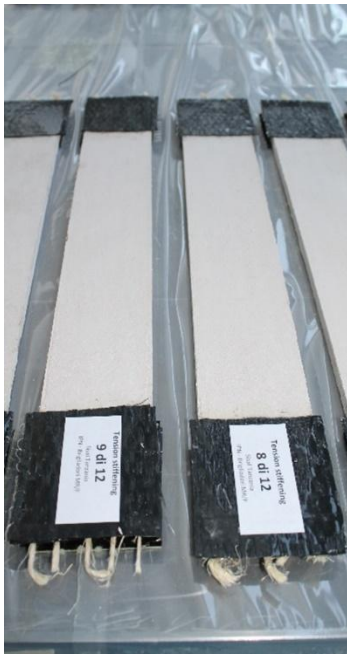
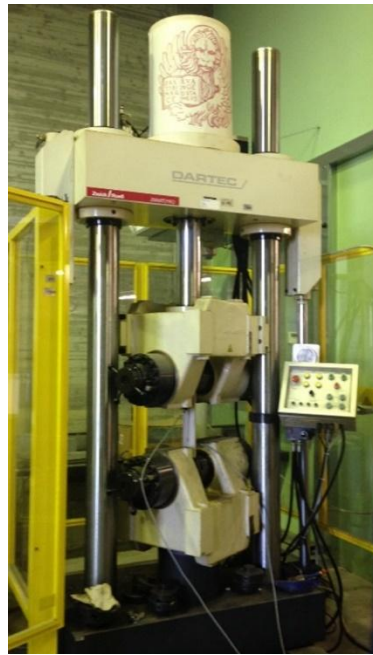
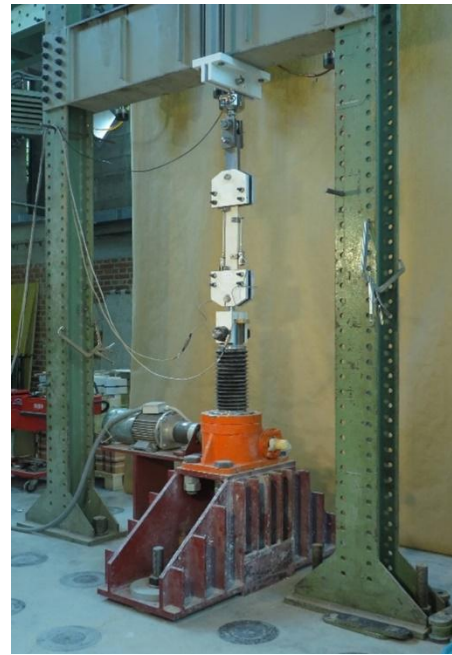
Fig. 6 Tensile tests on sisal-NFRCM samples: some specimens before testing (a) and test set-up at University IUAV of Venice (b) University of Trieste (c)

grip areas during the experimental test [3]. Actually, two overlapped CFRP (Carbon Fiber Reinforced Polymer) strips were applied by the impregnation of the carbon-based fabric with epoxy resin (Fig. 6a).

An illustration of the test setup adopted in the University of Trieste laboratory is reported in Fig. 6c [28]: the apparatus consisted of a metallic portal connected to a stiff reinforced concrete pavement and an electromechanical actuator, fixed at the pavement and placed between the two portal posts. The actuator (Costamasnaga K150, 300 kN capacity, 300 mm stroke) was installed at the top of the metallic base and was controlled by an electrical engine. On the top of the actuator, two coupled steel plates were installed so to create the lower clamping head for the samples. A loading cell (AEP Transducers, Type TC4 AMP 50kN) was mounted on the portal beam and, below, the upper holding of the sample (coupled steel plates) was positioned. The interposition of knuckle joints permitted to overcome for possible parasitic bending forces that may arise in the samples. The test apparatus was dimensioned so to limit as close as possible the elastic deformation related to the metallic elements and connections (apparatus deformation < 0.005 mm for a tensile load of 1 kN). Two potentiometer transducers (base lengths $l_d = 250$ mm and 325 mm) were placed along the specimens for monitoring the sample elongation during the loading procedure.

In both laboratories, the clamping of the specimens at both ends was realized by friction, applying a compressive load of about 20 kN (compressive stress ≈ 3.6 MPa). The load rate was about 0.3 mm/min, in the un-cracked phase (in order to provide recording the first phase of the test) and 0.5 mm/min after the cracking phase and with an acquisition frequency equal to 5 Hz.

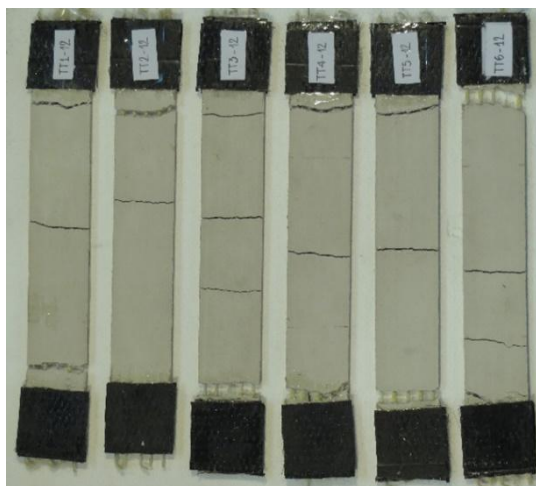
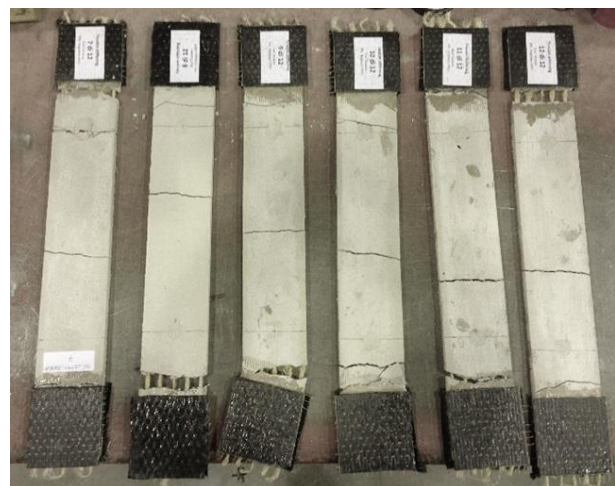
The samples tested in Trieste (named TT1 up to TT6) and in Venice (named TT7 up to TT12) after the tensile tests are illustrated in Fig. 7. The stress-strain curves are reported in Fig. 8: it is observed that the curves obtained from each laboratory are, in general, coherent among them and that the Trieste and Venice results are comparable. Actually, sample TT8 attained to significant lower values in terms of both strength and strain, as a consequence of a premature damage.

Fig. 7 Cracked samples after the tensile tests: samples TT1-TT6 tested in Trieste (a) and TT7-TT12 tested in Venice (b)

A combined collapse mode was, in general, detected (A-C, with reference to Fig. 9): in fact, once the mortar cracked in the vicinity of the clamping heads, the yarns-mortar slip activated in the clamping area. This partial, progressive slippage, which reasonably was not identical in the yarns, induced an uneven stress distribution among them and the tensile failure only of some yarns was achieved.

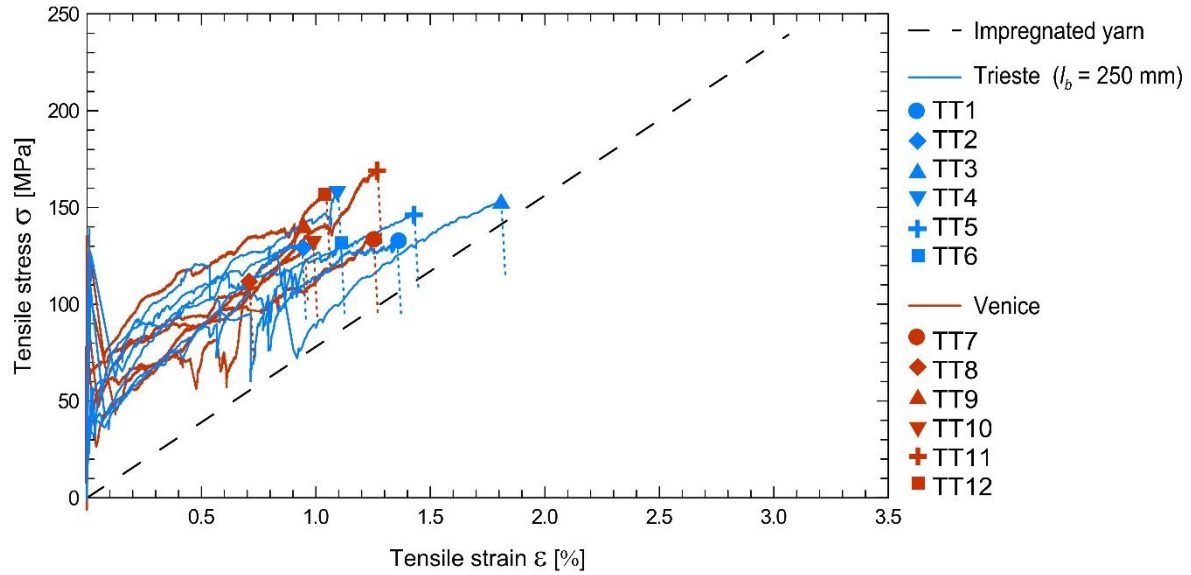
Fig. 8 Tensile behavior of Sisal-FRCM: stress-strain curves obtained by the Trieste laboratory (using transducers with a 250 mm base length) and of samples obtained by the Venice laboratory.

In Fig. 8 the typical trilinear behavior of the curves is evident. Actually, the specimens revealed a first elastic phase, in which the stiffness is very high and difficult to measure accurately. Then, the first cracking of the mortar occurred, with a sudden drop of load. The load associated the first cracking showed a great variability; in fact, considering the reduced thickness of the samples, small defects may anticipate the cracking. However, the load increased again and the curves attain rapidly to the third phase, in which the slope well accords to the stiffness of the yarns alone. The horizontal gap between the third phase and the yarns curve evidenced, in general, a not negligible tension stiffening effect. This indicates that the yarns are, to some extent, still adherent to the mortar between the cracks. However, at the increasing of the load, a gradual reduction of the tension stiffening effect was observed in some samples (in particular TT3), indicating the progressive increase in the detachment of the yarns from the matrix.

Nevertheless, the curves in Fig. 8 result meaningful to describe the actual behavior of the composite: reasonably, in the absence of the yarns slippage from the mortar in correspondence of the clamping heads, the stress-strain curves would have shown the same trend. The third branch would have continued until reaching, at most, 239.7 MPa in case of perfectly uniform stress distribution among the yarns. However, this hypothesis is unrealistic: as emerged in bond tests (section 4), the reinforcement is able to attain to a lower stress value, associated to the progressive failure of the yarns (169.5 MPa).

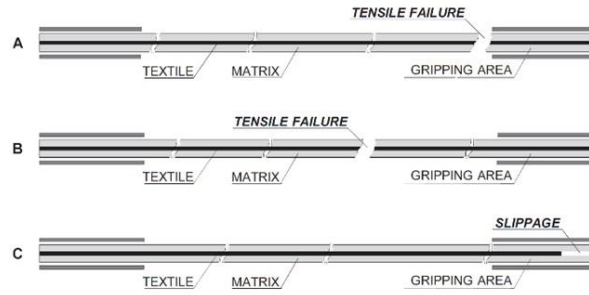
Fig. 9 Possible failure mode of FRCM samples subjected to tensile tests [9]

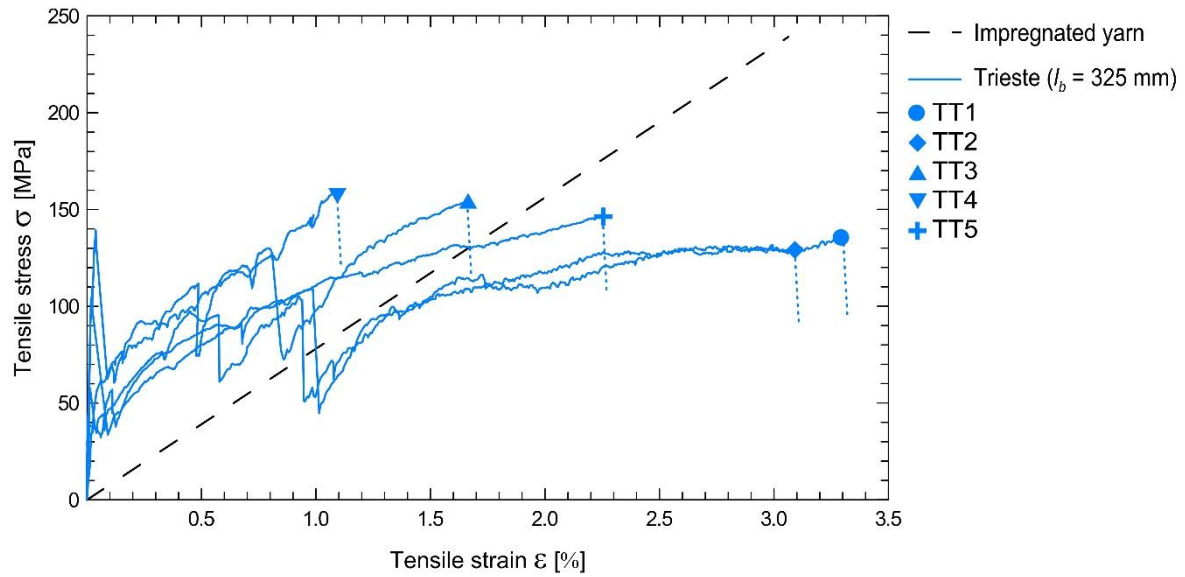
The occurrence of the slippage is evident in the stress-strain curves plotted Fig. 10, which refer to the strains evaluated from the transducers with higher base length ($l_d = 325$ mm), in samples TT1 to TT5: the stiffness of the third branch, initially parallel to that of the yarns alone, rapidly decreases at the increase of the strain (exception only for sample TT4, as the slippage occurred out of the measurement base). A similar slippage phenomena already emerged in some tensile tests performed by Gattesco and Boem [28].

Fig. 10 Tensile behavior of Sisal-FRCM: stress-strain curves obtained by the Trieste laboratory (using transducers with a 325 mm base length).

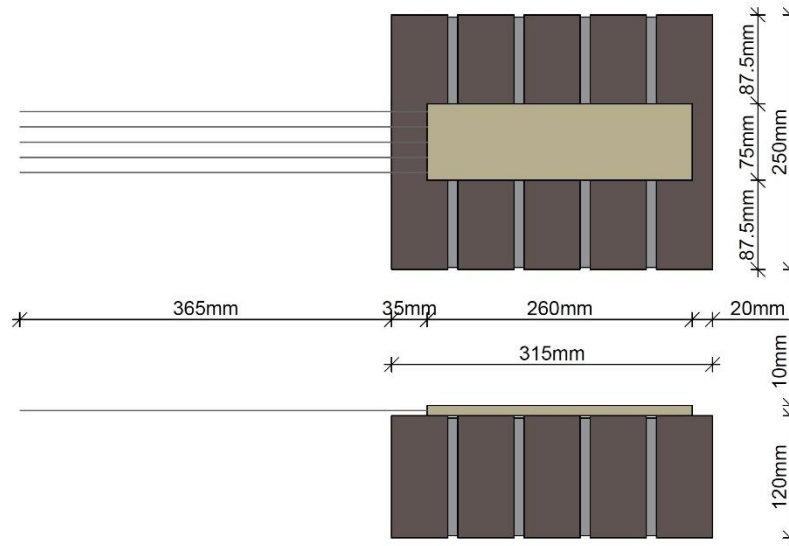
Fig. 11 Single-lap shear tests: specimen geometry

The Sisal-FRCM is applied on one wallet face, at a distance of 30 mm from the wallet upper face and 20 mm from both sides, following RILEM indications [31]. The un-bonded yarns length is 400 mm.

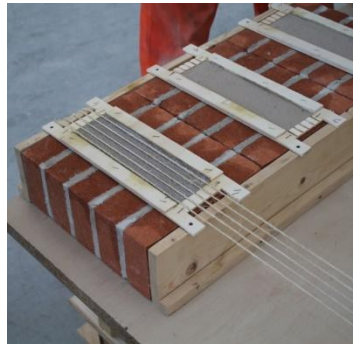
Fig. 12 Single-lap shear tests: specimen construction

The geometry and arrangement of the yarns are the same of tensile tests samples (section 3): five impregnated yarns embedded in a NHL matrix and placed in the center of the mortar thickness (Fig. 12).

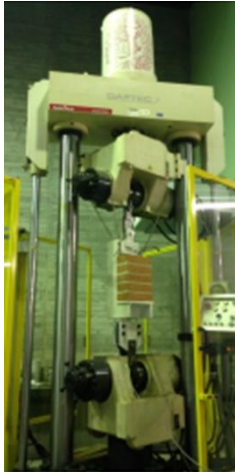
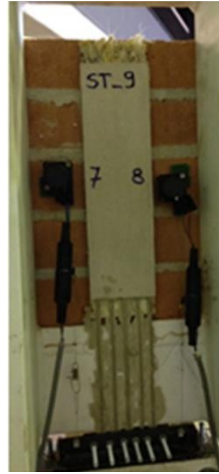
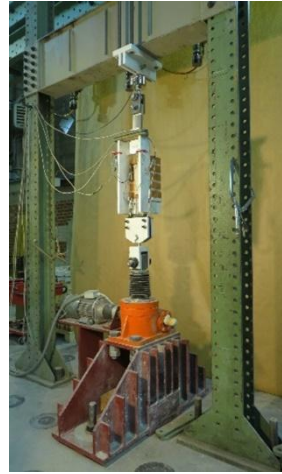
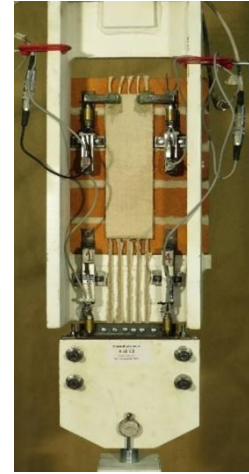
Fig. 13 Single-lap shear test: University IUAV of Venice test set-up (a) and transducers (b); University of Trieste test set-up (c) and transducers (d)

In the University IUAV of Venice laboratory, the tests were carried out with the same testing machine described for tensile tests, under displacement control (Fig. 13 a). A metallic device, shaped as a seat, was used to support the masonry wallet. The device was set so to maintain the yarns in the vertical direction and ensure the vertical alignment of the load along the specimens, taking care to avoid parasitic forces, perpendicular to the masonry surface, which could anticipate the sample failure. Two digital transducers were positioned along the specimens to measure the relative displacement between the masonry substrate and the yarns (Fig. 13 b).

The test apparatus of the University of Trieste laboratory (Fig. 13 c and d) was for the most the same of that employed for the tensile tests, but replacing the upper clamps with the same metallic device already described for the setup of the University IUAV of Venice. Two potentiometer transducers measured the displacement between the yarns and the masonry wallet. Two adjunctive potentiometer transducers monitored the displacement between the mortar layer and the masonry. However, these potentiometers revealed negligible displacements (< 0.1 mm).

In both laboratories, the yarns extremities were clamped through two metallic plates, coupled with bolts, to avoid the yarns slippage. At the beginning of the tests, the length of unbounded yarns included in the measurement base was $l_d = 200$ mm. A load rate of about 0.6 mm/min (acquisition frequency 5 Hz) was considered.

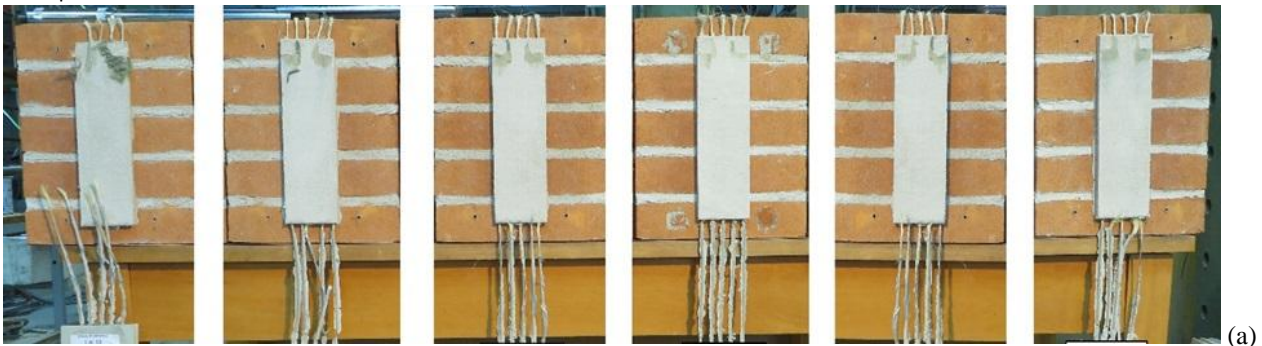
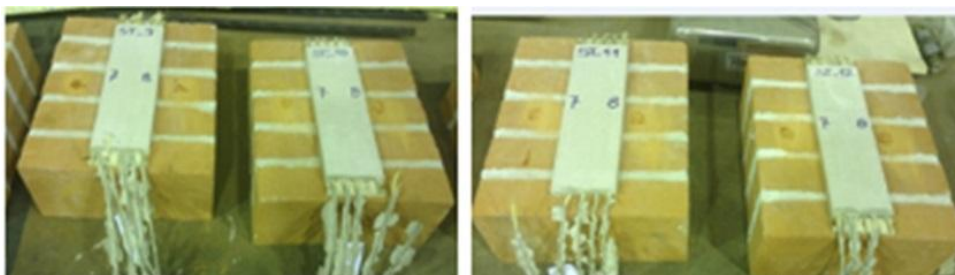
Fig. 14 show the samples after the tests; the samples tested at the University of Trieste were named ST1 up to ST6 and University IUAV of Venice ones are ST7 up to ST12. Actually, samples ST7 and ST8 were not considered, due to a premature damage emerged during testing, due to a sample defect in the construction.

Fig. 14 Sisal-FRCM samples after the shear bond tests performed in Trieste ST1-ST6 (a) and in Venice ST9-ST12 (b)

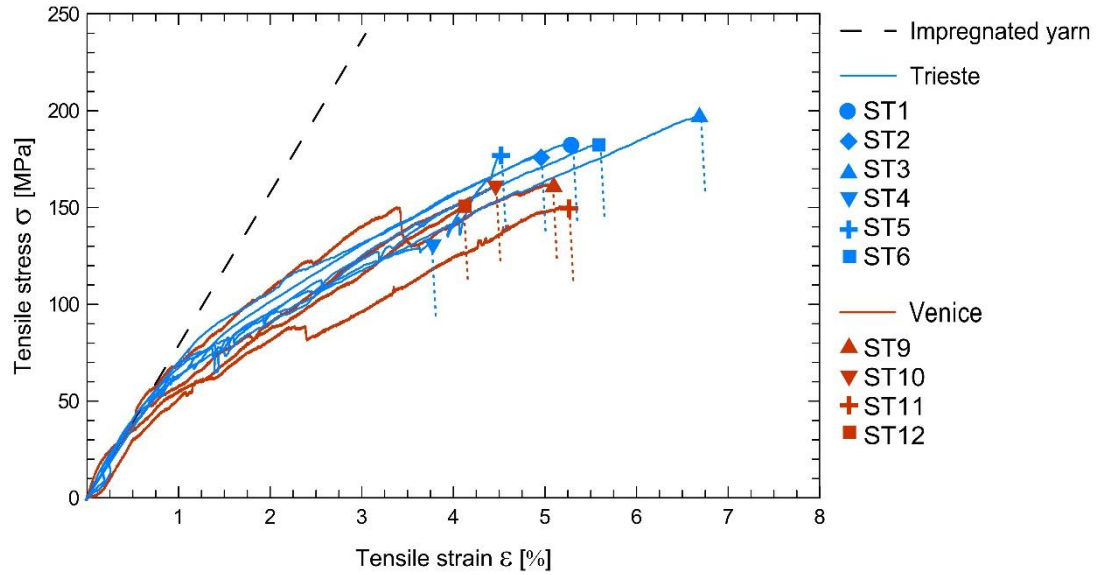
The stress-strain curves obtained from the single lap shear test are plotted in Fig. 15 (the stresses are related to the global fibers cross section, 10.45 mm^2 , the strains are referred to a base length $l_d = 200 \text{ mm}$). The results of each laboratory are coherent and the Trieste and Venice curves are quite comparable.

Fig. 15 Single-lap shear tests of Sisal-FRCM: stress-strain curves obtained by the Trieste and Venice laboratories.

It is evidenced that the monitored displacements may be due, in general, both to the elongation of the yarns and to the relative yarns-mortar slippage. Actually, at the beginning of the test, there was the perfect adhesion between the yarns and the mortar, thus the displacement was initially determined only by the strain of the unbounded yarns portion ($l_d = 200$ mm), as evidenced in Fig. 15. The progressive deviation of the ST curves from that of the yarns, which started at about 60 MPa, revealed the progressive slip and partial detachment of the yarns from the mortar matrix, due to the failure of the chemical adhesion. However, no evident yarns slippage emerged in correspondence of the upper edge of the mortar layer.

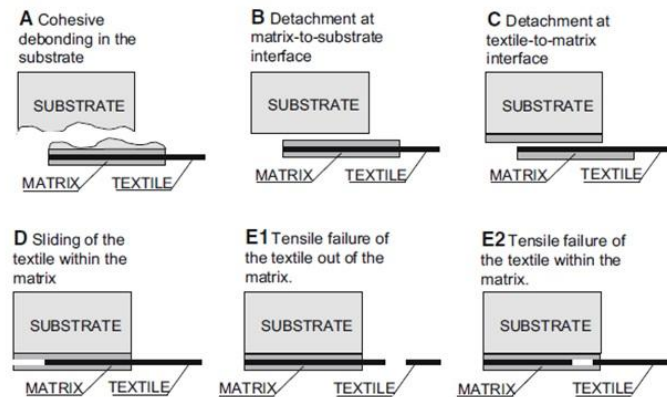
Fig. 16 FRCM failure modes for single-lap shear tests [31]

In general, the samples demonstrated a similar behavior, with the fibers rupture within the bond area, corresponding with the failure mode E2 (Fig. 16). Exception for the sample ST9, whose behavior corresponds to the failure mode E1 (fibers rupture out of the matrix). A bond length of 260 mm resulted thus adequate for Sisal-NFRCM to attain to the yarns rupture, avoiding premature failures for debonding or sliding. The average maximum tensile stress obtained (related to the dry fibers cross section) is about $\sigma_{max} = 169.5$ MPa (CoV 11%). These value resulted about 29% lower than that obtained from tensile tests on a single impregnated yarn (239.7 MPa) and is attributable to an uneven distribution of the stresses among the yarns.

No slips or detachments were observed at the masonry-mortar interface (failure modes A or B in Fig. 16), thus it was not possible to quantify the masonry-mortar bond strength. However, for the considered sisal-NFRCM, it is reasonable to consider unrealistic these kinds of failure, even for lower bond lengths, due to the reduced tensile load and the activation of the yarns slippage from the mortar matrix.
