Conductive atomic force microscopy studies of thin SiO₂ layer degradation

Patrick Fiorenza,^{a)} Wouter Polspoel, and Wilfried Vandervorst
IMEC, Kapeldreef 75, B-3001 Leuven, Belgium

The dielectric degradation of ultrathin (~ 2 nm) silicon dioxide (SiO₂) layers has been investigated by constant and ramped voltage stresses with the conductive atomic force microscopy (CAFM). CAFM imaging shows clearly the lateral degradation propagation and its saturation. Current-voltage characteristics, performed at nanometer scale, show the trap creation rate in function of the stress condition. The critical trap density has been found. © 2006 American Institute of Physics.
[DOI: 10.1063/1.2208370]

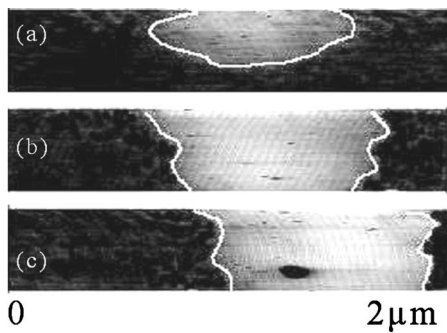
FIG. 1. Current maps at 4 V of $2 \times 0.5 \mu\text{m}$ after CVS in four points at 4.5 V for (a) 30 s, (b) 60 s, and (c) 120 s.

The possibility to study degradation effects in SiO_2 layers with the CAFM has been evaluated. We performed a CVS at 4.5 V for different times on four different points at the vertices of a square having a side of 250 nm in order to get a stressed region big enough for the CAFM lateral resolution. The stress processes have been followed by a scan on the stressed region looking for any changes in the current map of SiO_2 . Figure 1 shows the current maps obtained at constant bias voltage of 4 V on different regions after CVS at 4.5 V for 30 s (a), 60 s (b), and 120 s (c), respectively.

The current maps present dark and bright zones. The first ones represent the typical behavior of a common 2 nm thick SiO_2 layer under a constant applied bias voltage of 4 V. The bright regions are zones with lower current compared with the dark zones. These bright regions indicate the areas affected by the stress. We think that during the CVS additional traps have been created. They trap electrons and play a relevant role in the conduction mechanism of the stressed region. In fact, it is reasonable to believe that electrons are trapped at the Si/ SiO_2 interface and in the SiO_2 bulk, modifying the flat band voltage of the metal (tip) oxide semiconductor (MOS) structure. Consequently, the conduction mechanism is affected by trapped electrons and the effective oxide barrier height increases while the tunnel current flowing through the oxide decreases. Moreover, in Fig. 1 it is possible to note the stress changes in function of different stress times, i.e., smaller stress times correspond to smaller stressed regions [Fig. 1(a) and 1(b)]. If the stress time was large enough, the area of the stressed region did not change further but sometimes breakdown could be triggered (one of the four stressed points broke down) in the stressed region. This is shown by the big black spot (high breakdown current) inside the bright/stressed area in Fig. 1(c).

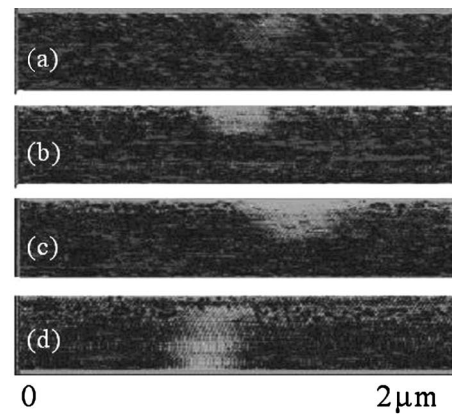
FIG. 2. Current maps at 4 V of $2 \times 0.5 \mu\text{m}$ after RVS in one point from 0 to 4.5 V for (a) 10 times, (b) 20 times, (c) 40 times and (d) 60 times.

Figure 2 shows current maps of regions after different numbers of RVS. From top to bottom, the current maps collected after 10, 20, 40, and 60 voltage ramps are depicted. The more stress ramps, the larger is the area affected by the

stress. This is a direct observation of how the damaging effect “spreads” in the dielectric. In fact, the dimension of the stressed region is always larger than the contact area of the metallic tip on the surface. This spreading effect can be partially due to a little hysteresis of the piezoelectric material, responsible for the motion of the tip, which causes a drift movement on the surface and the increasing of the stressed area. However, it is reasonable to assume that this phenomenon is negligible compared with the lateral spread shown in Figs. 1 and 2. Note that drift would not impose a circular stress zone as the drift is usually in one particular direction. In fact, after several number of ramps there is no more increasing in the dimension of the stressed region. Moreover, analyzing also the data from Fig. 2, it is clear that the increase of the stressed area is a function of time until the reaching of a maximum value of the diameter of about 350 nm. In Fig. 2, this maximum lateral propagation diameter is reached between the 40th and the 60th ramp.

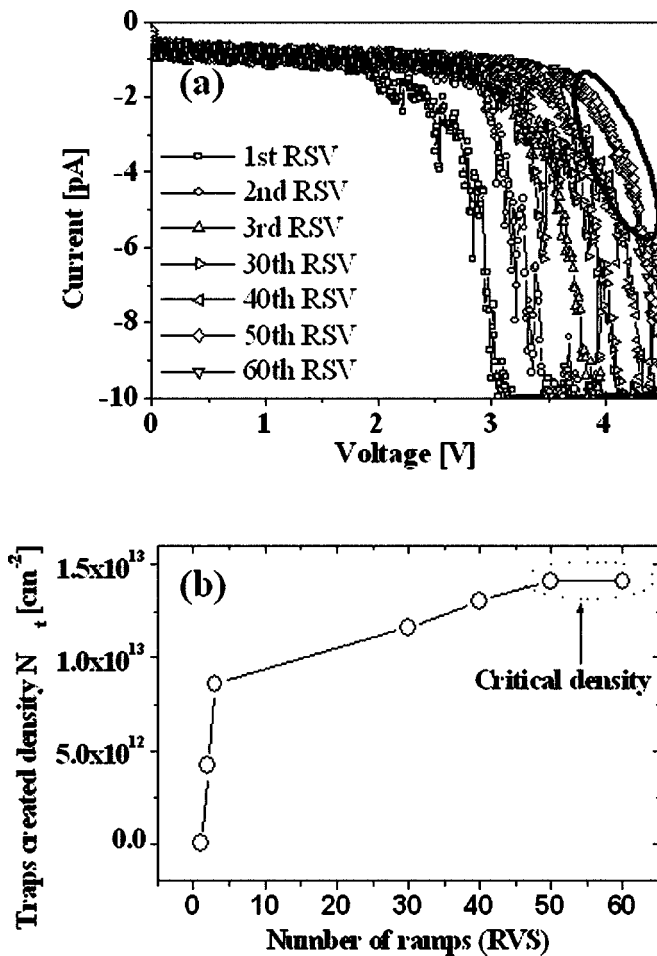
FIG. 3. (a) I - V characteristics after several voltage ramps. Between the 1st and the 60th there is a shift of about 1 V. In the circle the 50th and the 60th ramps are depicted. (b) Trend of the trap generation rate vs the number of ramps from 0 to 4 V.

The I - V curves recorded during the RVS are shown in Fig. 3(a). It is possible to note that the threshold voltage (defined as the voltage where the current exceeds the noise level) shifts to higher voltage values especially in the initial three curves. This observation and the growth of the stressed regions after a different number of voltage ramps indicate a direct relation between the voltage shifts and the trap creation rate. After the first ramps the threshold voltage tends to reach a fixed value and the difference between the 50th and the 60th ramps is practically zero. The slope of all the curves is the same and it is possible to suppose that it is still Fowler-Nordheim injection¹⁸ conditions. At the same time, it is possible to assume that the created traps produce a shift in the flat band voltage,

lated to be $N_t = 1.3 \times 10^{13} \text{ cm}^{-2}$. It is important to emphasize that to obtain the N_t value it is not necessary to know the contact area of the tip, while it is only important that the dimensions are not changing during the measurements. This condition is confirmed because these observations of sequential I - V 's are reproducible using the same tip at different locations. As already described, after several ramps the dimension of the stressed region stops its lateral growth and the threshold voltage does not shift anymore. Figure 3(b) shows the density of the traps created versus the number of ramps (from 0 to 4 V). The saturation density, or the critical density, has been found. This result points out that the maximum density of traps created during the stress is close to the critical defect density to trigger a BD event. In fact, BD events are triggered when, according to the percolative theory, a critical trap density is reached.¹⁹ It is possible to suppose that changing the trap creation rate, for example, using harder stress conditions, BD events should be triggered. This means that longer stress times or higher stress voltages will induce BD phenomena.
