## An example of inspections of compliance with the transport regulation (COUNCIL REGULATION (EC) No. 1/2005)

### The EU transport regulation

### Example of a cross-border transport within the EU

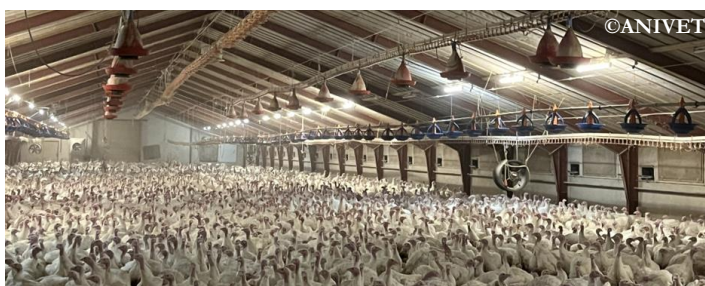
The barn containing 7300 female turkeys, age 17 weeks and with a body weight of approximately 11 kg.

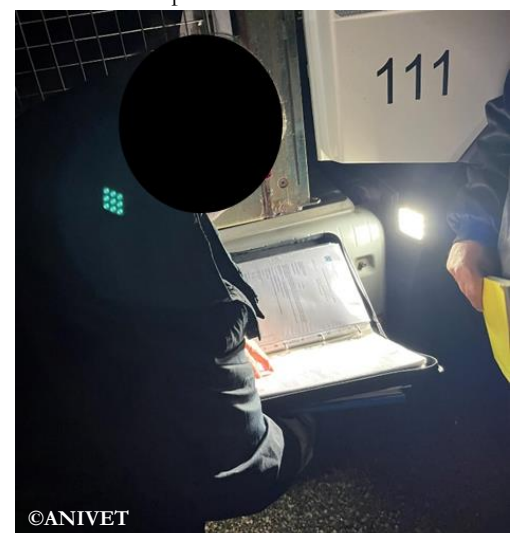
The truck driver was at the venue when the veterinary inspector arrived. The veterinary inspector checked his travel documents (the animal journey log (AJL), the planned journey, the authorization of the transport company, the approval of the vehicle and the certificate of competence for the driver.

*Checking the travel documents.*

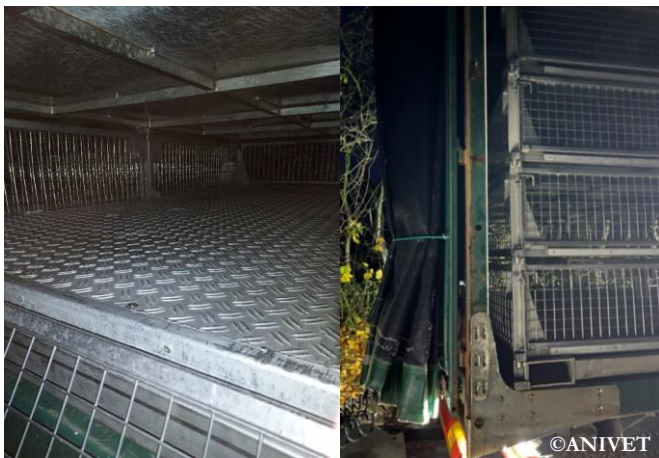
The design and condition of the vehicle were checked to ensure the vehicle was suitable for the transport of turkeys. The containers on the vehicle were inspected regarding proper ventilation, suitability for being cleaned/disinfected and whether the floor was solid and free of sharp edges. The driver explained and showed that the outermost edge of the container had been smoothed to avoid damage to the turkeys when they are pushed into the containers. The floor was solid such that faeces were prevented from dropping to lower-placed containers. The curtains and how they were attached to the sides were inspected to ensure that the turkeys were protected against harsh weather conditions during transport. The containers were checked, ensuring that they were in place and firmly locked. The requirement of a sign on the back of the vehicle warning other road users that live animals were on board was checked.

*Left: the floor in the containers; Right: the curtains in the storage position*

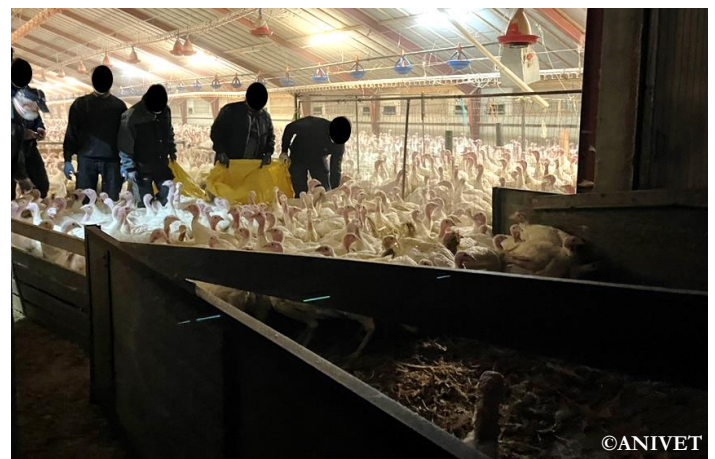
Corralling of the turkeys onto the bucket of the wheel loader was accomplished by 5-6 catchers walking behind the turkeys while swaying large yellow plastic bags. When reaching the bucket, some birds were pushed further into the bucket by one catcher, standing on the side, by placing one hand around the neck to steer the bird while using the other hand to push from the rump of the bird. The bucket was designed like a pen, with the front side being removed while the turkeys were corralled onboard and replaced when the bucket was fully loaded.

*Corralling the turkeys from the barn into the bucket of the wheel loader.*

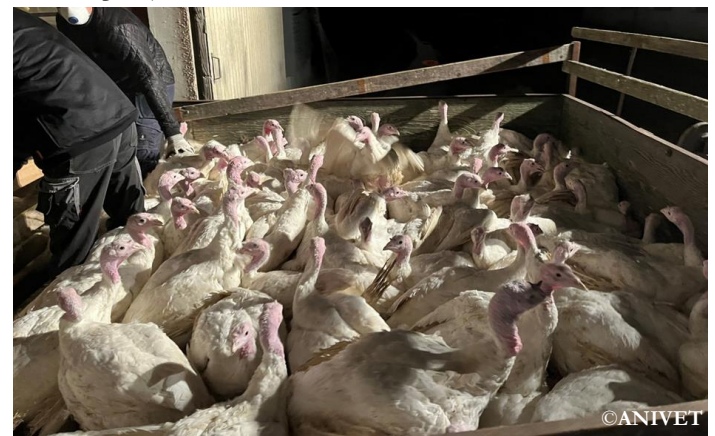
The inspector checked that the catchers did not corral too many turkeys into the bucket, i.e., each bird could stand on the floor without being squeezed, and that the process was done without imposing unnecessary stress on the turkeys. She also inspected whether the turkeys were fit for transport (see section '6. Fitness for transport').

*A full load of turkeys in the bucket of the wheel loader, ready to leave the barn and go the short distance to the vehicle.*

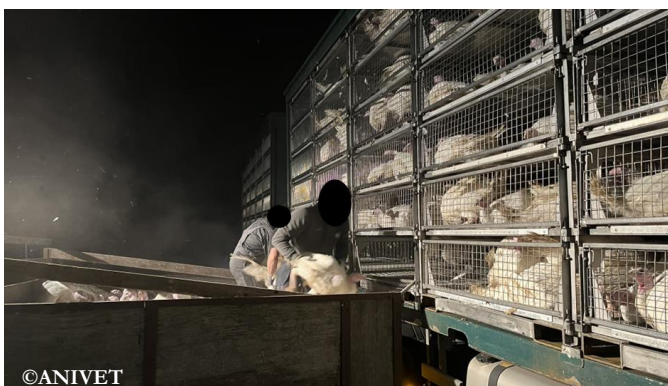
The veterinary inspector checked how the catchers handled the turkeys during the manual loading of the birds from the bucket to the containers on the vehicle. This included whether the catchers:

- Only lifted one bird at a time,
- Used both hands; one hand partly supporting the body by grabbing under the thigh while keeping the wing in the right place, while the other hand kept the other wing folded up against the body,
- Walked all the way up to the container before placing the turkeys inside, including ensuring that the throw used when starting to fill a container was not too rough, while at the same time checking that no turkeys fell out due to being placed too close to the opening of the containers.

*Manual loading of the turkeys from the bucket into the containers of the vehicle.*

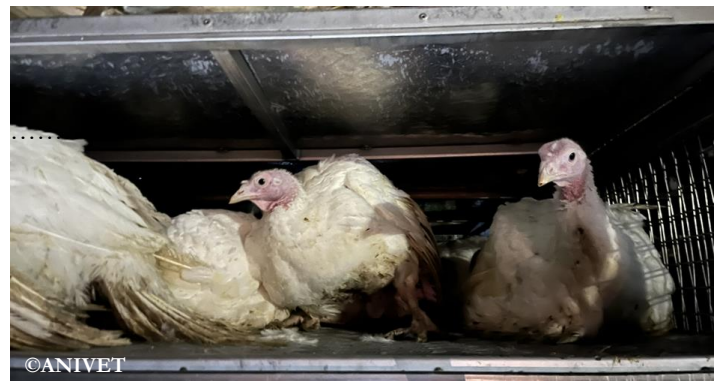
Stocking density within the containers was checked. While the catchers were loading the turkeys, the veterinary inspector counted the number of turkeys loaded into each container. This was done for several of the containers. A total of 27 turkeys were loaded into each container, with 15 loaded from one side and 12 from the other side of the vehicle. The driver informed that up to 33 turkeys were permitted in each container.

The height in the containers was 36 cm. The veterinary inspector checked whether the turkeys were able to sit comfortably with their head held in a natural position when loaded into the containers.

*Turkeys in a sitting position when loaded into the containers.*
