# A Secondary Disaster Due To Inhabitant's Action after a Strong Earthquake: a Case Study of the 2008 Sichuan Earthquake

Douangmala Kounsana, Xiang Wen, Jr., and Toru Takahashi

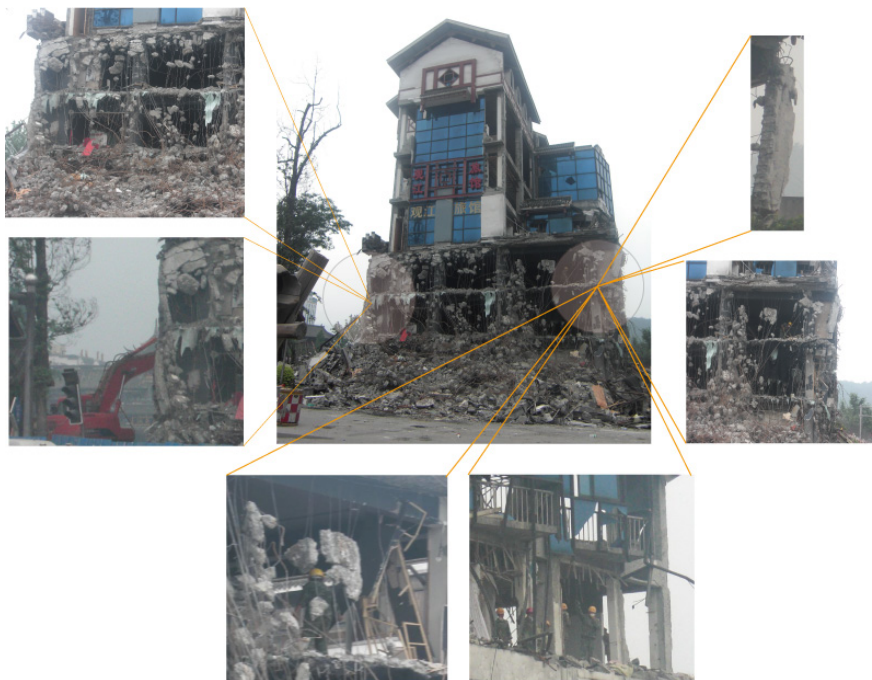
Photograph1. Dangerous Demolition

Photograph1 shows a demolishing of building which used human labor and truck. A whole state of building is severely damaged, all walls are demolished, columns are intense damaged and some columns shifted from central position and glass windows are breaking. At the left side of 1<sup>st</sup> floor, demolition work is done by a truck and at the 2<sup>nd</sup> and 3<sup>rd</sup> floor demolishing work is done by human labor.

In the middle of demolishing, the building can possible to collapse any time, but a housebreaker has used human labor to demolish inside of building along with using truck for demolishing building.

For demolishing of building, should not used human labor and not allow people to go inside demolished building.

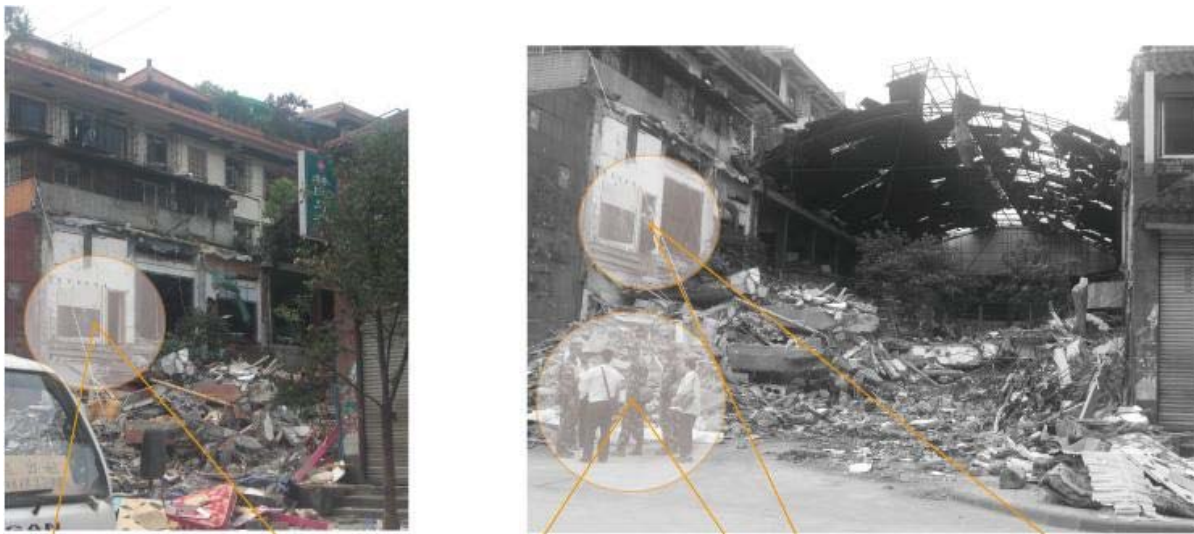
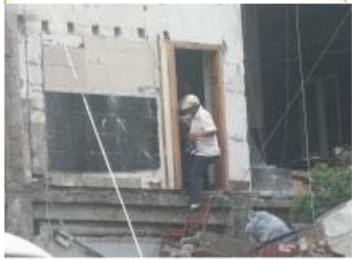
Photograph2. Inappropriate Action

A building quiet old and has a big damage, a fragment of broken buildings has littered surround building and resident possible to injury in the falling objects.

But inhabitants are going inside their house to take properties. Soldieries have watched around area but sound as they recognize those actions. Residents should not entire to the damage building witch not confirming the safety yet. Photograh2 is showing the inappropriate action.

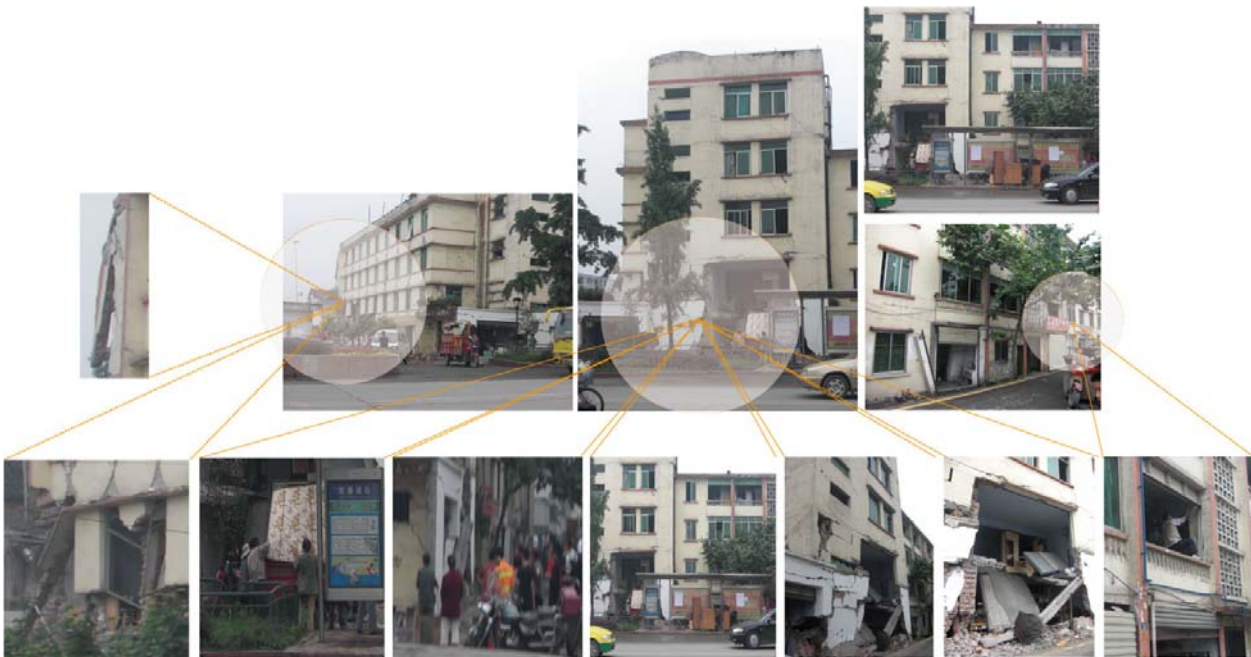
Photograph3. Dangerous Action

An apartment building of brick structure is near collapse state. Have large vertical cracks occur in an edge of L type building and have big diagonal cracks occur in around the walls. The brick columns in first and second floor are collapse and a floor is falling down. The building is losing structural support part and in the state that can't be reinforced. But, residents are going inside for taking their furniture and properties from the apartment for moving out. Moreover, have a man is detaching the window frame work in the next door. The building where structural support part is lost possible to unexpected collapsed by aftershocks and vibrations. Inhabitants should not entire or be around such the building. Photograph3 shows the dangerous action.

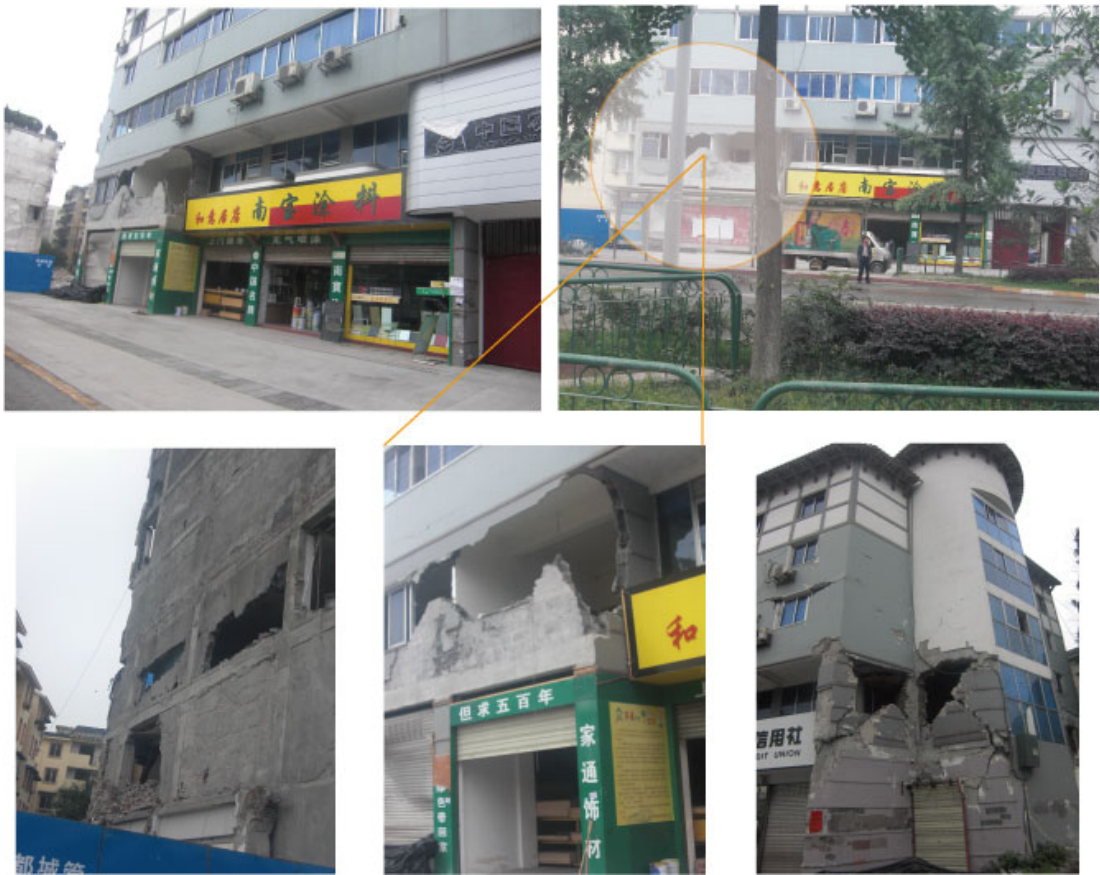
Photograph4. Dangerous Business

The wall has destroyed partially and early reinforcement is needed. Structure type is unconfirmed but bricks are showing at column. Before entire to the building rapid structural checked is needed. But resident is doing shop business in the building which not checked the safety and has intense damage. These actions can be a caused of expanding damage further. Photograph4 shows the dangerous business state.

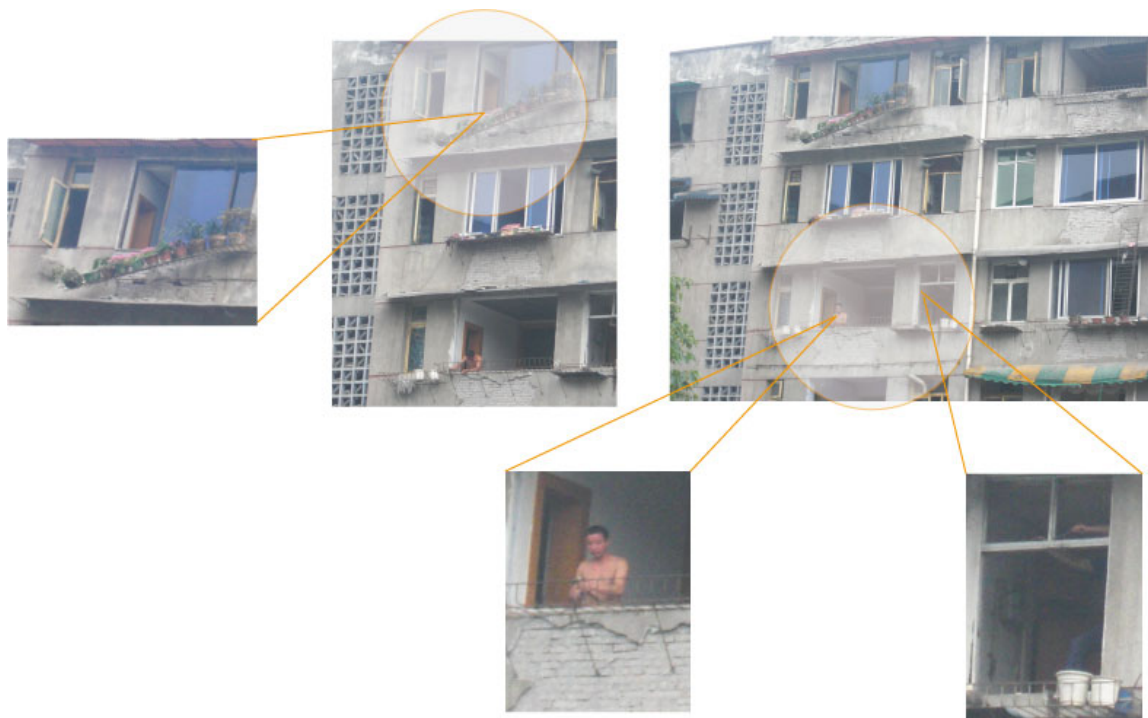
Photograph5. Danger posted by the Falling Objects

During his detaching work, these flower baskets can fall down anytime by the aftershocks or the shakes from the works but he isn't notice it. These actions can possible to make resident injured. A post earthquake quick inspection of damaged building to evaluate the risk of building collapse, fall of exterior walls and window glass and so on are needed.
