# Effect of Inhibitors on Weld Corrosion under Sweet Conditions Using Flow Channel

Khaled Alawadhi, Abdulkareem Aloraier, Suraj Joshi, Jalal Alsarraf

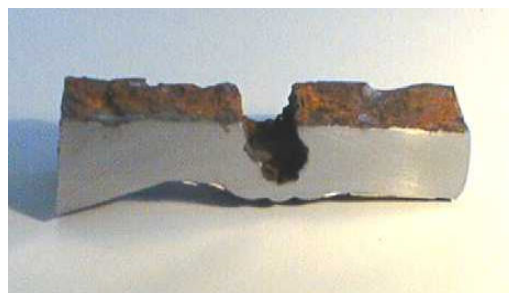
Fig. 1 Severe preferential weld corrosion in carbon steel pipeline carrying inhibited oil and gas [8]

Using inhibitors is one of the most important applications that have been used widely in corrosion protection of carbon steel in CO<sub>2</sub> environments. However, in some cases, the use of inhibitors to control internal pipeline corrosion has the effect of reversing the galvanic currents between the weld regions, such that the weld metal becomes anodic and accelerated rates of galvanic corrosion take place. An example of severe preferential weld corrosion (PWC) in a pipeline containing hydrocarbons and brine saturated with CO<sub>2</sub> is shown in Fig. 1 [8].

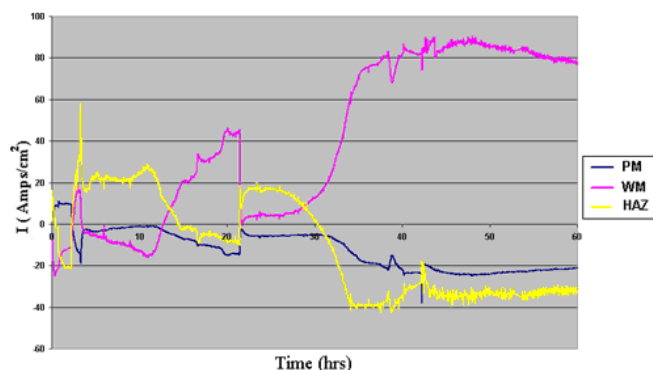
Fig. 5 (b) Galvanic current densities of flow condition using inhibitor (B)

The presence of 30ppm of both oilfield corrosion inhibitors caused a marked change in the galvanic corrosion behavior, as shown in Fig 5. At the beginning of the exposure, both inhibitors appear to be unstable due to current reversal. However, after exposure for almost 20 hours, galvanic current for both inhibitors can be considered as stable since current reversal behavior disappeared.

In terms of galvanic currents, inhibitor B seems to be more efficient as it enables reduction of galvanic corrosion given that the values are quite small compared to the values obtained for inhibitor A. Besides, with inhibitor A, the peaks representing reversals reached high values (more than  $100 \mu\text{A}/\text{cm}^2$  which is equivalent to more than  $1 \text{ mm}/\text{y}$ ). This is not the case observed with inhibitor B.

The galvanic current for inhibitor A was particularly high on the weld metal than for inhibitor B, suggesting that the inhibitor A film was more adversely affected by flow causing preferential removal of the inhibitor film from the WM compared to inhibitor B.

After 20 hours of exposure, both the inhibitors had similar behavior, with the WM becoming anodic and both PM and HAZ becoming cathodic. Galvanic currents gradually rose for inhibitor A toward anodic side for the WM, while for inhibitor B, the WM remained anodic but the currents were fairly constant over the test period.
