Long-term performance of high-albedo roof coatings

Sarah E. Bretz, Hashem Akbari

Lawrence Berkeley National Laboratory, Berkeley, CA 94720, USA

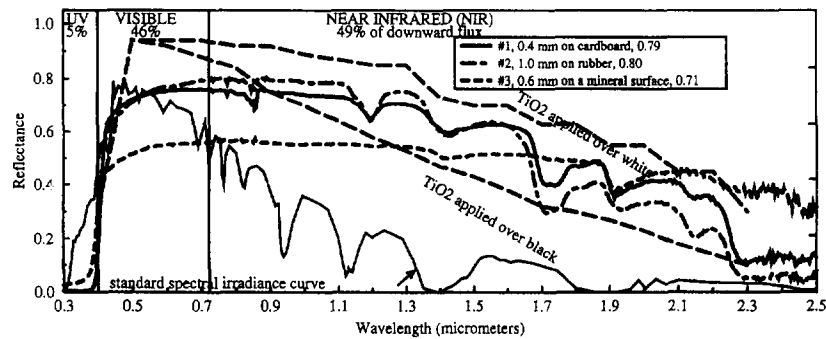
Fig. 4. Spectral reflectance of five white roof coatings. Also shown is the shape of the solar spectrum (lower curve), which indicates how the solar energy is distributed over wavelength.

Results from the spectrophotometer with integrating sphere for the unexposed laboratory samples described in Table 1 and titanium dioxide pigment, 0.2 μm particle size,

are shown in Fig. 4. The standard solar spectral irradiance is shown in the background.

As with the rooftop measurements, the purpose of the spectral measurements is not to compare reflectance values between coatings, because the samples vary in terms of thickness and substrate, as shown in Table 1. Note that this sample is far thicker than the recommended thickness of 24 mils. Coating #2 had a thickness of 1.0 mm and was therefore exhibiting maximum reflectance for that coating, 0.80 [6]. We suspect our samples of Coating #1 and Coating #3 are not exhibiting maximum reflectance. The sample of Coating #1 is slightly sub-standard thickness for roofs, while Coating #3 is below maximum reflectance because of the roughness of the substrate, in addition to the sub-standard coating thickness.

All three coatings absorb in the UV region. This feature is common to titanium dioxide, a pigment that is used in many white roof coatings, including Coatings #2 and #3. Coating #3 does not have the same absorption features, as Coatings #1 and #2, although there is a consistent small dip in reflectance at 1.4 μm . Molecular groups containing hydrogen (e.g. OH^-) can cause absorption in the near-infrared [11]. Commercial titanium dioxide pigments are often surface treated with aluminum hydroxide to improve various properties, such as dispersibility and durability [19].
