Saph Pani

Enhancement of natural water systems and
treatment methods for safe and sustainable
water supply in India

Deliverable D2.2

Documentation of acquired data and
conceptual model of MAR impact as
input for WP5 modelling

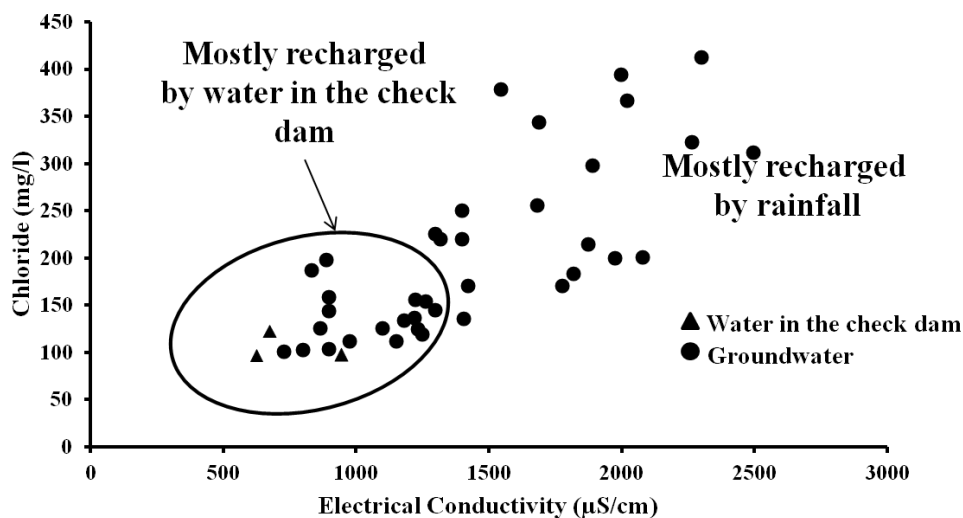
Figure 4 Plot on EC and chloride of groundwater and surface water.

The plot between electrical conductivity (EC), which is a function of TDS and chloride, a dominant conservative anion show that some wells plot closer to the origin, whereas the other wells plot away from it (Figure 4).

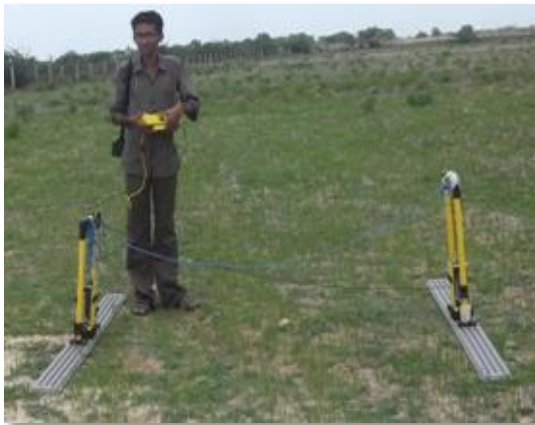
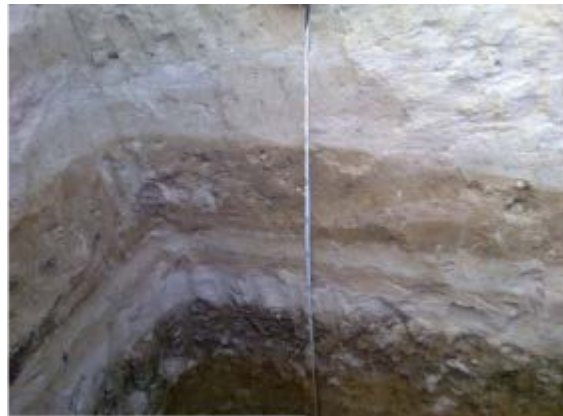
Figure 9 GPR survey under progress and the radargram obtained showing interpreted subsurface layers in the area.

The subsurface geophysical signatures of the area were mapped using Ground Penetrating Radar (GPR) with 50 MHz antenna (Figure 9) and resistivity meter (Figure 10). The GPR profile is taken parallel to the Arani River and Bay of Bengal. The maximum depth of penetration of electromagnetic waves, which depends on the velocity of the medium and frequency of the antenna, ranges from eight to nine meters from the surface. This may be due to the higher signal attenuation by saline water. In Figure 9, three types of subsurface signatures are visible which are indicated by layer 1, 2 and 3. Layer 1 extends to a depth of nearby 4 m and layer 2 extends from 4 to 7 m depth. In the first layer, parallel and continuous layers can be seen whereas in layer 2, distorted signals with maximum attenuation can be seen. The high attenuation below 4 m may be due to the high salinity and EC of water below 4 m. Clay patches occupying smaller area are also present in the area, which are marked in the Figure 9. Layer 3 is characterised by poor conductivity of electromagnetic radiations. Water table is not visible in the radargram. Layer 1 is characterised by sand with silt and layer 2 is dominated by silt with very less concentrations of sand.

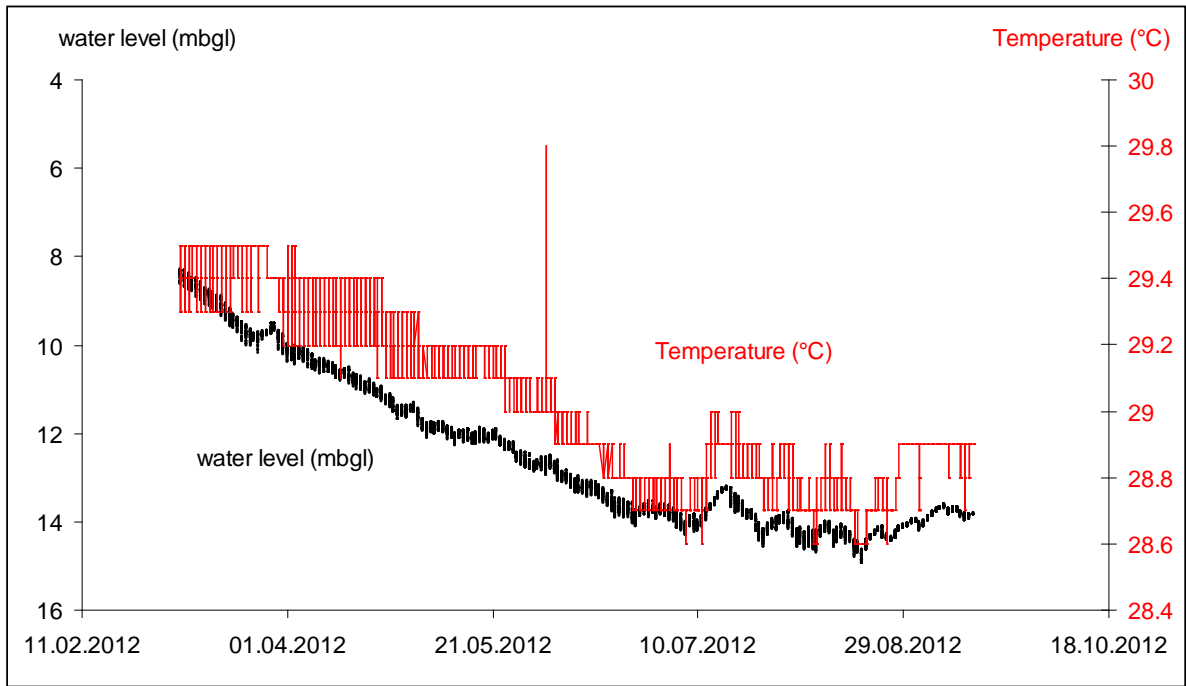
Figure 63 Water level (meter below ground level) of TW11 well close to the Paleshwaram check dam.
