NOTES.

Device for Reading "Nesslerized" Ammonia Tubes in Water Analysis.—The illustration shown herewith requires but little explanation. Two disks of brass $\frac{1}{4}$ inch thick and $6\frac{5}{8}$ inches in diameter are joined by twelve tubes of brass $\frac{13}{16}$ inch in inside diameter and $9\frac{3}{4}$ inches in length. The glass "Nessler" tubes, which are $\frac{3}{4}$ inch in diameter and 8 inches to the 50 cc. mark, just fit these tubes and are kept from falling through the open bottoms by the holes in the lower brass disk, being slightly smaller than the diameter of the brass tubes.

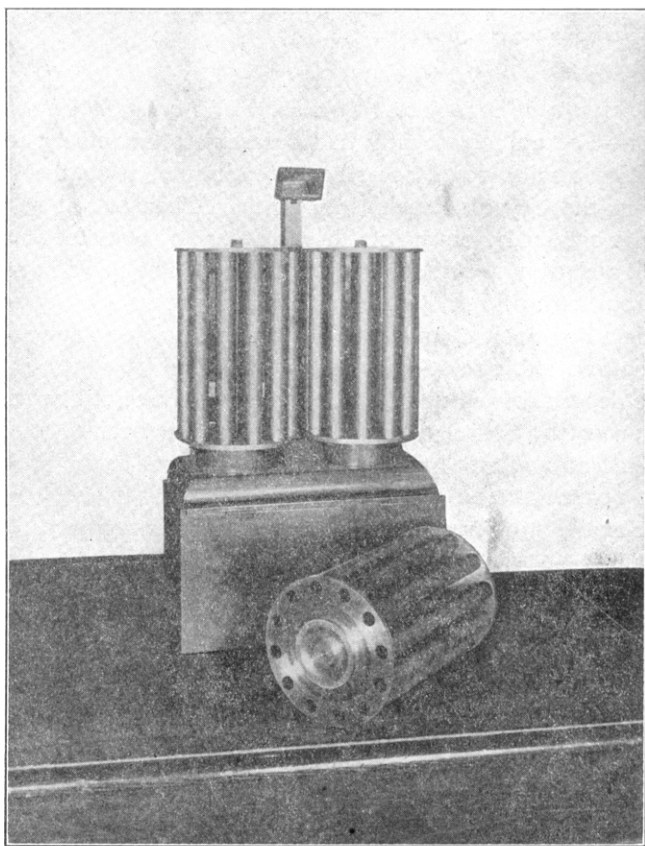
Each lower brass disk is furnished with a very short but broad pivot (3 by $\frac{1}{4}$ inches), which fits into a socket on the wooden stand, thereby permitting the set of tubes to be rotated about a

vertical axis. The wooden stand in question has a base of $6\frac{3}{4}$ by $13\frac{1}{2}$ inches, supporting a pair of wooden sockets. Between the sockets is a small mirror set at an angle of 45° , which throws light up through the two "Nessler" tubes under comparison, and permits the observer to see them in the upper mirror as though in horizontal position. The "Nessler" standards being placed in the set of tubes on the left and the "free" and "albuminoid" ammonias on the right, the two sets can be rotated at will until the colors on the right hand are matched by those of the standards on the left.
