(*Paper No. 2164.*)

“Colombo Harbour Works, Ceylon.”

By JOHN KYLE, M. Inst. C.E.

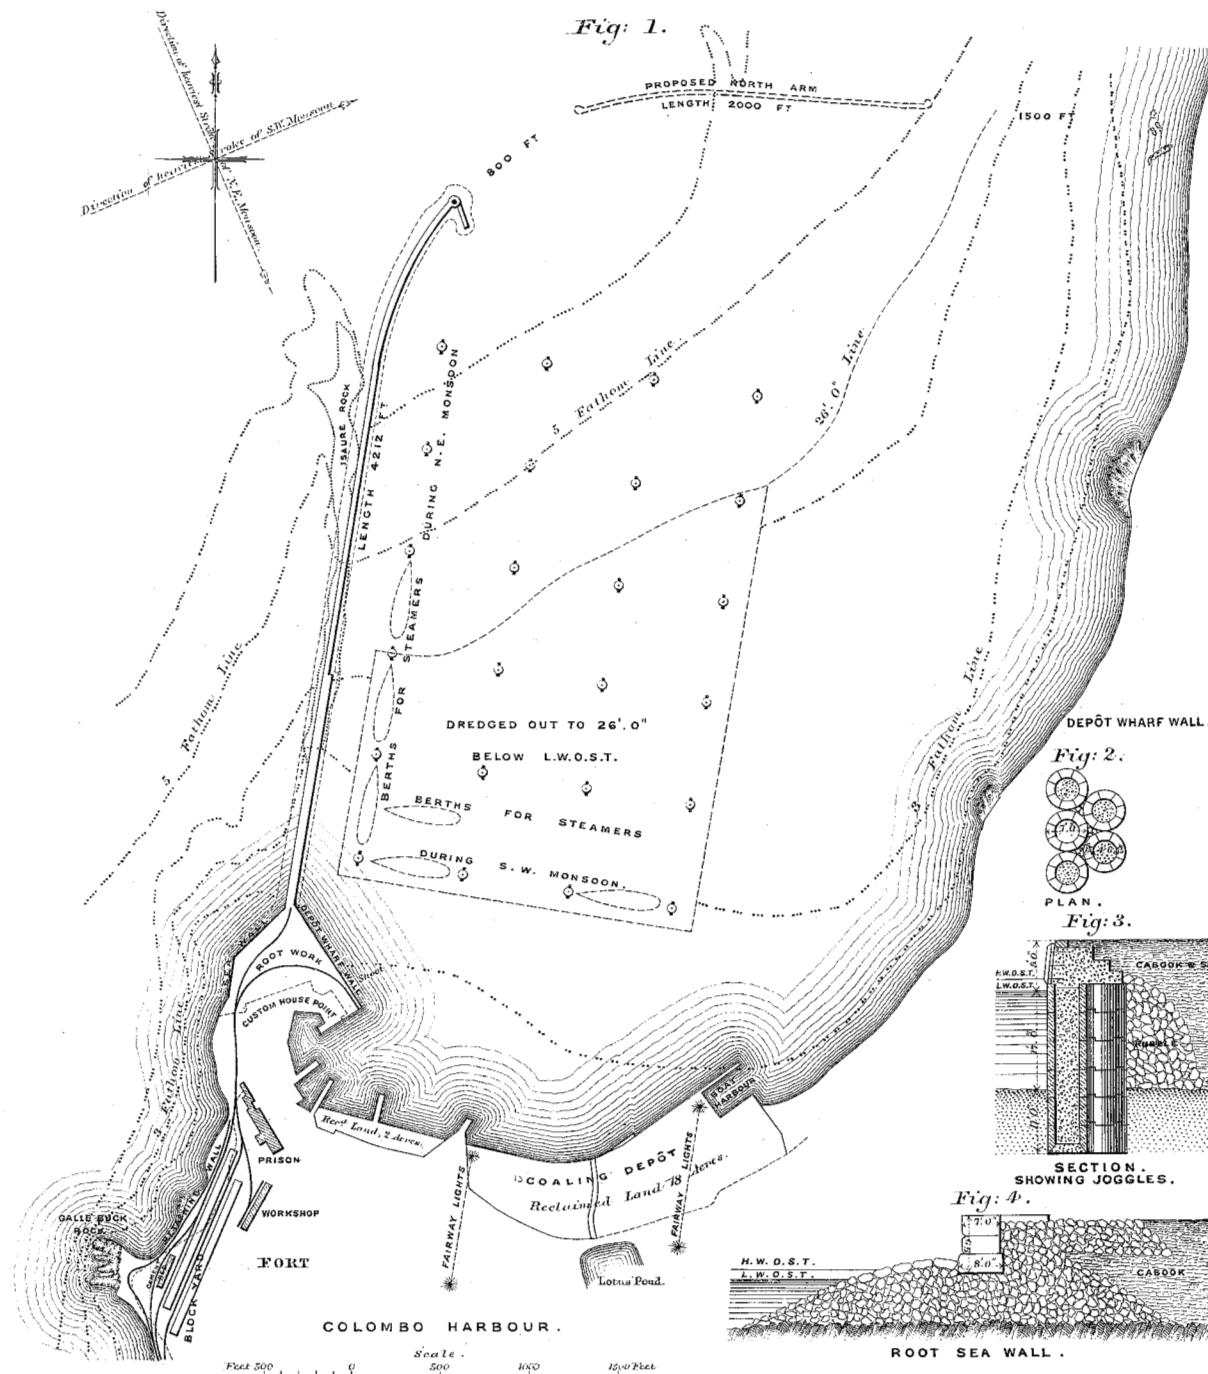
Block-yards.—The site at Galle Buck had to be levelled by the removal of 26,368 tons of granite and 66,726 cubic yards of earth; and 6,860 tons of the granite were utilized in the construction of a north and south dry stone sea-wall, reclaiming some bights along the shore. Workshops were erected, and lines laid down on this site (Plate 2, Fig. 1). A cement-shed, 205 feet by 35 feet, was

Dredging.—The position of the $85\frac{1}{2}$ acres in the harbour, to be dredged to a depth of 26 feet at low-water, is shown by a dotted line on Plate 2, Fig. 1; the amount to be dredged was 887,459 cubic yards, of which 678,459 cubic yards had been completed up to 1884. The sheltered water-area in the harbour is 502 acres at low-water, 329 acres with a depth of 18 feet and upwards, $242\frac{1}{2}$ acres of 26 feet and over, and $90\frac{1}{2}$ acres of 30 feet and more. A single ordinary bucket-dredger, of 75 nominal HP., was employed, capable of dredging in 29 feet of water. The dredgings from the harbour were conveyed 4 miles out to sea, and dropped in 15 fathoms of water by a hopper-barge carrying 500 tons, and making three trips a day in full work, or on the average two and a half trips. The barge cost £11,333 delivered at Colombo. An auxiliary barge took its place whilst absent on its trips, and carried away three cargoes of 75 cubic yards each.

Moorings.—Four tiers of six buoys each were fixed parallel to the breakwater (Plate 2, Fig. 1). The first tier is 300 feet from the pier-wall; and the buoys are 600 feet apart each way.¹ Twenty-five steamers of the largest class can moor in depths of from 26 to 40 feet of water; whilst there is space at low-water for a great number of vessels drawing from 6 to 26 feet. A vessel entering the harbour at night steers into the line of the fairway lights, where a passage of 600 feet is kept open for convenience in berthing. The cost of the moorings was £7,411.

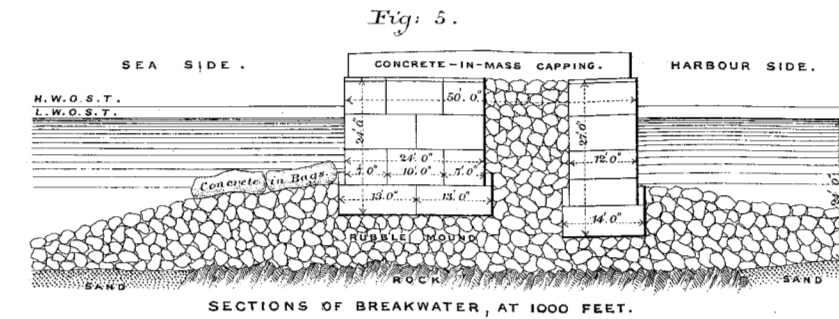
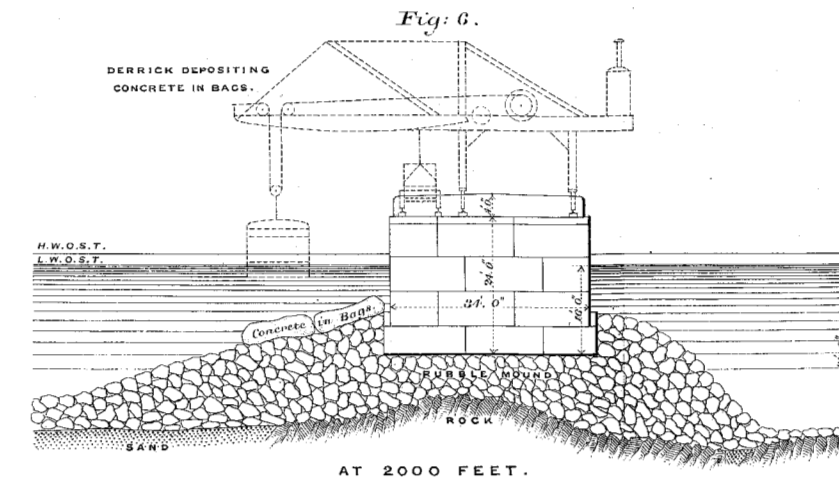
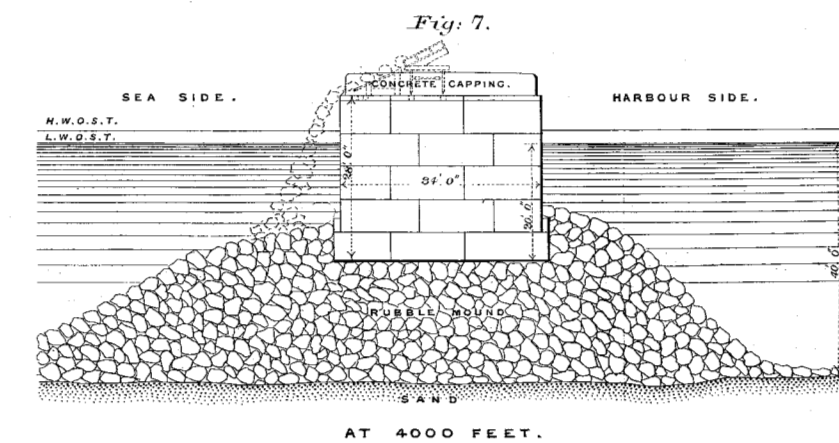
Depositing from hopper-barge.—The 80-ton steam hopper-barge, running 6 knots an hour with a full load, was loaded from the shoot alongside the depot wharf; and on reaching her destination ahead of the breakwater, the exact position for dropping the cargo was ascertained by means of high diamond and circular-shaped beacons on shore, and floating beacons in the sea. Five tiers of cargoes were deposited on the transverse line by means of marks on the vessel's gunwale, corresponding in shape to the land beacons numbered from 1 to 5. Three transverse sets of buoys were placed at the end of the work, marking the lines of the tiers of cargoes; and the man stationed at the number of the cargo to be dropped shouted out “let go” on getting into the corresponding beacon line. Cross sections of the mound are given in Plate 2, Figs. 5 to 7.

Berms and Hearting.—During the block-setting season, thirty-five wagon-loads of stone were daily discharged from the wall into the hand barges alongside, from whence they were thrown over on to the mound, as directed by the divers. Eighty-five wagon-loads a day were at the same time deposited on the sea and harbour berms of the breakwater, to make them up to their full section; and a portable shoot of old rails was provided for this purpose, overhanging the face of the wall, having the same slope as the bottom of the tip-wagons at their angle of discharge, and capable of withstanding the shock of falling pieces of rock of 3 tons weight (Plate 2, Fig. 7). Large blocks could thus be deposited, over a core of ordinary rubble, for protecting the berms in bad weather; and the berms were always fully made up at the close of each season. At the commencement of the setting-season, a series of cross sections of the mound were taken, 50 feet apart, whereby any settlement was detected, and was then made up with $3\frac{1}{2}$ -ton rubble. In shallow water, the berm was exposed to the action of the sea for about three years before reaching the condition shown (Plate 2, Fig. 5).

The first 1,326 feet of the pier was built with a sea- and a harbour-wall, having an interval between them of 14 feet, filled in with rubble (Plate 2, Fig. 5). The sea-wall consists of two foundation blocks, 13 feet long and weighing 28 tons each, supporting three courses, 24 feet long, composed of blocks of 14 to $26\frac{1}{2}$ tons each. The harbour-wall is 12 feet wide, making a total width of 50 feet. At 1,326 feet from the commencement, a single wall, 34 feet in width, was adopted, with four to five courses of blocks weighing from $16\frac{1}{2}$ to 31 tons each (Plate 2, Figs. 6, 7, and 10). The sloping joints are $5\frac{1}{2}$ feet apart on the square, and have an inclination of 68° to the horizon (Plate 2, Fig. 11). The last sloping courses of blocks, and the closing blocks up to the pier-head, were laid before the close of the setting-season, in March 1883 (Plate 2, Fig. 9).

Bag-work on Sea Berm.—An apron, 24 feet broad, composed of 10-ton bags of concrete, protects the top of the sea berm from disturbance (Plate 2, Figs. 5 to 9). The bag, having been sewn up on five sides, was adjusted in a skip, carried on a wagon under a shoot, through which concrete was poured into the open mouth of the bag from the mixer-skip. The top of the bag was sewn up during its journey to the derrick, by which the skip with its contents was hoisted, run out, and lowered, and the bag dropped into its place (Plate 2, Fig. 6). No damage was done to any bag, either by the sea, or by the rubble mound on which it fell. The depositing of the bags was commenced on February 11th, 1884, when the progress sections showed that the first length of 2,150 feet of berm, having attained its normal slope, was ready to receive the bags; proceeding landwards, the whole seven hundred and

Along the inner portion of the breakwater, consisting of two walls (Plate 2, Fig. 5), a 40-ton steam derrick was used for setting the harbour-wall blocks; it travelled on the sea-wall, and its jib hung over the harbour-wall.

where the foundation was stepped down to $23\frac{3}{4}$ feet below low-water (Plate 2, Figs. 5, 6, 7, and 9). The block-work rose to 8 feet above low-water; and the capping raises the centre of the wall to 12 feet above low-water.

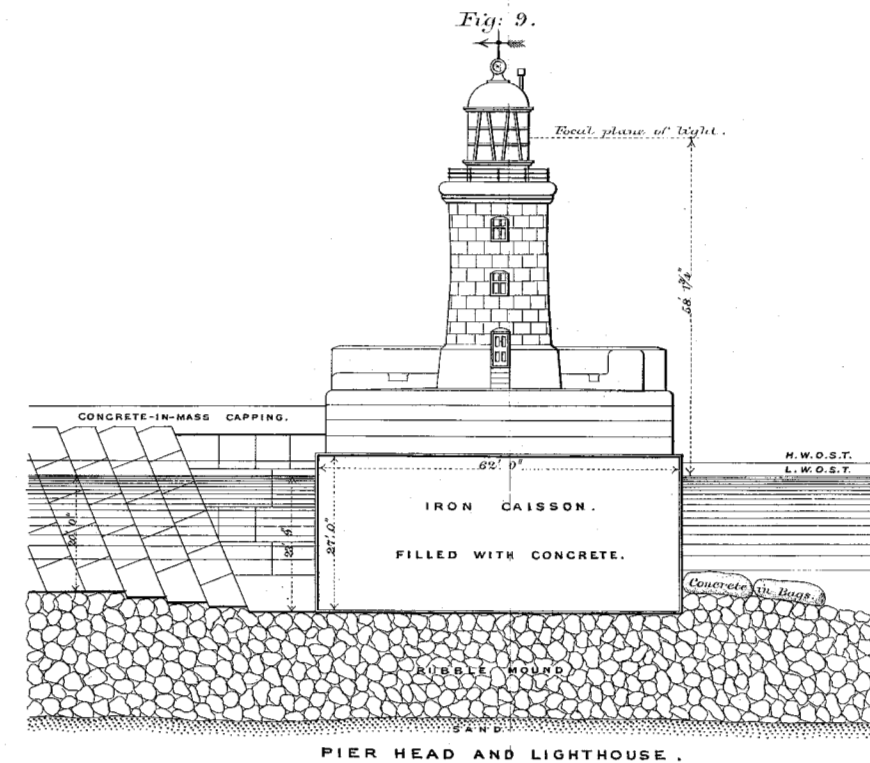
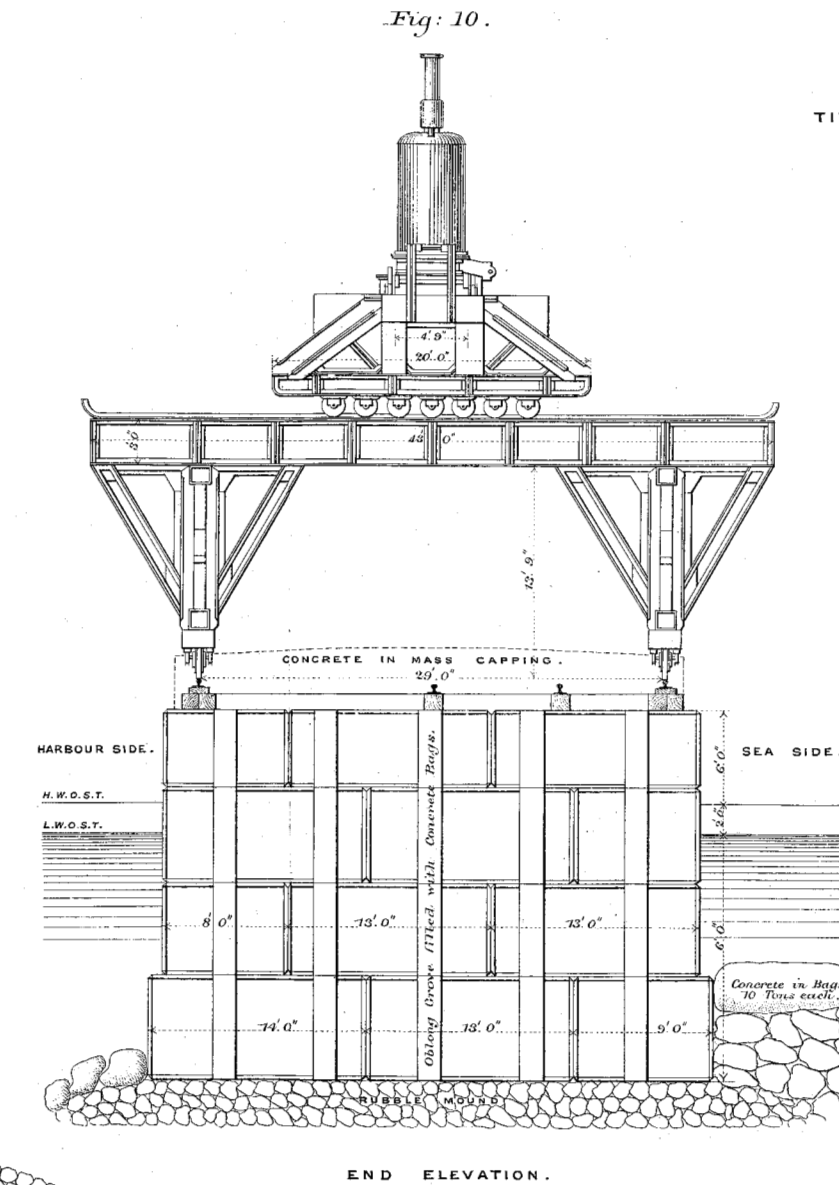
The concrete blocks were set by a Titan (Plate 2, Figs. 10 and 11), the first block being set on the 12th of December 1876. The Titan could carry a load of 40 tons, on an overhang of 28 feet; its weight, including rubble-ballast, water, fuel, &c., was 180 tons; and it cost £5,562 set up in Colombo. The foundation blocks,

Joggle Grooves, Scar End, and Capping.—The joggle grooves left between each row of sloping blocks (Plate 2, Fig. 10) were filled up to high-water level with strong concrete in bags, dropped into the hole and rammed down hard.
