*On the causes of the unexpected breakage of the Journals of Railway Axles; and on the mean of preventing such accidents by observing the Law of Continuity in their construction.* By WILLIAM JOHN MACQUORN RANKINE, Assoc. Inst. C. E.

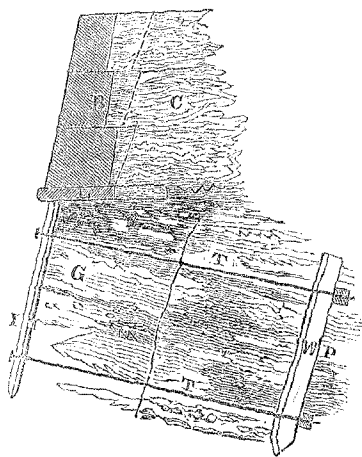
We abstained last month from giving any account of the failure of this pier, which took place on 16th of May last, as we had not then an opportunity of personally inspecting it, or of ascertaining its construction; we have since been favored by our valuable correspondent, O. T., with the following observations, and sketch of the pier. He observes, "the failure of Greenwich pier is not a matter of surprise to parties who understand the practical construction of such works. The immediate cause of the failure was dredging in front of the piles, after the contractor had left the works, and the arrangement of the piles being faulty, as regards construction; the upper part is composed of brick-work in cement B, 18 feet high, and 14 inches thick at top, capped with granite 1 foot thick, backed with concrete, C, and standing upon a foundation of Yorkshire stone landings, L, laid on a small quantity of concrete, with a substratum of foul gravel, G. The landing, in front, rests on a row of cast iron piles, I, P, 25 feet long, and 5 feet apart, grooved to admit between them three cast iron plates, each 6 feet in height, these iron piles were fastened by four, or two, pair of wrought iron land ties, T, 2 inches square, to wooden piles, W, P, 18 feet long, and 12 inches square, driven in land at a distance of  $25\frac{1}{2}$  ft. from the front, and 5 ft. apart." The high water mark is about 4 feet from the top, and low water mark 22 feet below, or about 7 feet below the stone landing. From inquiry, we rather suspect the lower ties, as shown in the sketch, were not fixed, nor do we see how they could
