Geomorphological Landscape Research and Flood Management in a Heavily Modified Tyrrhenian Catchment

Keywords: geomorphological landscape; land use change; runoff; sustainable landscape planning; Tyrrhenian catchment

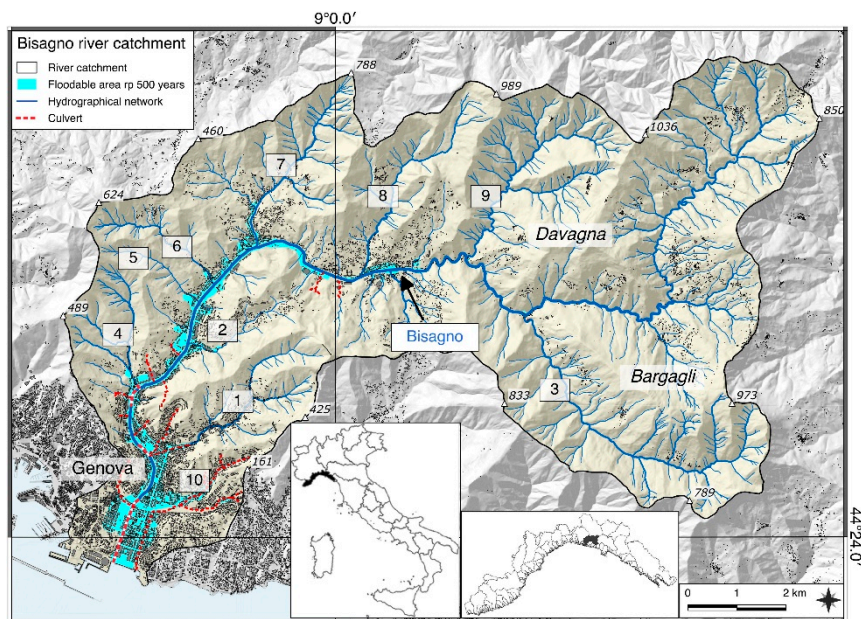
Figure 1. Geographic sketch map of Bisagno basin showing the floodplain, completely urbanised, and floodable areas of the valley floor; see Table 1 for details on subcatchments.

Between 1850 and the Second World War, the new urban areas mostly involved the bottom of the valley, which became almost entirely built up [34]. In the post-war period, new urban surfaces are found mainly on the hills of the lower stretch of the valley. The terminal stretch has been progressively incorporated in the city, while its upper part, NE of Genoa, which is included within the municipalities of Bargagli and Davagna still has some rural characteristics. Its drainage basin covers approximately 95 km² and the main stream has a total length of 25 km (Figure 1, Table 1).

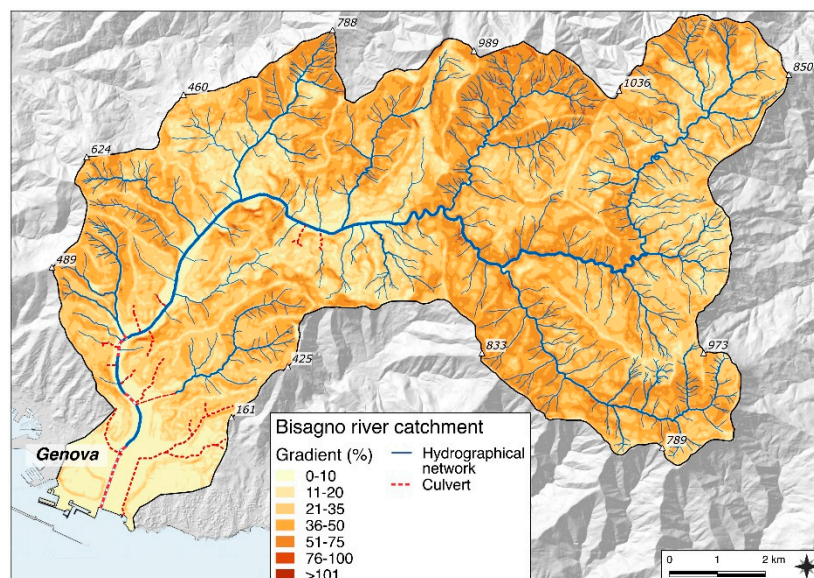
Figure 2. Slope map of Bisagno basin, from Digital Terrain Model (5-m resolution); the map shows the main elevations of the basin, concentrated in its northern and eastern part.

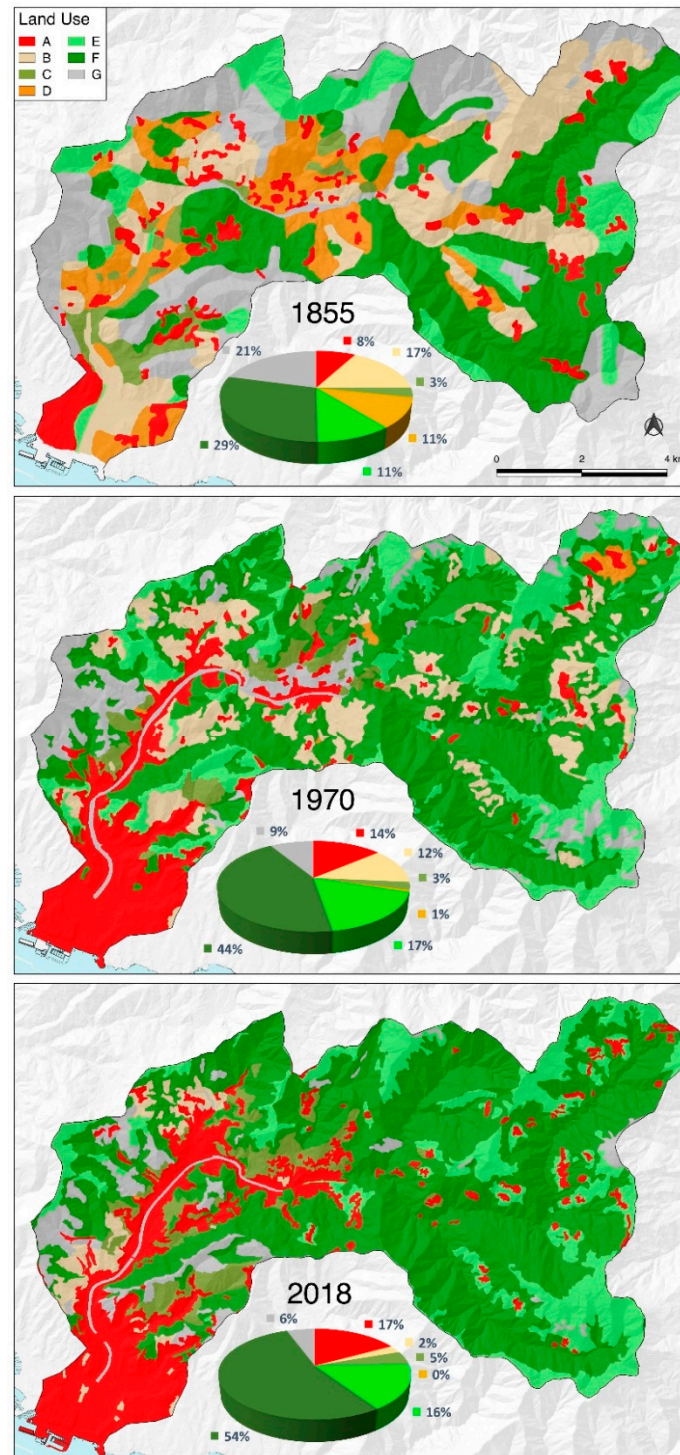
Figure 3. Land use sketch map of the Bisagno catchment in 1855, 1970 and present-day. A: urban, B: field, C: olive orchard, D: vineyard, E: pastureland, meadow, F: wood, and G: bare land, rock. The map underlines the high landscape diversity of the nineteenth century compared to 1970 and 2018. Today, two colours prevail, showing the significant extent of wooded surface and urban area.

The land use of the Bisagno catchment for 1850, 1970 and 2018 is shown in Figure 3. A remarkable decrease in agrarian surfaces is directly proportional to the increase in urban areas, which increased from 7.9 to 17% of the catchment. Fields and vineyards decreased dramatically, particularly the latter, which dropped down to 0. In some areas, vineyards were replaced by olive plantations, which is the only stable land use class. In 1850, cultivated fields were spread across the whole basin, while in 1970, they were concentrated along the bottom of the valley and at lower elevations. The higher slopes, which in the nineteenth century were mainly open and used as pastureland and for haymaking, went through progressive secondary reforestation and, today, woodland is the most prominent land use category, covering over half of the entire basin.

terraces around the villages; (b) how, today, managed or cultivated terraces only represent 26% of the total terraced area. In accordance with the results of Figure 3, which shows the progressive loss of cultivated fields and vineyards in the rural parts of the valley, the reduction of managed terraces is more significant in the upper catchment, distant from the main settlements.

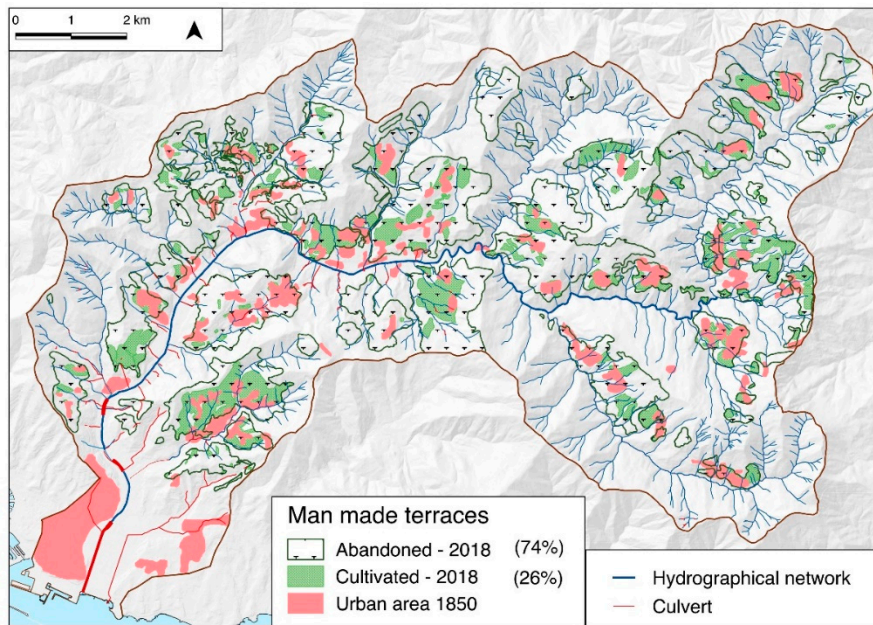
Figure 4. Terraces with dry stone walls map. Abandoned terraces are mainly located far from the urban area.

The map of Figure 4 shows the total surface of terraced areas in the Bisagno catchment (30%) in relation to the Genoa urban area and rural settlements in 1850, highlighting: (a) the distribution of

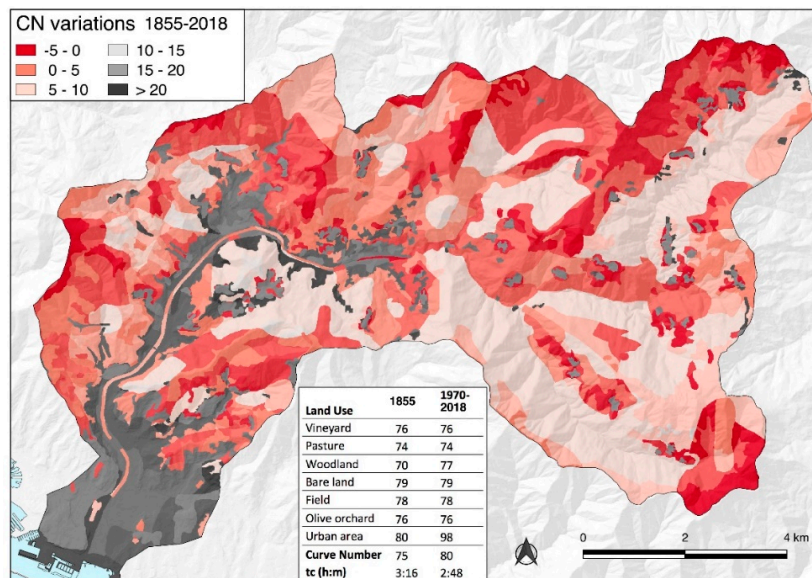
Figure 5. Curve Number variations between 1850 and 2015; the table shows its recent increase which is due to land use changes, particularly the increase in woodland and urban area and the reduction of managed agricultural land.

For the analysis of the Curve Number, we applied the parameters from the SCS-CN tables [61,64] assigning different values to two categories, woodland and urban surface, depending on the year. If compared to 1850, the urban surface, today, is more compact and continuous, particularly because of the presence of a dense network of new asphalt roads (CN = 80–98), while woodlands, today, are in poorer condition due to lack of management (CN = 70–77). The CN passes from 75 in the nineteenth century to 80 in 1970 when most of the landscape variations had occurred. The analyses show an increase in the CN in the last 200 years due to land use changes: the significant CN increase due to urbanisation of the floodplain is only partly balanced by the increase in woodland in the upper catchment (Figure 5). The concentration time passes from 3h 16' to 2h 48'—a very significant variation in a small basin with very rapid hydrological responses.

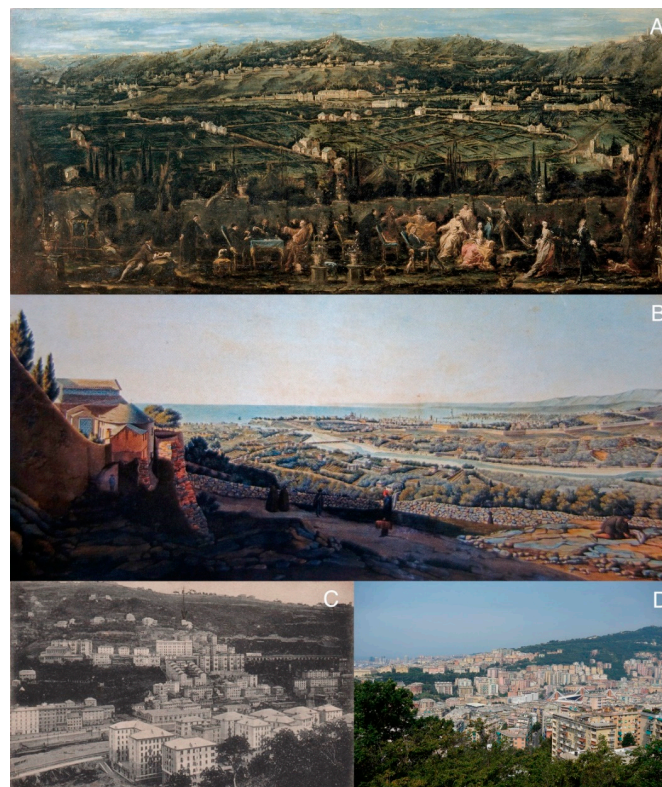
Figure 6. Historical images and landscape changes in the lower stretch of the Bisagno Valley: (A) Alessandro Magnasco, 1740 (collezione Palazzo Bianco, Genova, from <https://bit.ly/33Qw4fZ>); (B) Luigi Garibbo, c. 1825 (Centro DocSAI, Genova, Coll. Topografica); (C) historical photograph, 1929 (from <http://ceraunavoltagenova.blogspot.com/>); (D) present-day. The views, taken from the eastern side of the valley, document the landscape of the pre-industrial period, when the Bisagno area was devoted to agricultural production for the city of Genoa. The urbanization process started in the early twentieth century, initially along the valley and successively on the hills. Today, urbanization is complete.

The comparison between paintings and photographs of different historical periods provides evidence of the remarkable landscape changes in the lower Bisagno valley in the last three centuries (Figure 6). Painting (A) is a view by the Genoese artist Alessandro Magnasco (1667–1749) which depicts the “villa landscape” typical of the Genoese countryside in the pre-industrial period. The painting highlights the regular pattern of walled fields in the valley bottom, which was intensively exploited for agriculture and characterised by scattered houses. The hills around, partly terraced, are completely open and scarcely urbanised, the main settlements being along the ridges. The situation is very similar in 1825—the date of a watercolour by Luigi Garibbo (1784–1869) (Figure 6B). The view is taken from Madonna del Monte, on a prominent hill along the left watershed of the valley which became a very popular viewpoint among artists in the nineteenth century [65]. Garibbo depicts with detail the diverse and well managed rural landscape of the valley in the early nineteenth century, characterised by small cultivated fields, olive orchards and vineyards on terraces, with the city of Genoa, surrounded by the city walls in the background. By 1920, the situation is completely different: these are the years of Genoa’s industrial and urban development, and as the photograph of Figure 6C shows, the bottom of the valley is almost completely built up, while the hill above is only partly urbanised. By this period, the lower Bisagno valley had already almost entirely lost its traditional agriculture, but the process soon involved the hills around the city, which by 1970 also became heavily urbanised. Today, both the valley and the hills immediately above are intensively built up, with only the highest part, next to the old Genoa walls, still open. Hardly any sign of rural exploitation and management is detectable in the landscape.

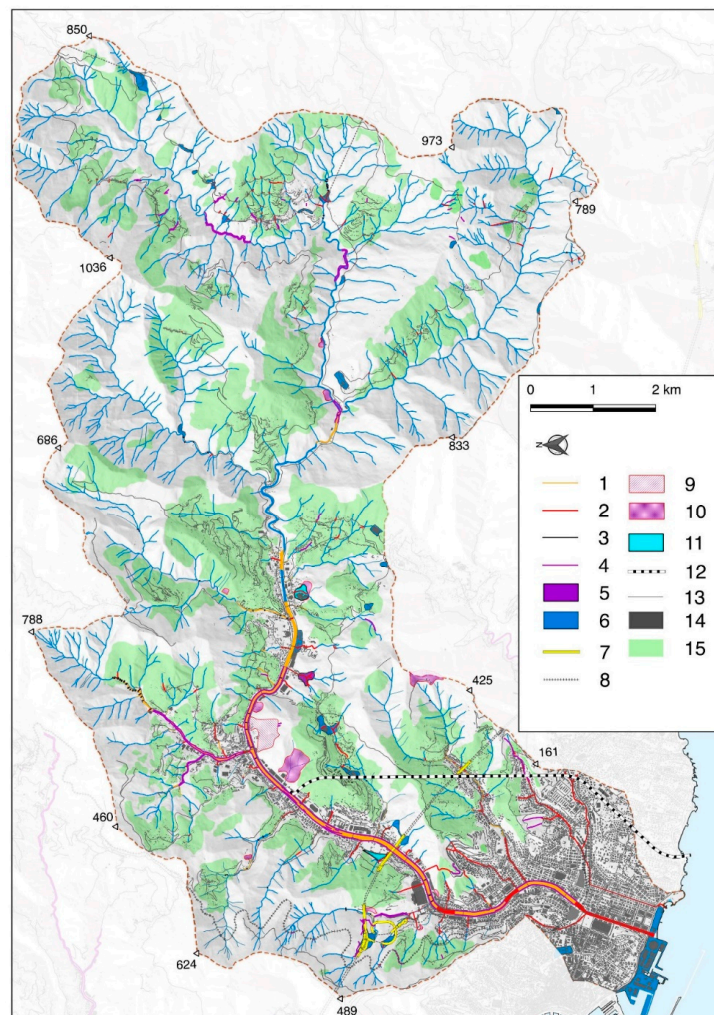
Figure 7. Anthropogenic landforms in the Bisagno stream catchment: MODIFIED RIVER NETWORKS: 1. Artificial rivernetwork; 2. Culvert; 3. Weir; 4. Riverbank. MADE GROUNDS: 5. Dump; 6. Landfill, embankment; 7. Motorway; 8. Railway; WORKED GROUNDS: 9. Active quarry; 10. Inactive quarry; 11. Excavation surface; 12. Drainage channel (final design). INFILLED GROUNDS: 13. Road. LANDSCAPED GROUNDS: 14. Buildings; 15. Terraces (with dry stone walls).

Figure 7 shows the main anthropogenic landforms of the Bisagno stream catchment, an area internationally known for its artificial grounds that have been a dominating morphogenetic process since the C19th. Rosenbaum et al. [66] classifies them into made ground, worked ground, infilled ground and landscaped ground. an additional category is represented by main and secondary hydrographical network. Amongst made grounds, we can summarise dumps, landfills, sea embankments, railway and motorway. Worked grounds are open quarries for the extraction of marly limestone, whose unmanaged fronts often undermined slope stability. Amongst infilled grounds, there are mid-slope roads, with cuttings and fills and some quarries, partly refilled today. Terraces are a particular example of landscaped ground; their building, which probably dates back to the Middle Ages [16], means significant modifications of the slopes of the most superficial stratigraphy of the soil. Built up areas are landscaped grounds too, both along the valley and on the slopes; their buildings entailed a large movement of material, although in this case the distinction between areas of excavated and areas of made ground is difficult to discern. The main hydrographical network has been intensively modified, with culverts, canalisations and narrowing of the river bed, while minor streams are characterised by river bridles built to reduce erosion and improve embankment stability. The valley is crossed by a railway track and by a motorway, while a mid-slope narrow-gauge railway goes along the right-hand side of the valley.

Anthropogenic landforms characterize the final stretch of the valley floor, but important modifications also involved the valley slopes, as shown by Figure 7. Moreover, a very dense network of paved roads has replaced the old mule tracks, increased soil sealing and cut through the slopes, contributing to soil instability and modifying the hydrographical network.

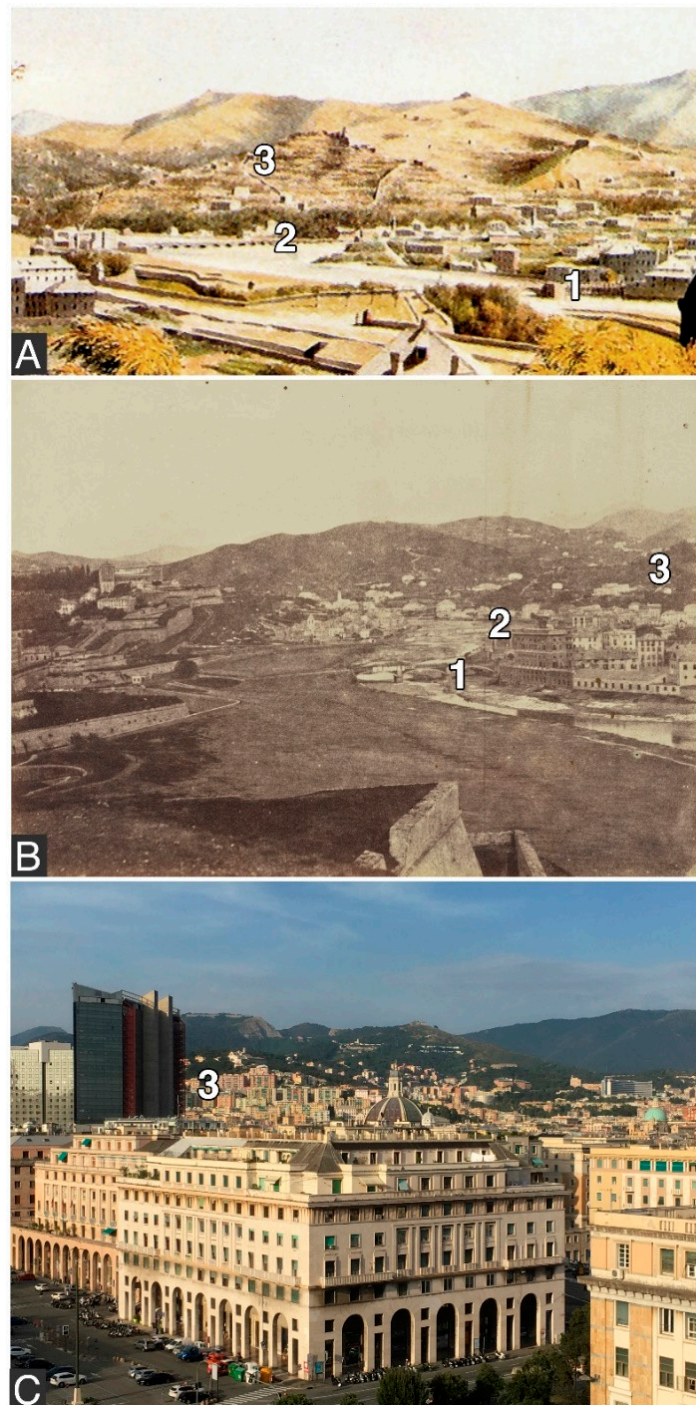
Figure 8. Photographical comparison of the final stretch of the Bisagno floodplain from the western side of the valley at Carignano: (A) L. Garibbo, 1822 (Centro DocSAI, Genova, Coll. Topografica); (B) Jane St John, *Genoa from the Ramparts*, 1856–1859; The J.Paul Getty Museum, Los Angeles, Digital image courtesy of the Getty’s Open Content Program; (C) present-day. The numbers show three specific sites of the valley. 1: Pila bridge; 2: Sant’Agata bridge; 3: Monte hill.

The Bisagno riverbed channel has been severely constricted in the last 200 years. Figure 8 focuses on the terminal stretch of the valley, providing evidence of the progressive narrowing of the riverbed alongside urbanisation. The process of urbanization of the Bisagno floodplain started in the first decades of the twentieth century and, today, the area is almost completely built-up. The first drawing, by the Genoese artist Luigi Garibbo shows the situation in the early nineteenth century, with the wide and empty river bed of the Bisagno crossed by the St. Agata and Pila bridges; before the narrowing of the river channel, they were respectively 280 and 120 m wide. The floodplain had several water channels used for irrigation and water regulation. Until 1823, the village of Borgo Pila, next to the river mouth, was five metres higher than today; it was lowered at the end of the nineteenth century to facilitate the road link with a new road to the centre of Genoa (now Via XX Settembre) over Pila Bridge. In addition, a small hill between Borgo Pila and the city centre, which was part of the river's western edge, was dismantled in the same period. The situation is similar in the mid-nineteenth century, when the British photographer Jane St John (1801–1882) took a photograph of the area from the old city walls (*FrontiBasse*); the riverbed is wide and open, and the landscape has only scattered buildings and settlements. Today, urbanisation is complete—the embankments are characterised by roads, warehouses and factories while the alluvial plain and the sides of the valley are heavily built up with residential buildings and more culverts were established. The bridge of St. Agata is no longer visible from the same viewpoint; it is 70 m wide and only 5 arches remain of the original 28, while the Pila Bridge no longer exists.

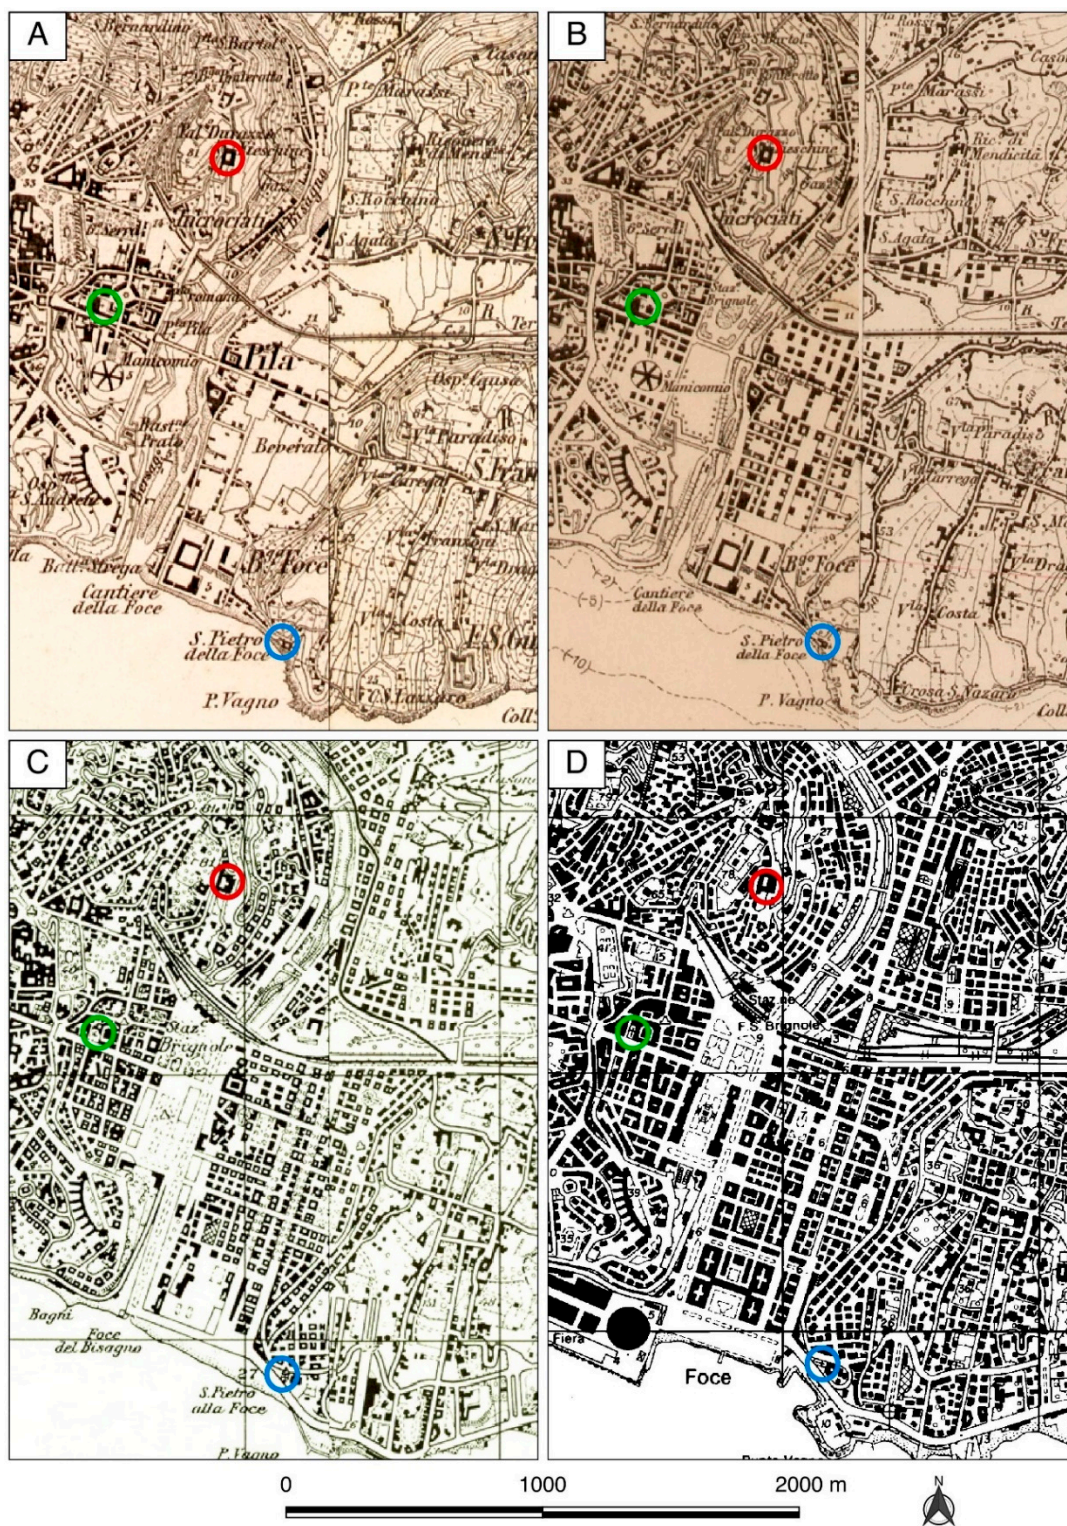
Figure 9. Multitemporal comparison of historical maps of the terminal stretch of the Bisagno Valley: (A) Tavoletta Istituto Geografico Militare Italiano (IGMI), 1878; (B) Tavoletta IGMI, 1907; (C) Tavoletta IGMI, 1939; (D) Regione Liguria, 1997. **Blue circle:** San Pietro church; **Green circle:** Consolazione church; **Red circle:** Fieschine convent.

Figure 9 documents the gradual occupation of the fluvial plain as shown in historical maps from four different periods between 1878 and 1997. The buildings have increased from 65,000 to 305,000 from the second half of the nineteenth century to today [67] and the river width decreased dramatically, passing from c. 250 metres (1878) to 50 metres (today) at St. Agata. By 1930, new buildings, roads and railways had been established including the new Genoa–Tuscany railway line and Brignole railway station, and the river was already partly channelled. The maps show the urbanisation of the plain and the construction of the final culvert on the Bisagno in c.1930. However, the flow section was based on incorrect calculations which underestimated the maximum flow rate of the Bisagno, based on the assumption that the maximum flow rate could not exceed 500 m³/s [45]. This value is significantly smaller than the water flow peaks that, in recent years, the stream has reached during its most violent floods. In the same period the Fereggiano Stream (the last left tributary of the Bisagno), was embanked first and then covered for over 1 km. Other parts of this stream were culverted in the 1950s and at the beginning of the twenty-first century. Today, almost 40,000 people live in the terminal stretch of the Bisagno Valley (Foce district), characterised by a very high flood hazard [33].

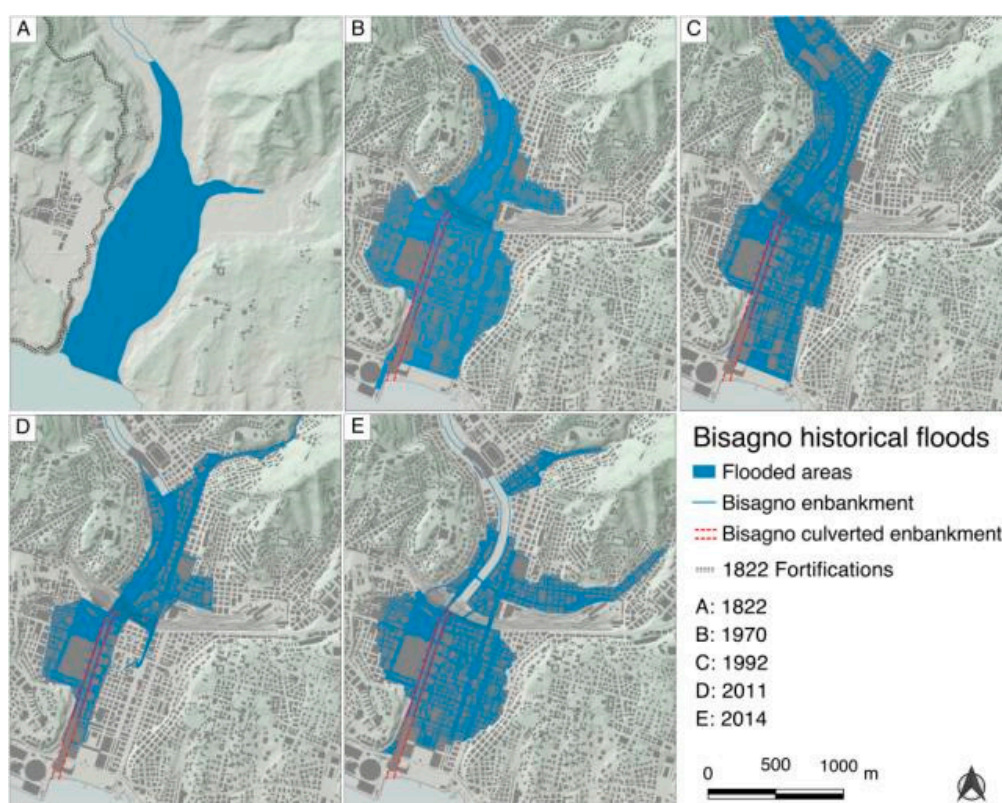
Figure 10. Historical flooded areas of the Bisagno floodplain during the most significant flood events of the last two centuries. Since 1970, the Bisagno floods have affected a densely urbanised area.

century. The maps of Figure 10 show the flooded area of the five most significant flood events of the period. The terminal floodplain is flooded in every flood event, although with different distribution and water heights depending on the flood entity and the morphological and urbanisation conditions.

The 4 November 2011 event was a flash flood which struck the Fereggiano Valley with a peak of rainfall of over 500 mm/6 h [32]. The stream rapidly overflowed at approximately 1 pm, flooding the roads and washing away cars, buses and people; maximum water height was 1.5 m. There were six fatalities and 150 million euros of damage. The rainfall and discharge peaks were concentrated in the Fereggiano, the tributary of the Bisagno, and the flooded surface shown in Figure 10 is different from the others.

There is clear evidence that the frequency of floods in the post-war period was higher than in the nineteenth and early twentieth century. The comparison of inundated surfaces for five different flood events showed similar flooded areas (Figure 10). There are, however, substantial differences between the flood of 1822, when the floodplain was not urbanised, and more recent floods. In the nineteenth

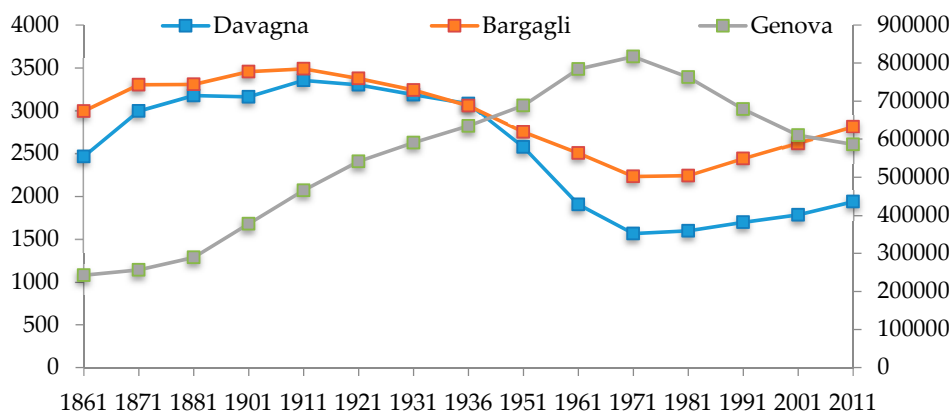
Figure 11. Demographic changes in the Bisagno Valley Municipalities in the last 150 years (data from Italian Institute of Statistics).
