Esthetic restoration of dental fluorosis with ceramic veneers: A case report.

Abstract

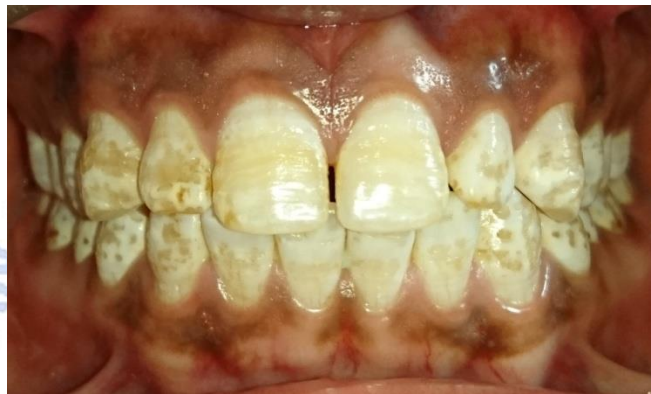
Figure 1

A 21-year-old male reported with chief complaint of stained teeth (Figure 1) History revealed that his native village has endemic fluorosis. According to Dean's fluorosis index, the case was classified as SEVERE.^[7] There was midline diastema. No gross TMJ derangement was detected. The patient had no interference during protrusive or lateral movements. Overjet and overbite was optimum (2mm). Treatment plan decided was indirect porcelain veneers with lingual wrap technique for maxillary and mandibular anterior teeth.

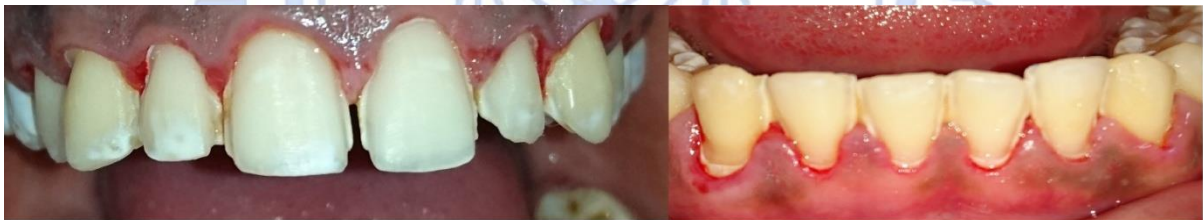
Figure 2

After diagnostic impressions, teeth preparation started. Depth-cutting diamond burs were used to keep depth of preparation 0.5 mm. Cervically preparation was subgingival to maximise esthetics (Figure 2). Proximal preparations were kept short of contact points facially for all teeth except maxillary central incisors (Figure 2). The incisal preparation was a lingual wrap design where the incisal edges were reduced by 1mm and preparation extended lingually/palatally by 0.5 mm from the reduced edge. The lingual preparation was terminated in butt joints. Shade selection (VITA Classical shade guide) was done under natural daylight.

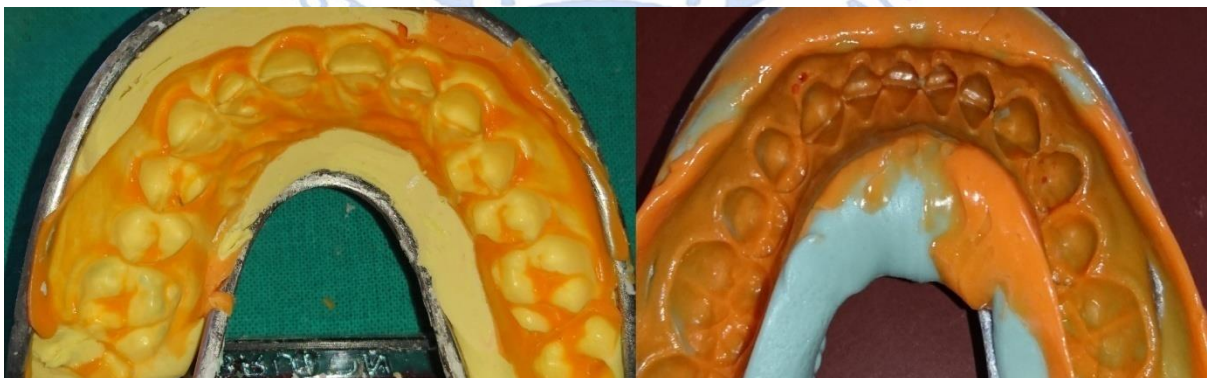
Figure 3

Impressions were made for both arches on same day using putty and light body (ZETAPLUS PUTTY AND KIT, ZHERMACK SPA, ITALY). Fig3 Prior to that, gingival retraction was done (ULTRAPAK KNITTED RETRACTION CORD #000, ULTRADENT, GERMANY). Since, the veneers were cemented in 48 hours, temporisation was not done. The laminates (IPS Empress Emax) (Figure 4) were tried in using a drop of glycerine. The shade was analysed, finish lines assessed and incisal interferences in maximum intercuspation corrected. Following adjustments, they were glazed and cemented.
