Reclamation of the Enugu Coal Mine Site at Abandonment

Abstract: Mining of coal (fossil fuel) resources in Enugu resulted in groundwater pollution/depletion and left the mine site with the potentials of air pollution, loss of landscape/aesthetic degradation and soil contamination. Other Environmental impacts were extensive soil damage, alteration in microbial communities and affecting vegetation leading to destruction of vast amounts of land and displacement of dwellers. Reclamation is the process to restore the ecological integrity of these disturbed mine land areas. It includes the management of all types of physical, chemical and biological disturbances of soils such as soil pH, fertility, microbial community and various soil nutrient cycles that makes the degraded land soil productive. Mining does not mean permanent loss of land for other use. On the other hand it holds potential for altered and improved use apart from restoring for agriculture, forestry and irrigation. This paper attempts to view the best practices for reclaiming the abandoned Enugu coal mine site which ceased production since 2002.

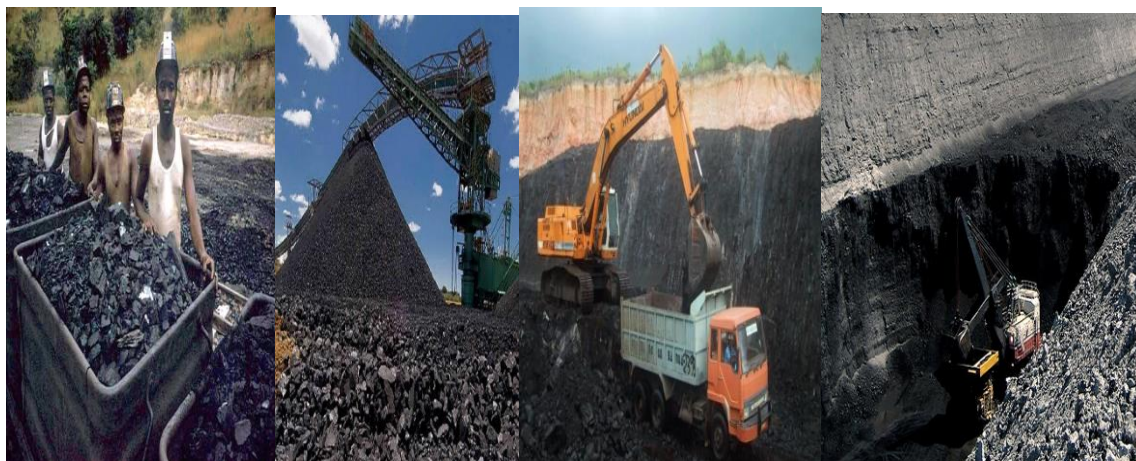
Figure 6: Enugu Ekulu Coal Mine (ejatlas.org; engineersforum.com.ng; mosaicmanagementltd.com and grassroot.ng)

The first discovery of coal was in 1909, in Enugu, at the ridge of Udi. This was discovered by a British mine engineer called Albert Kitson. Coal extraction (figure 6) started with the Ogbete mine in 1916. The Enugu coal mine production attained about 183,012 tonnes in 1920 and about 574,758 tonnes in 1960. However, production got crippled and abandoned in the mine due to the civil war which went on the 6th of July, 1967 to 15th of January, 1970. All efforts for revamping and recovery met a brick-wall. The major aim for the application of the Enugu coal is for the running of the Nigeria railway works.

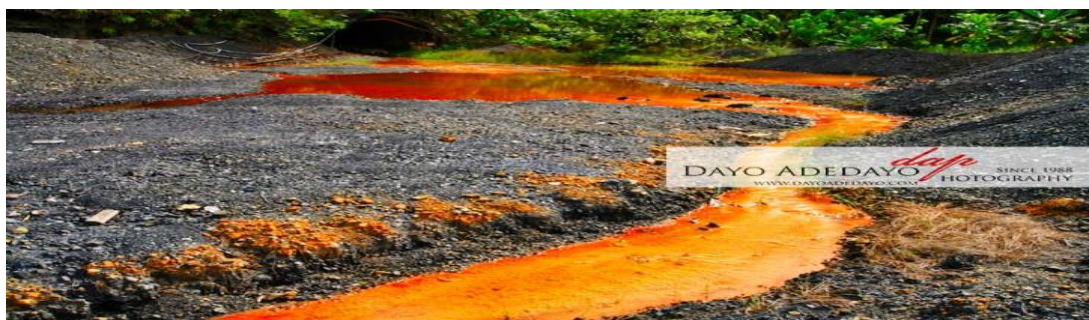
Figure 7: Acid Mine Drainage in Enugu coal mine causing Water and Soil Contamination (dayoadedayo.com)

Apart from landscape damage, the operations of mining create sands that are laden with heavy metals that have mixed with the parental soils which eventually contaminates land areas and water bodies (see Figure 7).

- a) The main sources of pollution associated with mining is acid mine drainage (AMD) (see Figure 7) caused by pyrite (especially exposed iron sulphide) which reacts with the water and oxygen, forming sulphuric acids and dissolving iron which later precipitates (yellow, orange or yellow sediments) down to aquifers sources (surface and ground water) which invariably causes harm to man, wildlife and the environment (Ezemokwe and Madubuike, 2015) WHO (2011) also made report of a total dissolved solids (TDS) values that range between 21.80 mg/l and 520 mg/l that were below their permissible limits of 0.00-1500 mg/l even though these may still be hazardous to the aquatic ecosystem in the location (WHO, 2011).
- b) Slurry tailings that are dumped into water or close to it contaminates it through leaching which leads to death of aquatic life and hazards to the ecosystem.
