DURABILITY OF WHOLE CULM BAMBOO: FACTS, MISCONCEPTIONS AND THE NEW ISO 22156 FRAMEWORK

Sebastian Kaminski, Arup, UK, sebastian.kaminski@arup.com
Kent Harries, University of Pittsburgh, kharries@pitt.edu
Luis Felipe Lopez, Base Bahay, luis.lopez@base-bahay.com
David Trujillo, Coventry University, aa7170@coventry.ac.uk
Hector Archila, University West of England, Hector.Archila@uwe.ac.uk

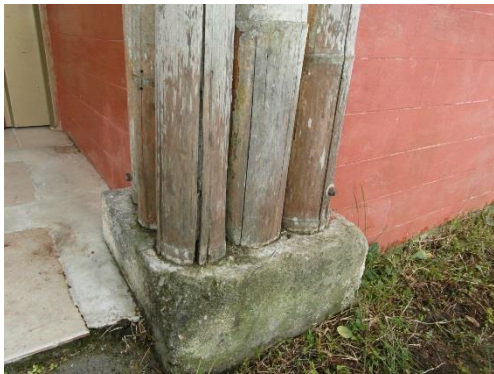
a) Rotten bamboo columns which were exposed to driving rain (Colombia) (Kaminski, 2016)

Rot is not always immediately evident as it is more likely to occur in hidden areas (which are poorly ventilated and therefore stay wet); additionally the fruiting bodies are not always visible. Evidence of severe rot includes a change in sound if the bamboo is tapped, a softening of the culm or a change in colour and texture of the fibres when drilled (Bravery et al. 2003; Lawrence & Ross, 2020). Because rot is not always obvious and may take some years to manifest itself, it is often an underestimated risk to bamboo buildings.

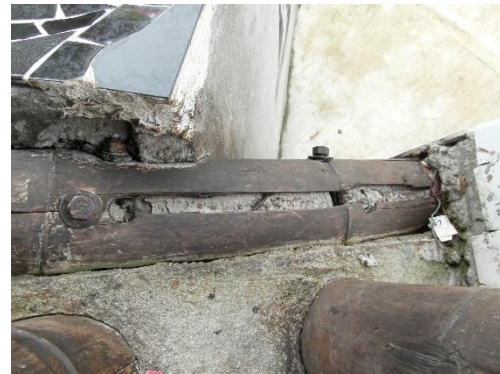
b) Rotten bamboo chord of a bridge, where a bolt hole allowed driving rain to enter (Colombia) (Kaminski, 2016)

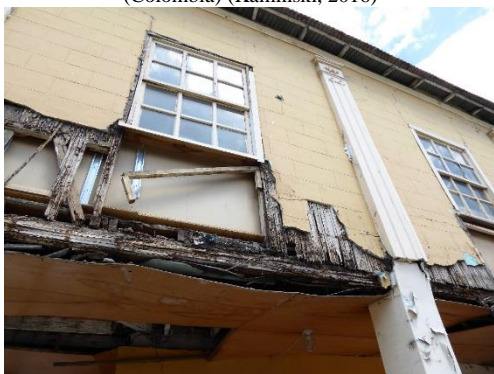
c) Rotten timber and bamboo inside the wall (Ecuador) (Kaminski, 2016)

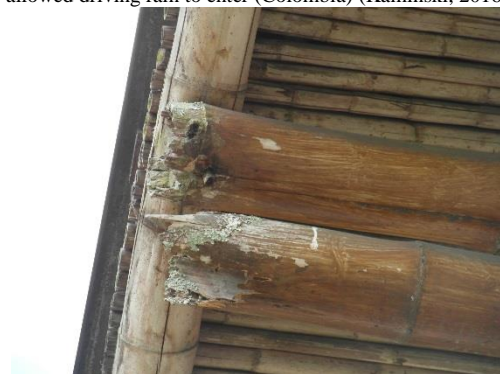
d) Rotten bamboo where a beam was exposed and collected water (Costa Rica) (Kaminski, 2016)

Figure 1: Illustrations of rotten bamboo in different parts of structures

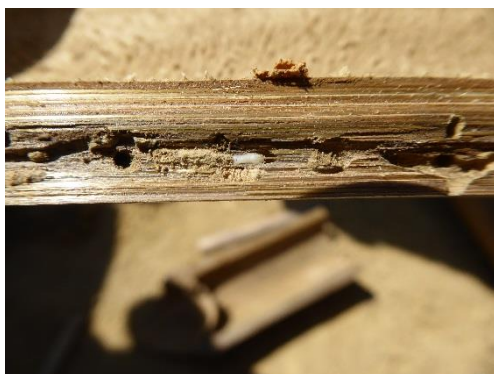
a) Beetle larvae inside bamboo (Bangladesh) (Kaminski, 2016)

Certain beetles are attracted to the starch in bamboo and lay their eggs inside the culm. Upon hatching, the larvae eat along the inside culm (soft and less dense cell-tissue) and eventually through the culm walls to escape, leaving small round or oval exit holes (about 1mm–6mm diameter) (BRE, 2003), as seen in Figure 2. This attack effectively makes many holes inside the bamboo, weakening it by reducing the area available to carry the load.

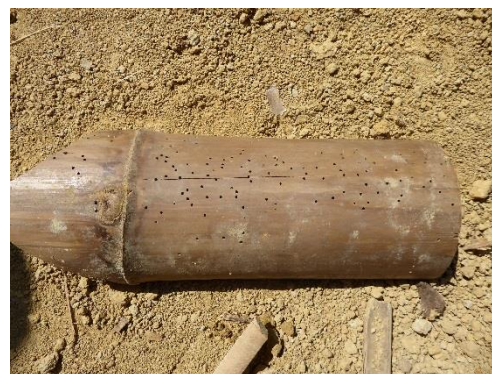
b) Beetle exit holes visible on side of bamboo (Bangladesh) (Kaminski, 2016)

Figure 2: Beetle attack in bamboo

Bamboo which is young (immature), green or when it is exposed to high humidity appears to experience greatest beetle attack (Liese & Kumar, 2003), however even mature and dry bamboo in air-conditioned environments can be attacked by certain species. Species with higher levels of starch such as *bambusa vulgaris* have reportedly higher levels of beetle attack ((liese & Kumar, 2003). There are many different types of beetles worldwide that can attack bamboo (BRE, 2003) found in most warm climates around the world; however, since the method of protecting against beetles remains the same, there is generally no need to distinguish between them. Evidence of beetle attack includes beetle exit holes and small piles of dust of a similar colour as the bamboo.

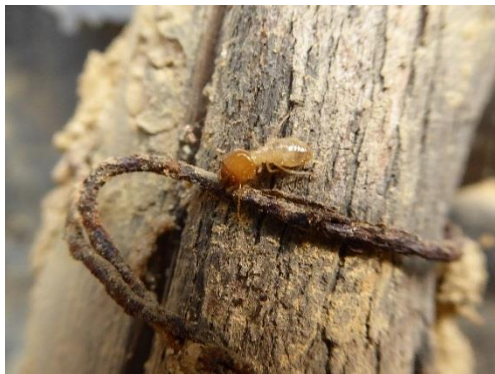
a) Subterranean termite (Bangladesh) (Kaminski, 2016)

Termites are small ant-like insects which live in colonies and feed on plant material (Figure 3a). Termites are also attracted to the starch in bamboo, but unlike beetles, they have enzymes which enable them to break down cellulose (BRE, 1999). Because they live in large colonies they can cause

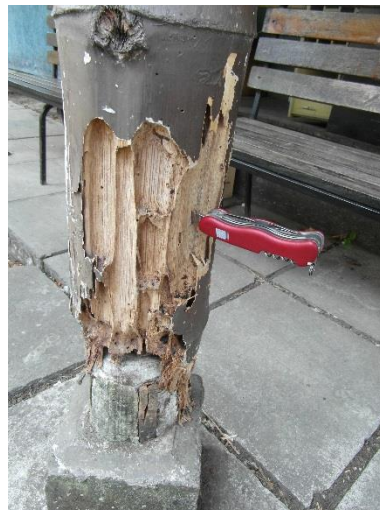
b) Significant termite damage to bamboo column (Costa Rica) (Kaminski, 2016)

Figure 3. Termite attack in bamboo

significant and rapid damage. This attack makes longitudinal tunnels (known as “galleries”) inside the bamboo, weakening it by reducing the area available to carry building load (Figure 3b).
