## Semi-selective demolition: current demolition practices in Flanders

**Keywords:** case studies; demolition; stony fraction, current practices

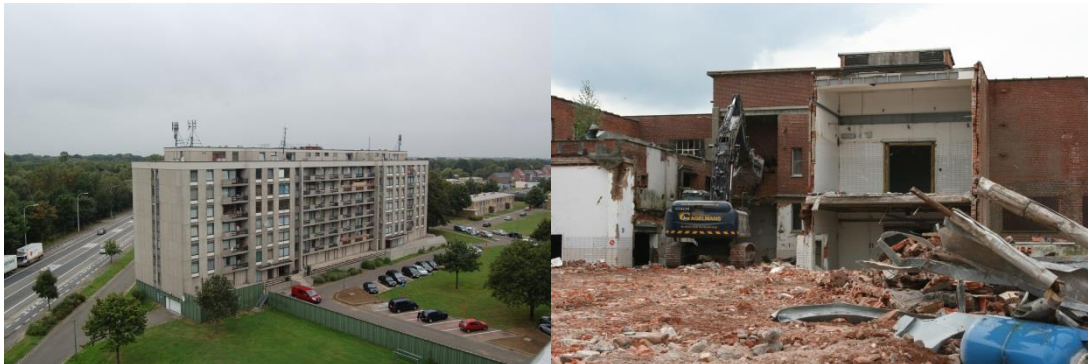
**Figure 1. BAU case studies (left: apartment complex, right: old milk factory).**

In 2 case studies, the demolition works were documented without interfering in the process in order to assess the Flemish business-as-usual (BAU) demolition practices. We selected a complex with 20 apartments and an old milk factory for this task (Figure 1).

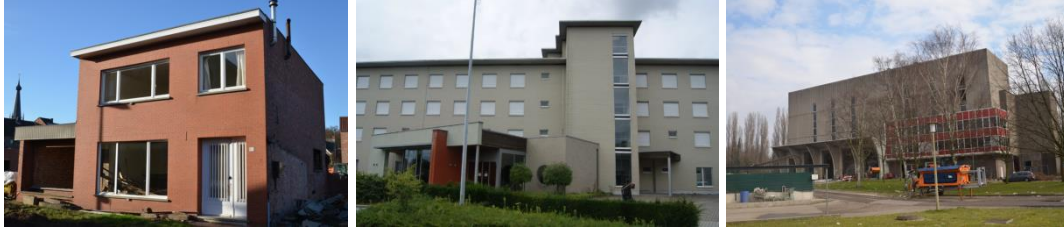
**Figure 2. Case studies for the testing of the monitoring system (left: single family house, middle: residential care center, right: incineration plant).**

Furthermore, a new quality management and traceability system, developed by the Flemish construction confederation VCB, was tested in 3 case studies. This monitoring system aims at the certification and quality assurance of waste streams that originate from selective demolition. We selected the following buildings: a single family house, a residential care center and part of an incineration plant (Figure 2).

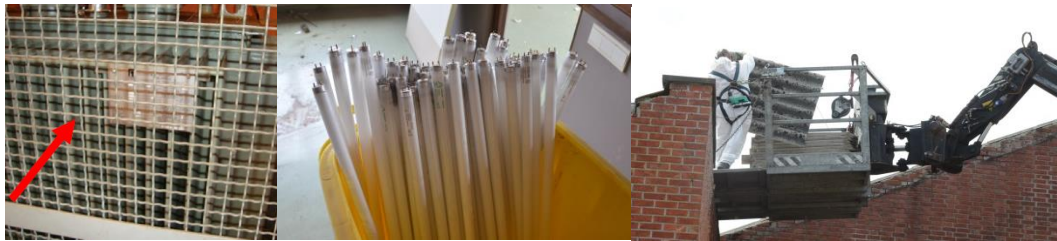
**Figure 2. Hazardous materials (left: PCB-containing transformer, middle: mercury-containing lamps, right: asbestos).**

In a first stage of a BAU demolition project, the hazardous substances (e.g. asbestos, mercury-containing lamps, PCB-containing equipment) that are present in the buildings are removed (decontamination). The performance of this decontamination step mainly depends on legislation and law enforcement.

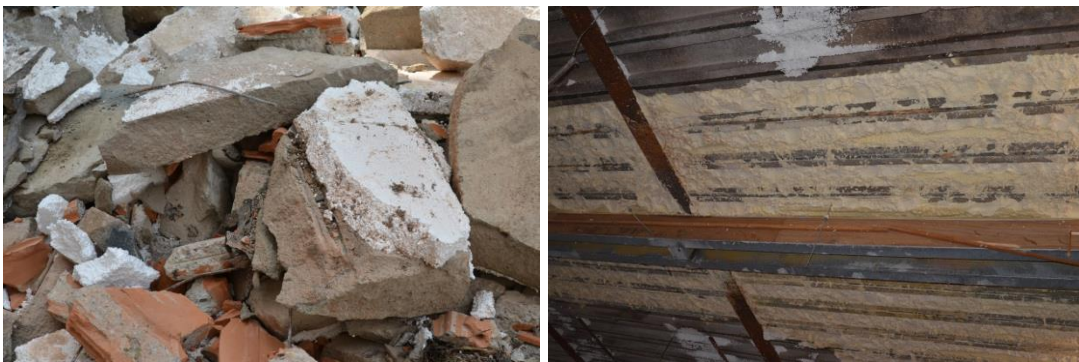
**Figure 3. Examples of complex insulation materials that are difficult to dismantle (left: expanded polystyrene, right: polyurethane foam).**

- **A lack of cost efficient techniques for the selective deconstruction and removal of “complex” materials.** In several studied case studies, this was the case for the removal of gypsum plaster. The presence of gypsum plaster in the stony fraction hampers high-grade recycling but selective removal is labor-intensive. A similar problem arised with the removal of organic insulation materials (e.g. PUR foam) (Figure 3). The presence of the latter is expected to be higher in the demolition projects of the future. It is important to continue to invest in research to efficiently remove these complex materials and design construction products that are easier to dismantle.
